**May
2014**

East Winner Bank Shipwreck

*Archaeological
site visit report*

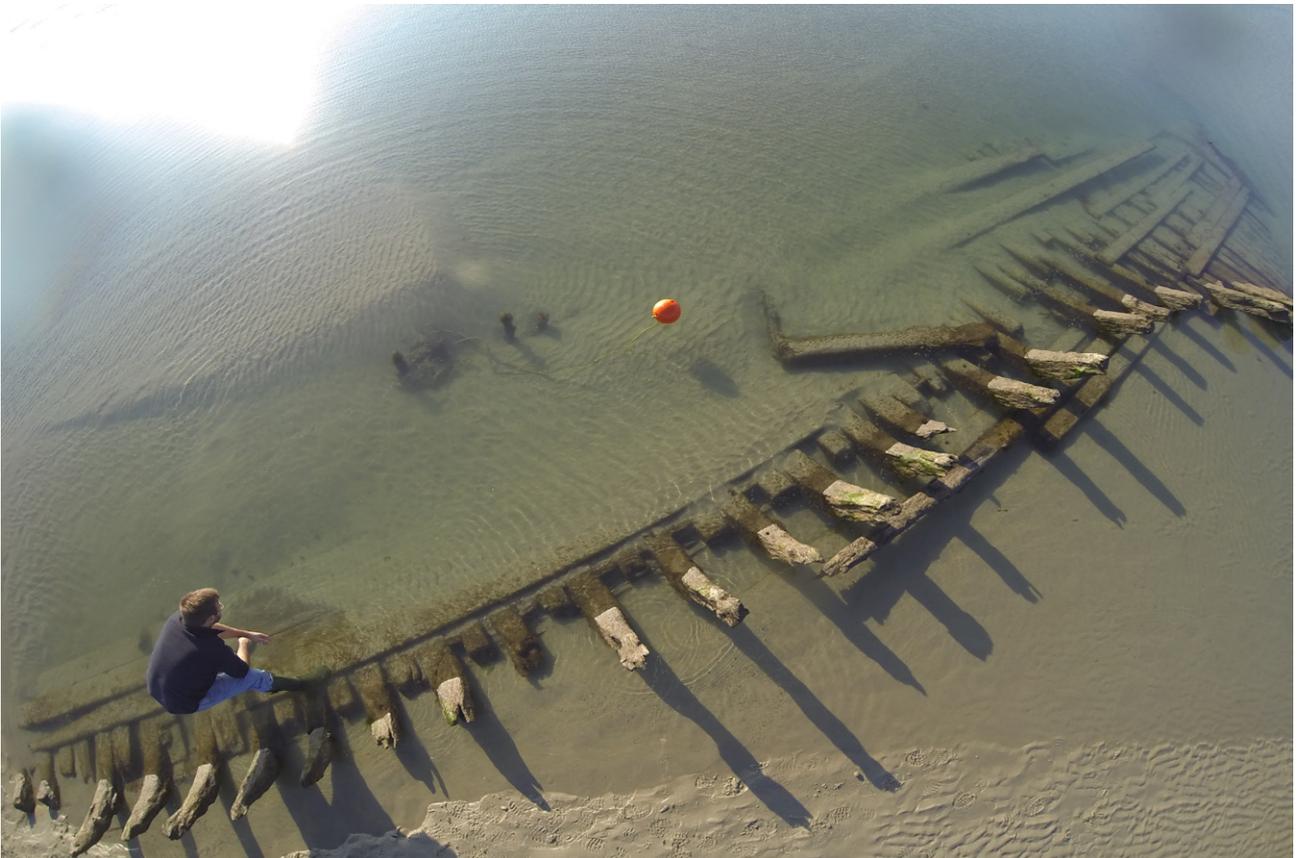
served to scour out the wreck remains (Figure 3) to expose the degraded stern post and much of the port side of the vessel. While on-site it was possible to observe the build-up of sediment in the drainage stream to the west of the exposed remains as the flow rate slows down towards the end of the drainage period and sand becomes deposited. This area probably corresponds to the middle and starboard side of the vessel and it therefore seems likely that a significant amount of the bottom of the vessel is still buried in the centre of the drainage stream (Figure 5). Between the two visits undertaken on the 16th and 29th April, a significant amount of additional structure was exposed at the north of the site, revealing the stern of the vessel, including the stern post. It is clear from this that there is ongoing potential for further elements of the original vessel to become exposed in the future. At present, there is little evidence of any processes of reburial taking place.

Figure 3. General view of the wreck structure, looking northwest on the 29th April 2014.

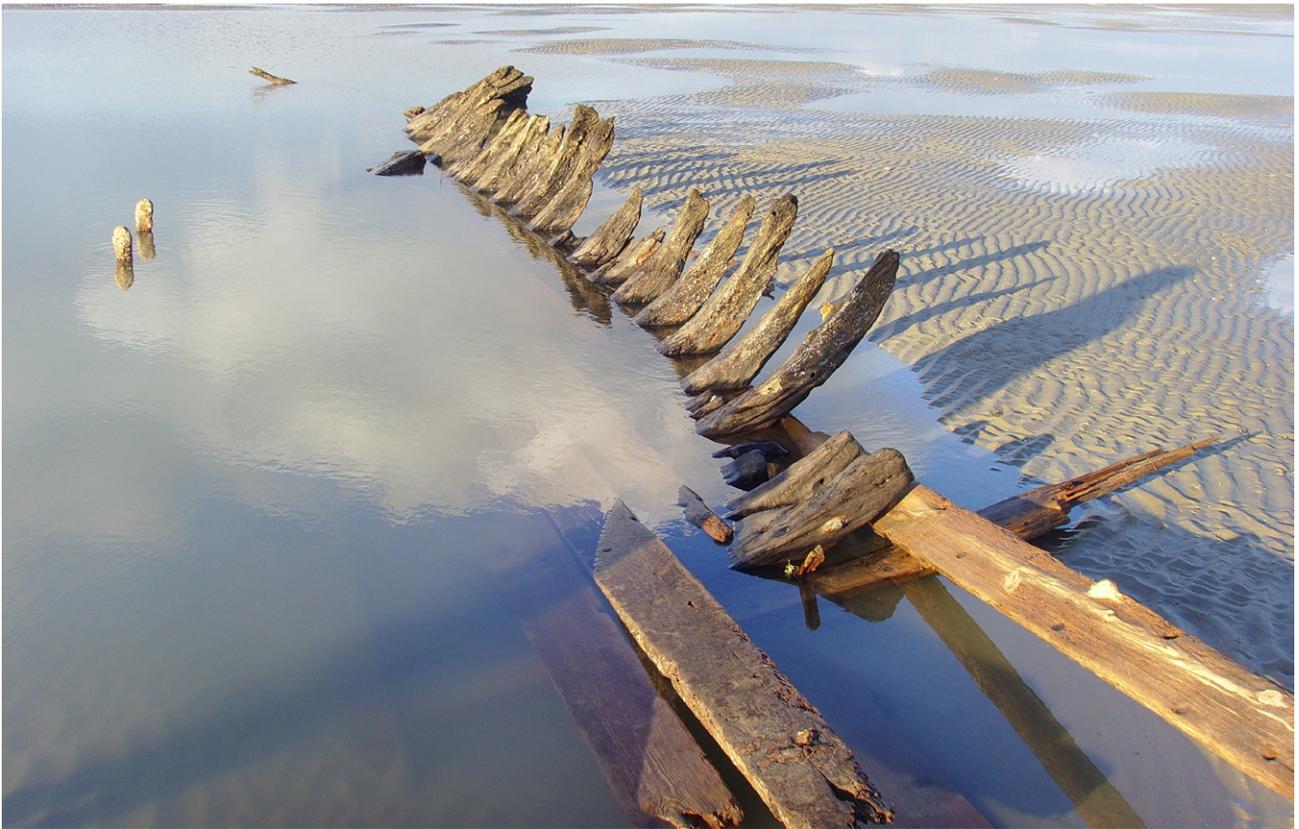
Figure 4. General view of the wreck structure, looking north, on the 3rd January 2014 following its initial exposure. The surfaces of the timbers are largely free from sand and weed cover (Image: Richard Smith).

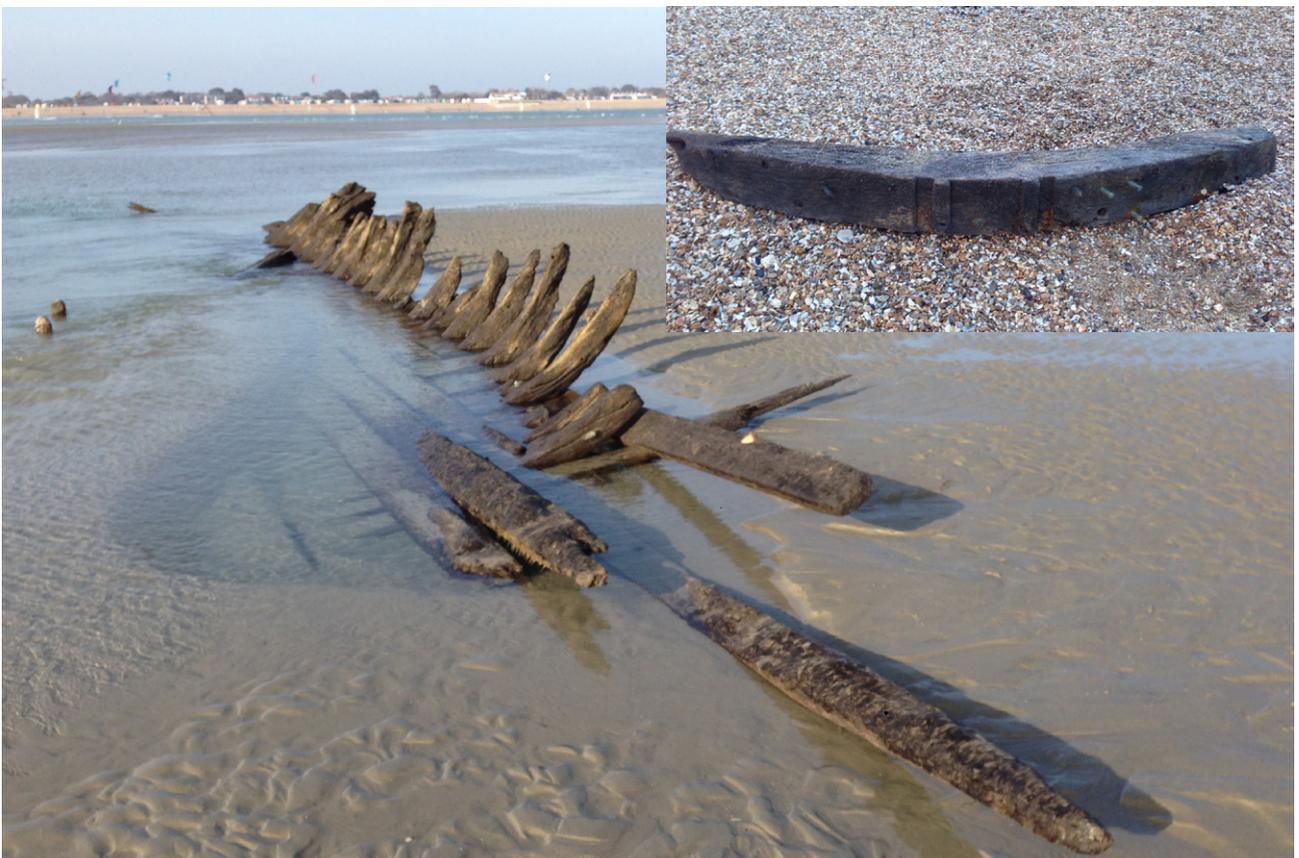
Figure 5. General view of the wreck structure, looking north, on the 29th March 2014. Structure, now buried, is visible to the west of the main structure (Image: Langstone Harbour Board). Inset: Timber washed up on Hayling Beach in February 2014 (Image: Dave Robbins).

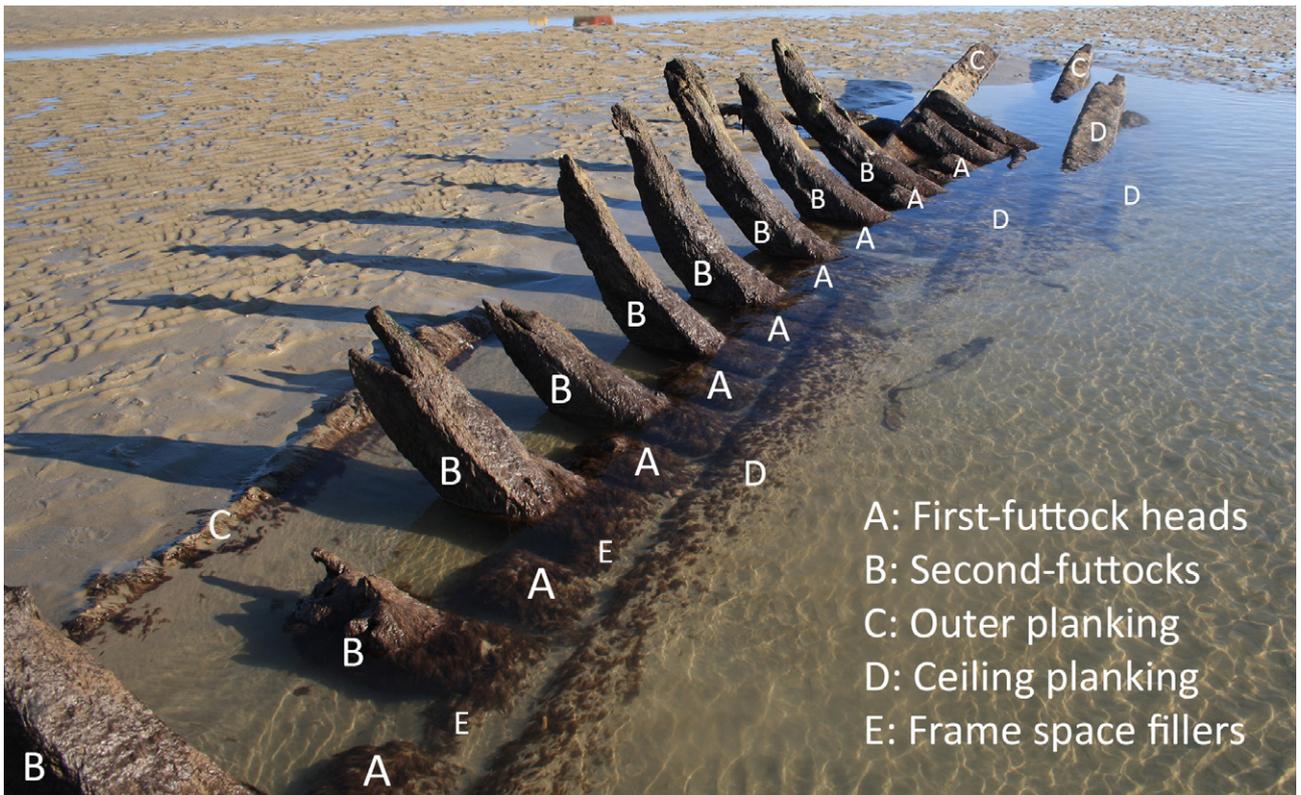
A number of extant planking elements survive on the site and include both outer planking and ceiling planking (Figure 6c&d). As with the framing described above, it seems highly likely that further planking of both types is well preserved beneath the exposed remains and in still buried areas to the west. A number of outer planks survive *in situ* along the eastern edge of the site. On average these are 140mm in width, with a thickness that varies between 70mm and 90mm in thickness. There is no discernable pattern to this, with variation in plank thickness by up to 10mm within a single plank. There is no evidence of any edge-to-edge joining between planks and all observed scarphs are simple butt end joints located at a frame station. One stealer plank was observed that was fastened into place with treenails. There is no evidence of any hull-sheathing, copper or otherwise, on the exterior of the vessel at the time of loss, or having been applied/removed previously.

Figure 6. Overview of the wreck, looking south-east towards the bow, annotated with an interpretation of the main structural components observed during site visits.

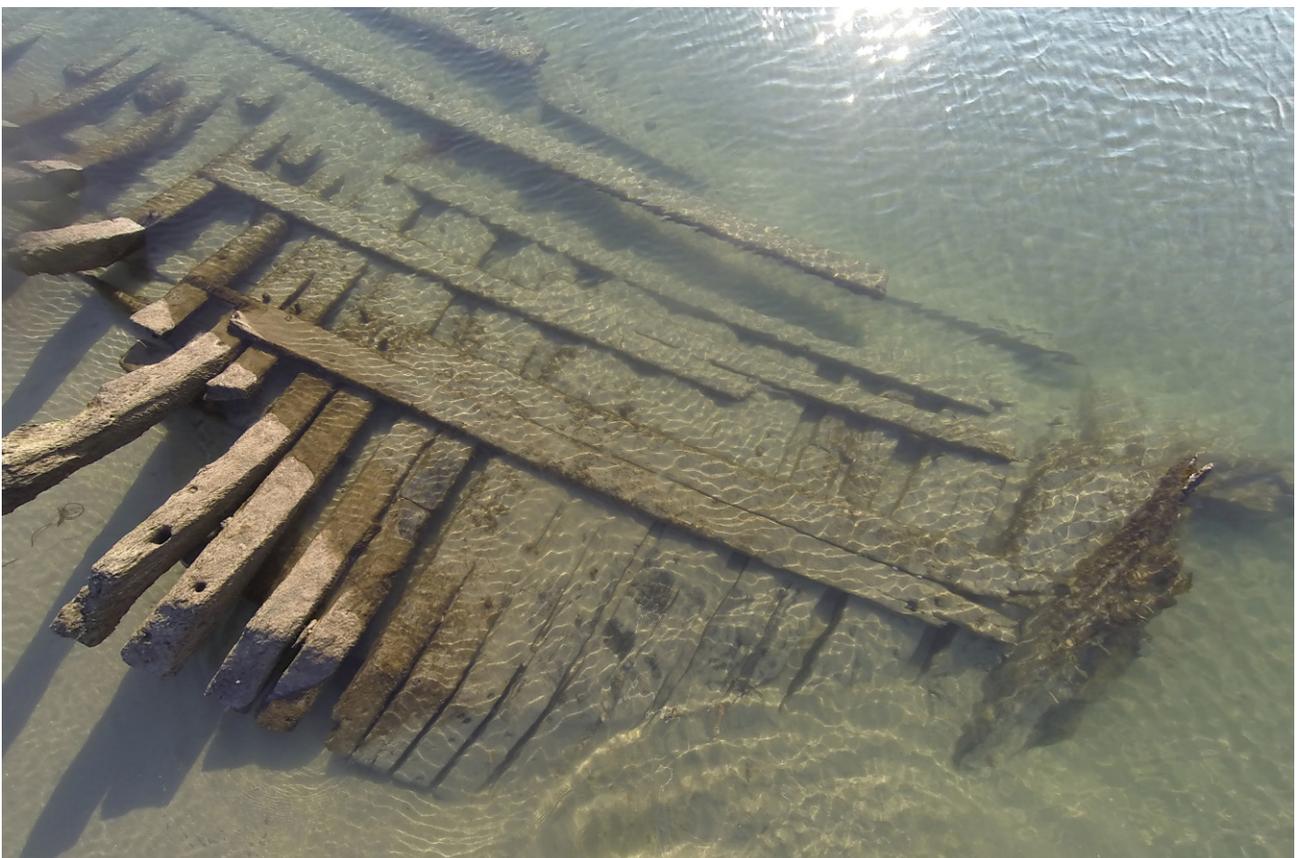
Also in the north of the site is the partial remains of the vessel's stern post, indicated by the *in situ* remains of a rudder gudgeon. The stern post itself is heavily degraded by gribble as well as being difficult to access. A rebate to receive the hood ends of the planking is still visible, along with a line of copper fastenings to secure the hood ends (section 4.3). The diameter of the gudgeon hole is c.60mm and the strap at this point is 65mm tall, before being broken off. The overall form of the gudgeon, albeit slightly larger, is nearly identical to that illustrated by McCarthy (1996: fig. 16). The width of the stern post where the gudgeon strap spans around it is c.200mm.

Figure 7. The stern of the vessel at northern end of the wreck, looking west. The stern post is visible at the righthand side of the picture. Third-futtocks and top-timbers have been trimmed off flush with one another. This area of structure would have originally been far more vertically aligned but has fallen outboard, to lie flat on the seabed.

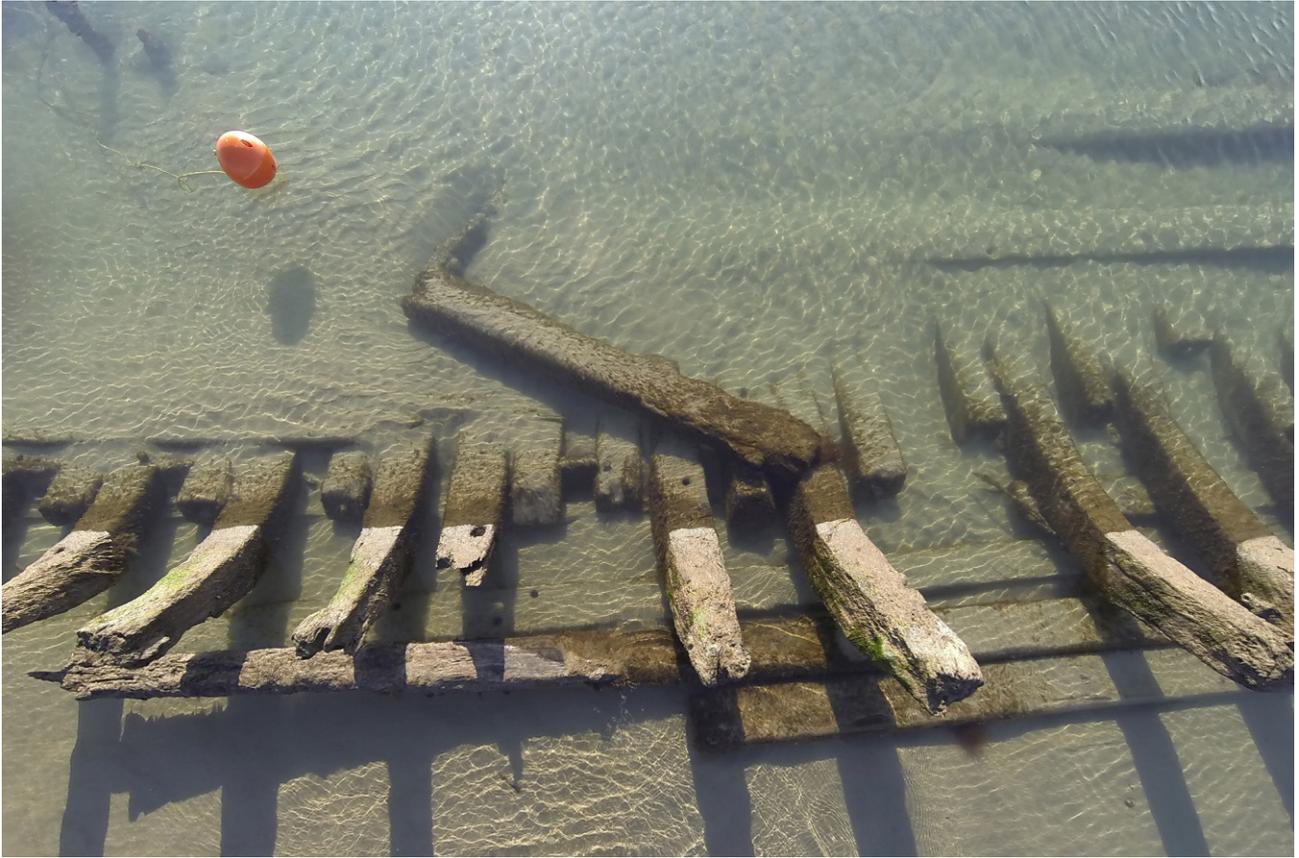
The remains of a substantial timber are located in the middle of the site (Figure 8) that was only fully interpreted when the photographic record of the site was reviewed. This, along with the inaccessible nature of the timber meant that it was not recorded in detail. The timber appears to represent the partial remains of a deck beam, with an iron knee still *in situ* at the western end of it to attach it to the sides of the vessel.

Figure 8. The central area of the vessel, looking west. A partial beam is located in the centre of the wreck with the remains of an iron knee at the western end.

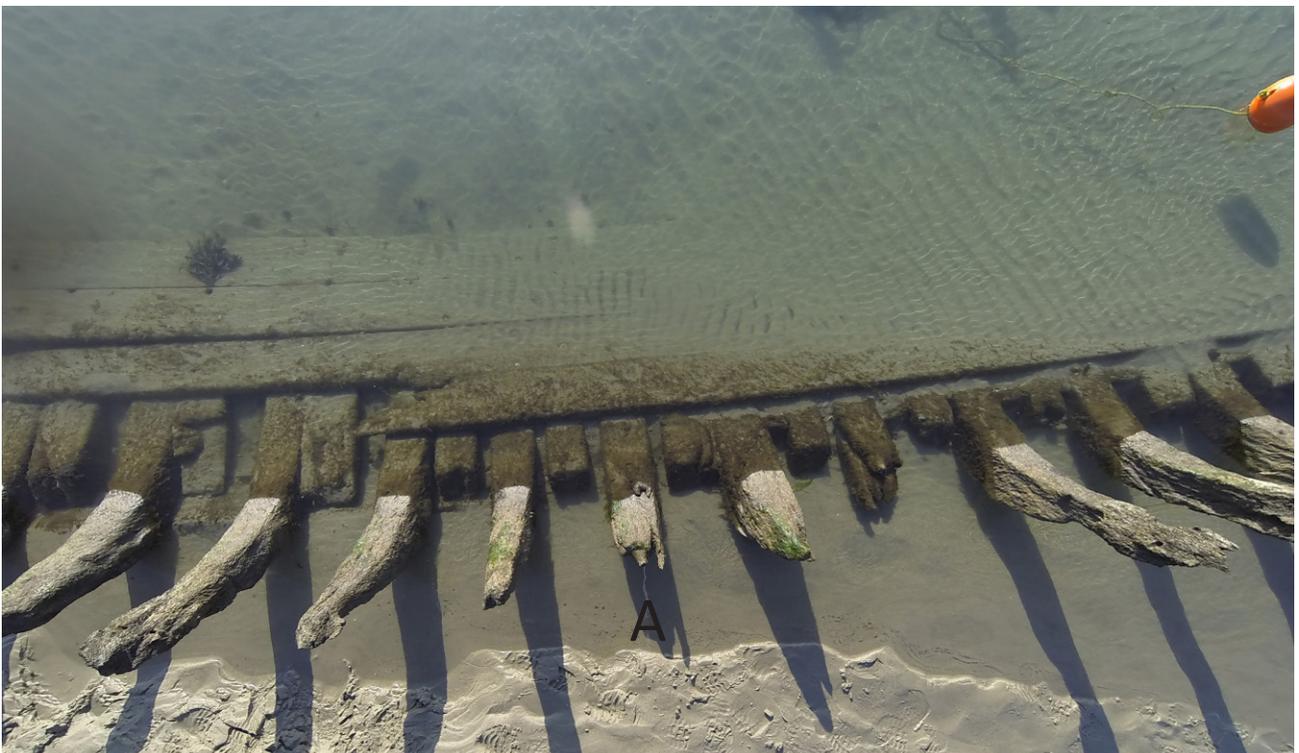
Figure 9. Overview of the disposition of floors and first-futtocks, looking west in the same area as Figure 6 illustrating the transition in the alignment of first-futtocks from the aft face of the floor/second futtock towards the bow (left) to the opposite alignment towards the stern (right). The timber marked 'A' is considered to be the midships timber and/or master-frame.

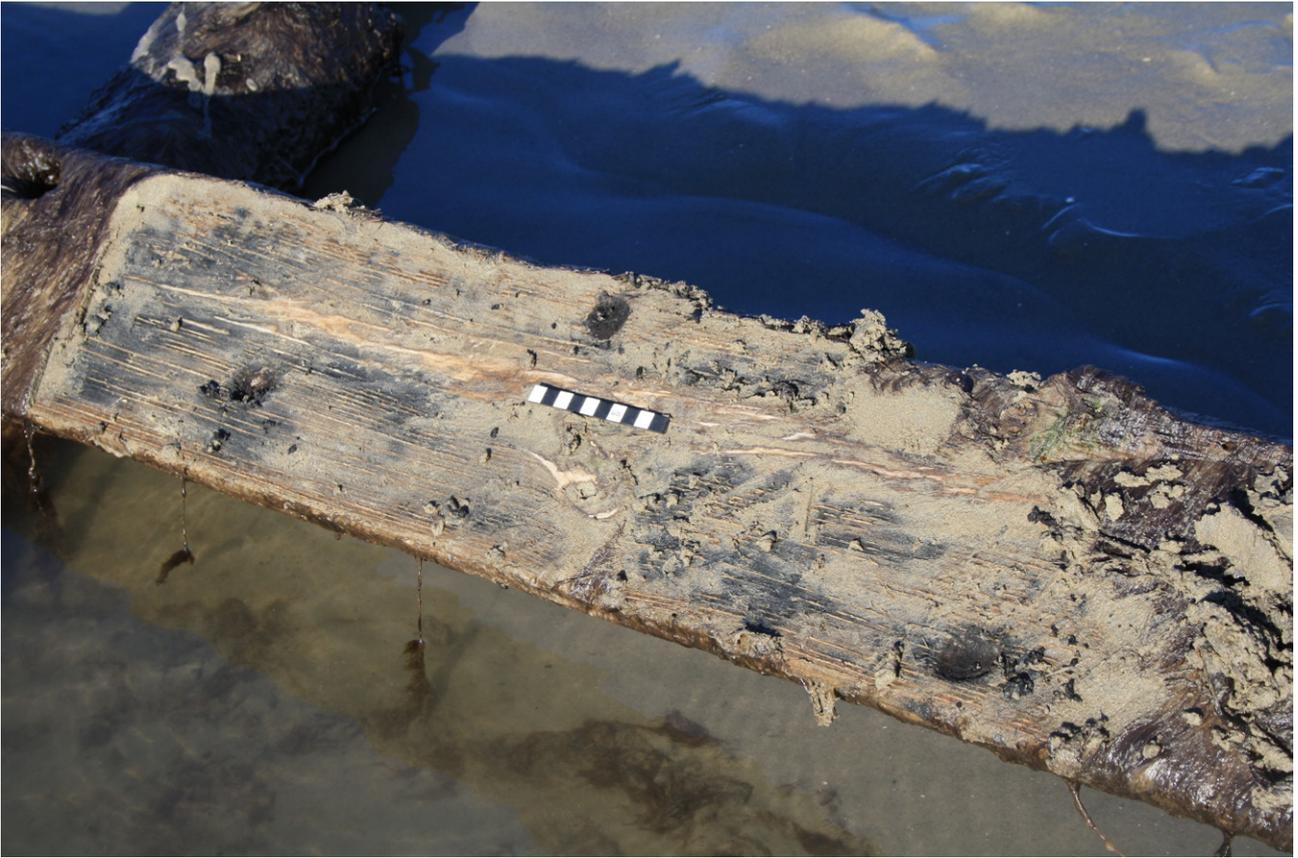
Figure 10. Detail of the inner face of an outer plank, following the removal of some of the covering sand. Treenails are visible in the form of circular patches of darker wood (scale = 10cm).

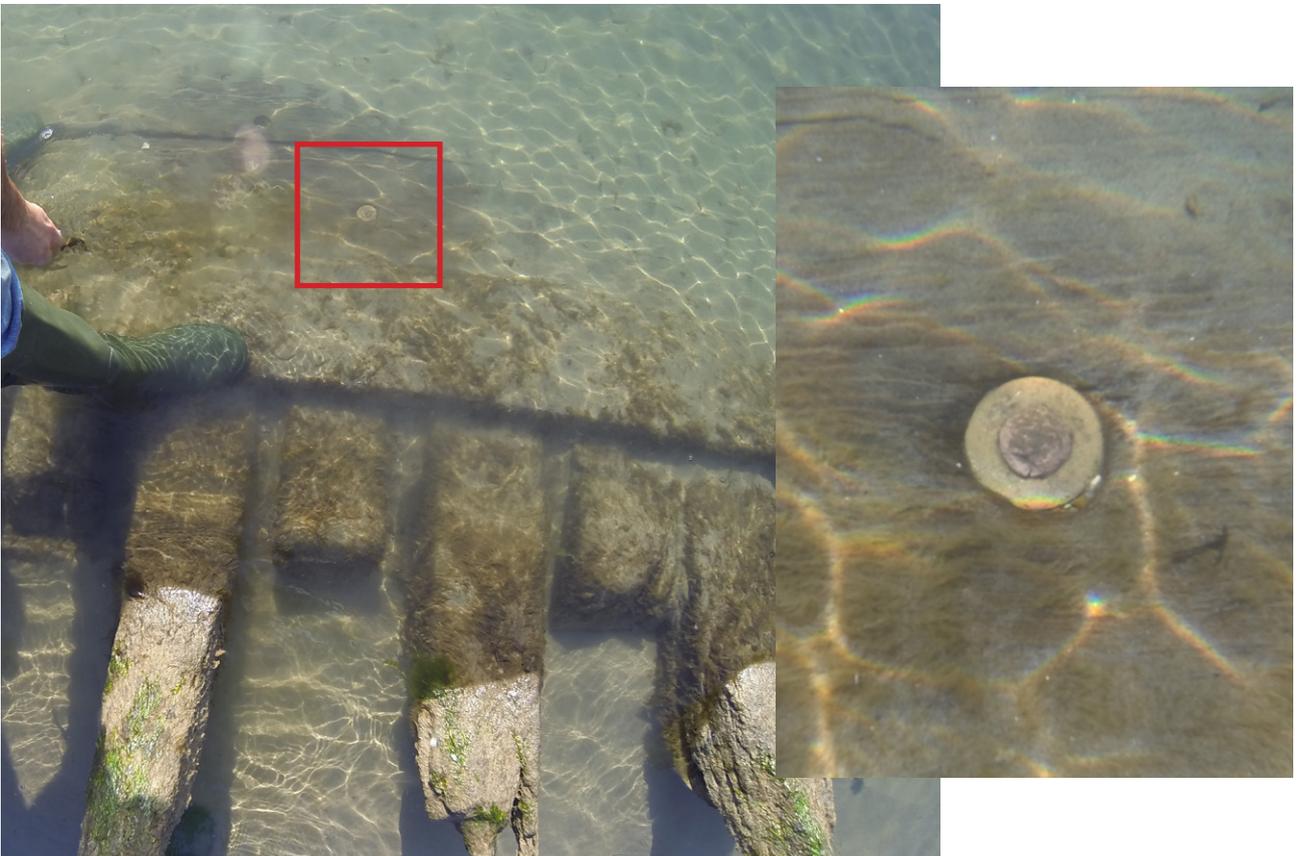
The presence of two non-copper washers in conjunction with a copper bolt for a repair to the ceiling planking in one area of the vessel is therefore instructive. Such a combination was unlikely to have been used prior to the mid-1830s and its use on the East Winner vessel is a clear deviation from the tradition within which the rest of the ceiling planking was fitted. It therefore seems likely to be a repair to the vessel carried out during its lifetime. Overall, the most plausible explanation is probably for construction of the East Winner vessel prior to 1832 with a subsequent repair after that date, but probably not significantly later. It should be emphasised that this is based only on visual inspection of the copper and copper-alloy fastenings, rather than on any metallurgical analysis which would probably serve to refine the date further.

Figure 11. A pair of copper bolts and non-copper washers were used to replace the original wedged treenails that fasten the ceiling planking in place. Inset: detail.

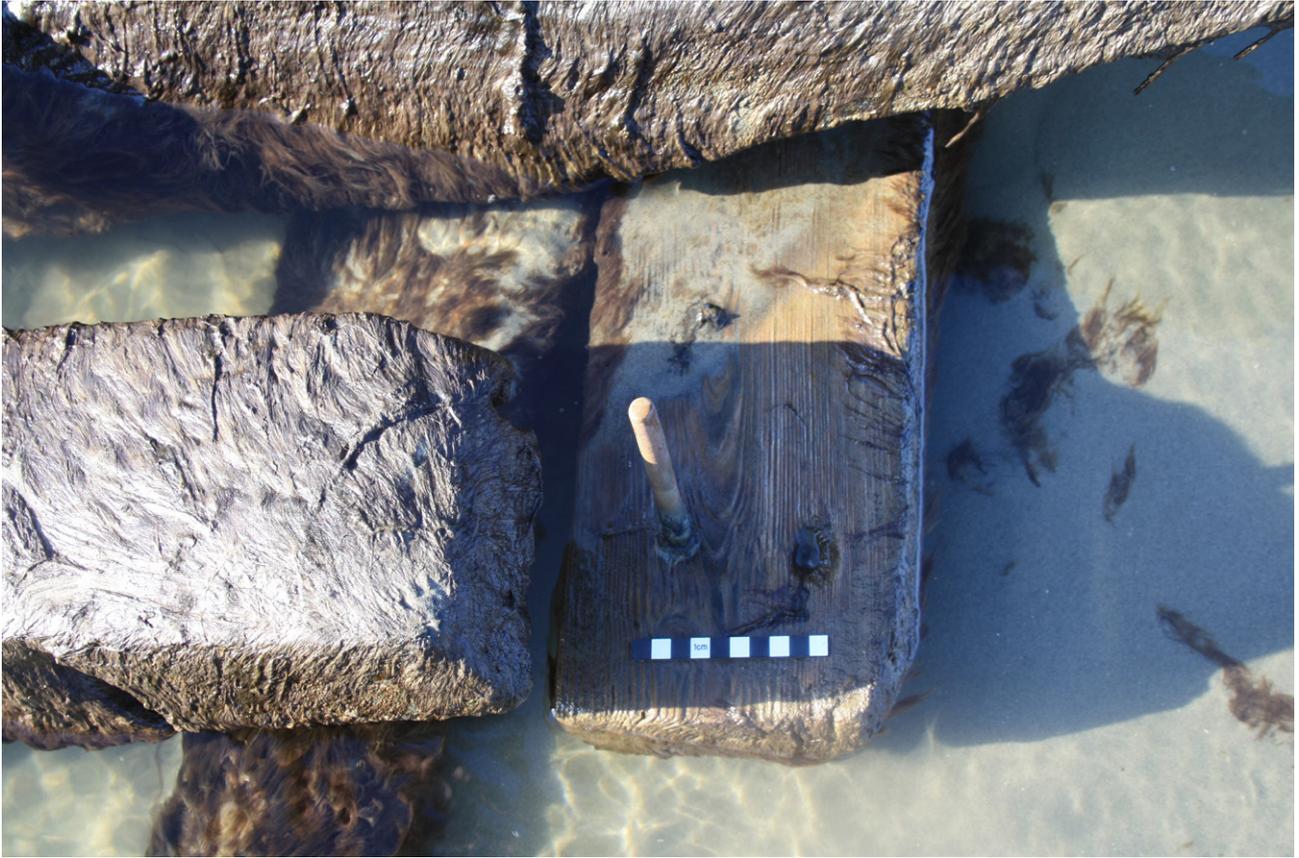
Figure 12. Planking butt end containing a retained copper fastening bolt. A hole for a second (upper) bolt is to the right (scale = 10cm).

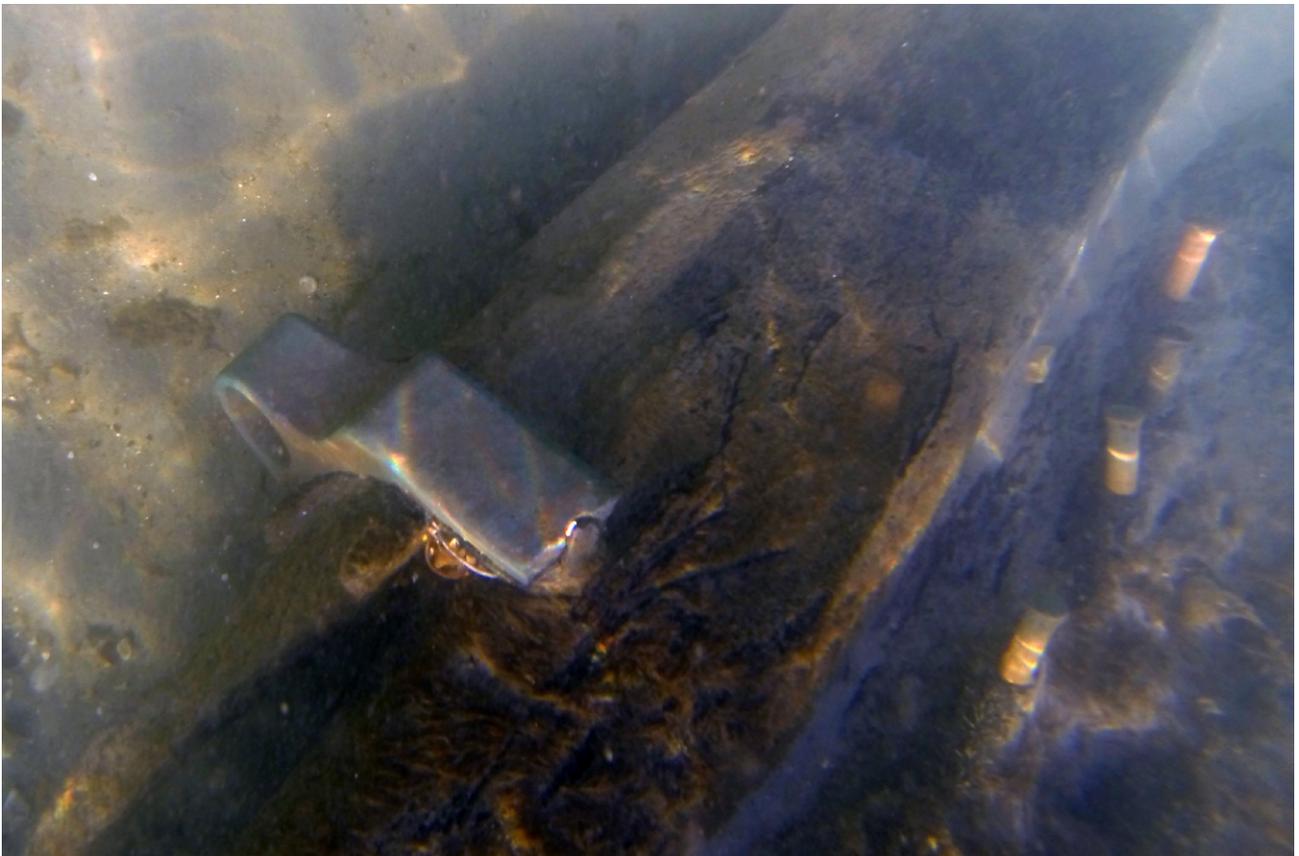
Figure 13. Stern post, upper end is to the top-right. Preserved copper bolts used to secure the planking hood ends into the adjacent rabbet remain preserved and the surviving rudder gudgeon is visible to the left.
