Maritime Archaeology Trust

2019

Lelant Quay, Hayle

Site Report

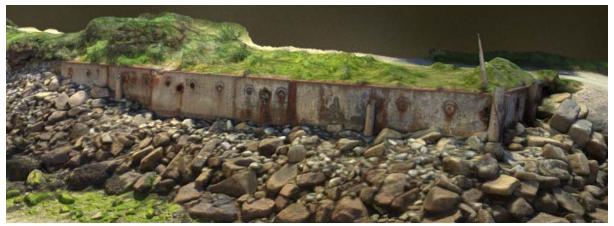
Figure 8: Northern most section of revetment, from 3D model (2016)

For example, by 2016 it can be seen that a bank of rubble and stones has been introduced at the base of the hull sections, concealing the bottom of them (Figure 8 & 9).

The 2009 photograph (Figure 9) shows three horizontal rows of panels (strakes). The top strake is lap joined, overlapping the middle strake in clinker fashion, fastened by a double row of rivets. The middle strake appears to be welded to the bottom one. In 2016, only the horizontal join between the top and middle strakes could be seen (Figure 8).

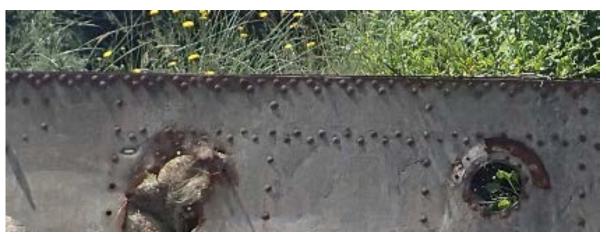
Figure 11: riveting pattern at the gunwale, panels 6 to 9 (2016)

For Panels 6-9 a 'zig-zag' riveting pattern can be seen at the gunwale, with each rivet in the lower row positioned between two rivets in the row above (Figure 11).

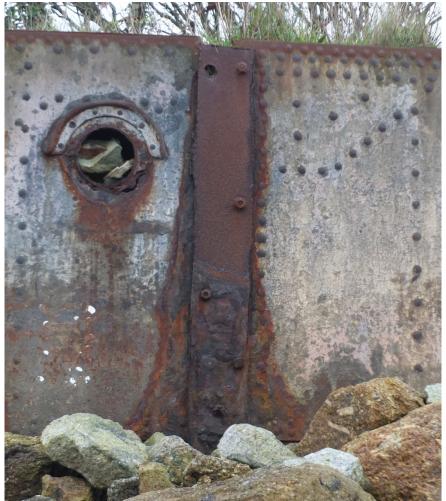
Between panel 6 and 5 there is a joining strip of metal approximately 25cm in width, attached to both panels with round-headed bolts. The riveting pattern at the gunwale on either side of this joining strip is different (Figure 12).

Figure 12: joining strip between panels 6 (left) and 5 (right) – the riveting pattern at the gunwale changes

For Panels 5/4 (to the right/north of the joining strip) the rivets in the upper and lower rows are directly above/below each other, contrasting with the zig-zag riveting pattern for panels 6-9.

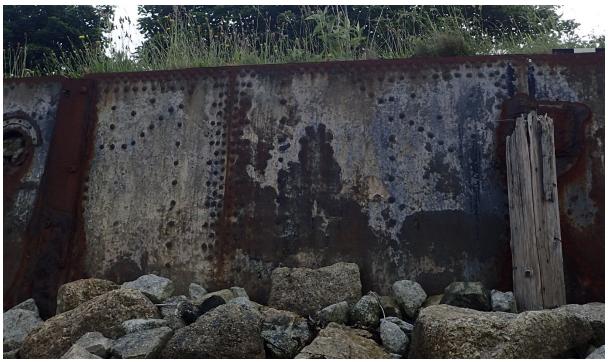
Figure 13: Panel 4 (right) and 5 (left)

Panels 5/4 are also unusual in having no portholes and having extra riveting running diagonally across the panels (Figure 13). The gunwale riveting pattern for Panels 3 - 1, reverts to that of Panels 6-9.

It seems likely that panels 4 and 5 represent a different section of the original vessel (requiring different construction techniques and riveting patterns), or (perhaps less likely, given other similarities between all the panels at the site) they are from a different vessel.

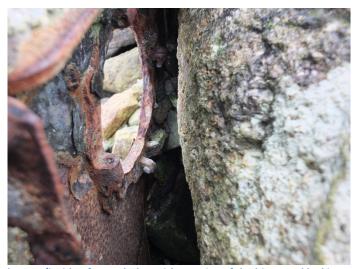
In one instance, the porthole could be viewed from what would have been the inside of the vessel and remains of the hinge and locking mechanism could be seen (Figure 18).

Figure 18: the rear/inside of a porthole - with remains of the hinge and locking mechanisms

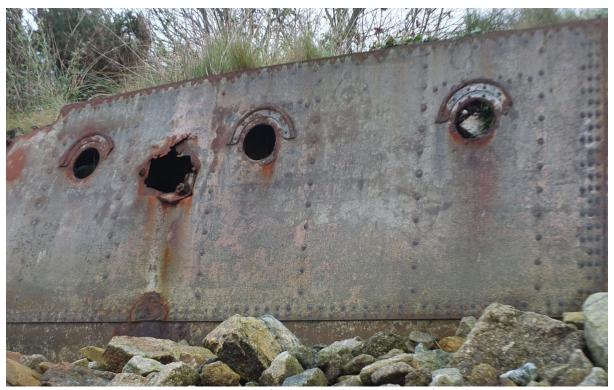
Figure 19: Panel 7 (see Figure 10 for panel numbers)

Panel 7 is unusual in having 3 portholes. In addition, there appears to be another opening in the hull panel, possibly rectangular in shape, between two of the portholes (Figure 19).

This rectangular opening has bolts through the hull plating on either side and a bolted feature of unknown purpose protruding from what would have been the inside of the vessel (Figure 19).

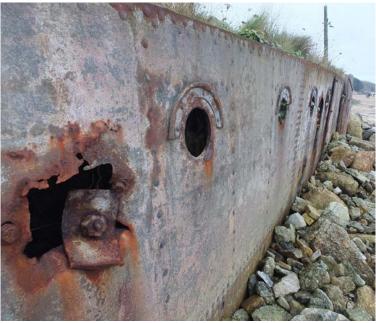
Figure 20: rectangular opening in hull plating, Panel 7

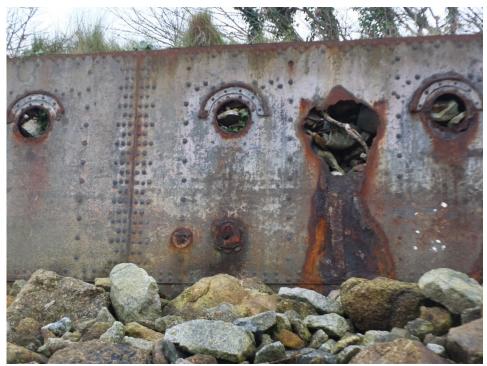
Figure 21: Panel 6 (see Figure 10 for panel numbers)

Panel 6 also has an additional opening in the hull between the two portholes, though it is difficult to determine its shape (Figure 21).

Panel 6 also has two roughly circular areas of damage in the bottom left corner of the panel (Figure 21). The larger of the two appears to have been sealed, in a similar manner to some of the portholes (see below). The position, size, shape and general appearance of these features are consistent with ship battle damage, which may also provide an explanation for the larger hole between the two portholes in this panel.

Features present in the surviving sections are consistent with a vessel built in the late 19th / early 20th century and signs of damage (extant Panel 6, Figure 21 and the no longer surviving panel shown in Figure 34) are consistent with shell damage, likely to have been sustained in the First World War.

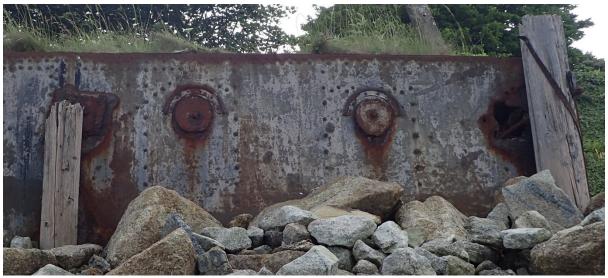
Figure 22: Panel 3

A number of portholes have storm covers or seals in place, covering the hole, e.g. Panel 3 has two portholes, both with storm-covers/porthole seals (Figure 22).

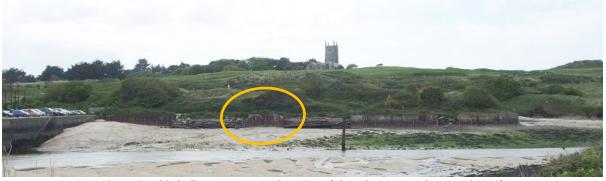
In 2016, a section of revetment that can be seen in Raymond Forward's 2009 photographs, was no longer present (Figure 31).

Figure 31: ship hull revetment at Lelant Quay (Photo by Raymond Forward 2009)

In 2016, the section of hull plating circled in Figure 31 and 32, was no longer present, having been replaced with a bank of rubble (Figure 33).

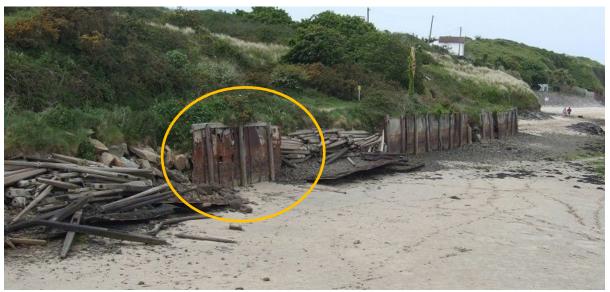
Another of Forward's photographs shows this area, with sections of ship hull collapsed onto the sand either side, and what Goacher & Mossop describe as "concrete and iron debris" that had been held behind the shuttering prior to collapse (Figure 32).

Figure 32: collapsed hull plating either side of a standing section, supported by 3 wooden stakes (Photo by Raymond Forward 2009)

This section of hull plating, present in 2009 (Figure 31 & 32) showed signs of damage and repair, described as: "a 'star' shape with a central patch measuring 0.35m by 0.3m and radial repairs reinforcing an area of c. 3.5m diameter repaired with metallic mesh and welded iron" (Goacher & Mossop 2011). While no longer present in 2016, this feature was fortunately photographed by Raymond Forward in 2009 (Figure 32 & 34).

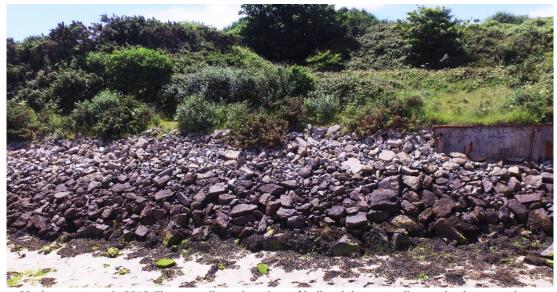
Figure 33: the revetment in 2016. The two collapsed sections of hull and the upstanding section between them seen in Figure 31 & 32 no longer survives

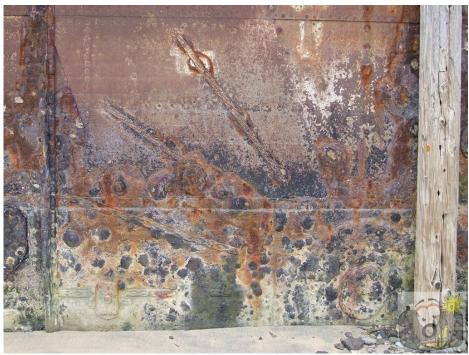
Figure 34: Damage to ship's hull plating (Photo by Raymond Forward 2009)

In the bottom right of Figure 34, a large roughly circular impact mark can be seen, this has been sealed, in a similar manner to some of the portholes and the possible shell damage in Panel 6 (Figure 21). Radiating out from the main impact mark are the repairs described by Goacher & Mossop (see above). The MAT is extremely grateful to Raymond Forward for his photographs which constitute an important record of our maritime heritage that sadly no longer survives.

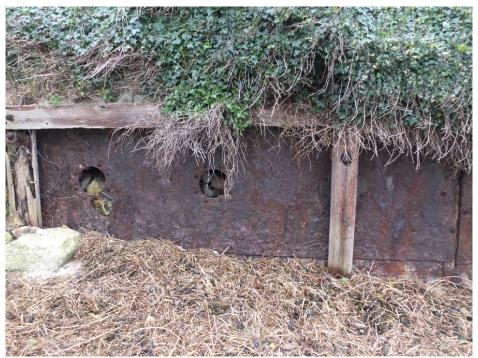
that used in Section A & B, i.e. the heads of bolts/rivets can be seen near the circumference of the sealing plate (Figure 36). There are no signs of the semi-circular reinforcing strip/visors that can be seen above the portholes in Section A & B, though his may be due to the poorer preservation.

Figure 36: Portholes (one sealed and partially obscured by post) in Section C

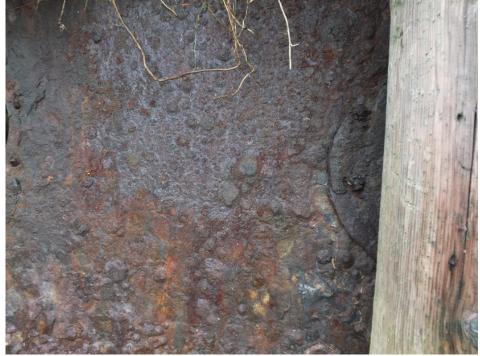
Figure 37: Sealed porthole, Section C

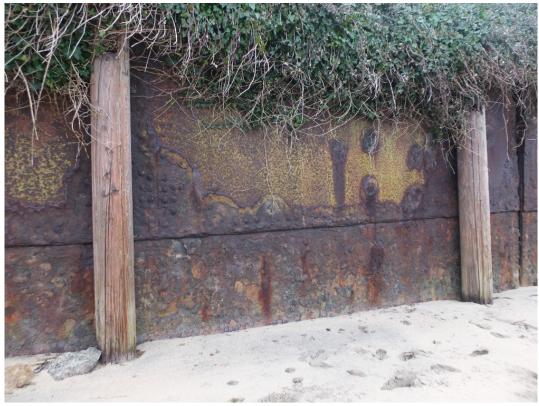
The poorer preservation of the ship hull panels in Section C makes it hard to identify the riveting patterns, but in places, common features to those of Section A & B can be found (see Figure 38 & 39).

Figure 38: Treble chain riveted vertical butt joins, double riveted horizontal lap joins in Section C

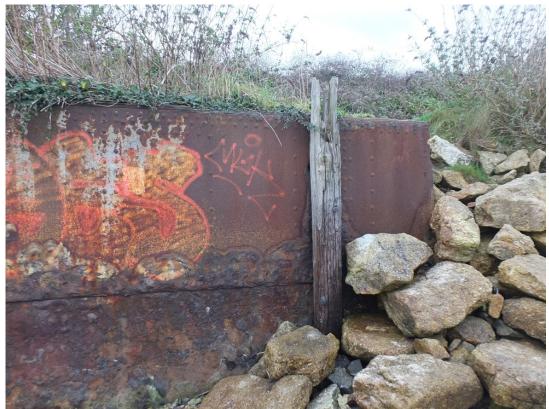
Figure 39: Gunwale riveting (zig-zag pattern) in Section C
