# **Uncovering the Past**

## **An Archaeological Study of Oyster Beds at Emsworth**

### **Final Project Report**

Hampshire & Wight Trust for Maritime Archaeology  
Room W1/95  
National Oceanography Centre  
Empress Dock  
Southampton  
SO14 3ZH

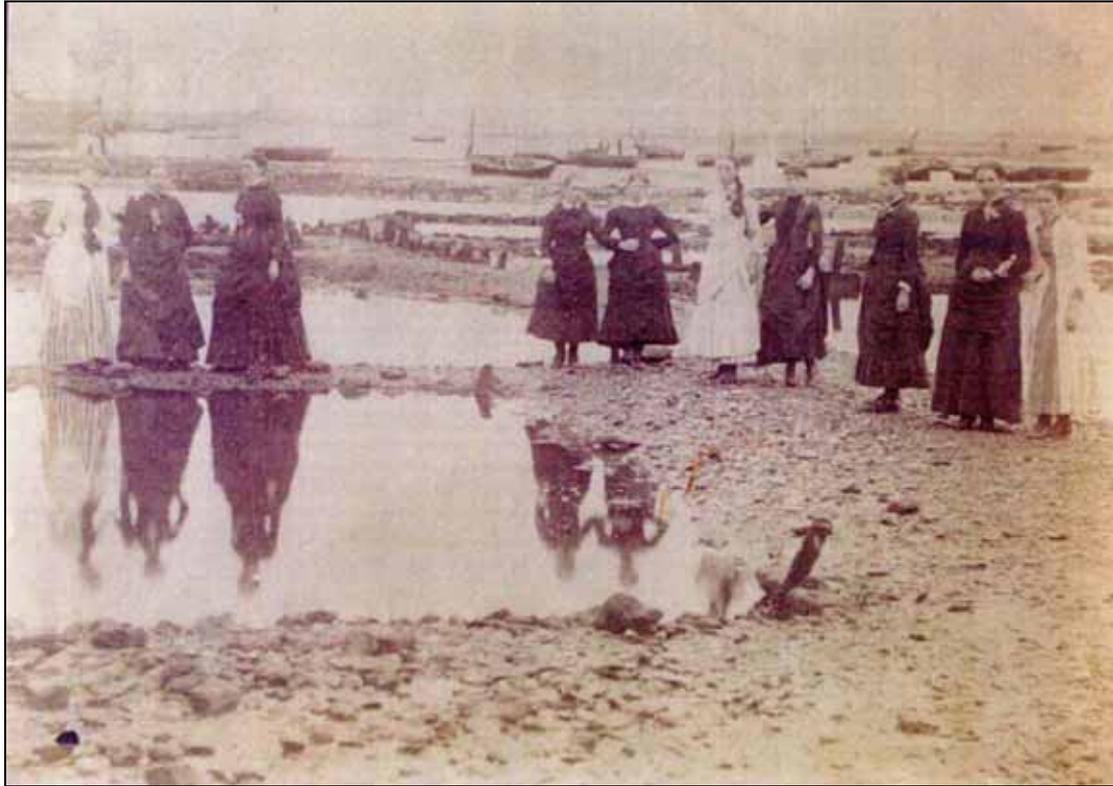
**Figure 19: An historical photograph dating to 1898 of the Emsworth oyster pits. The water filled pits are well defined and the rough timber lining of the pits is evident.**

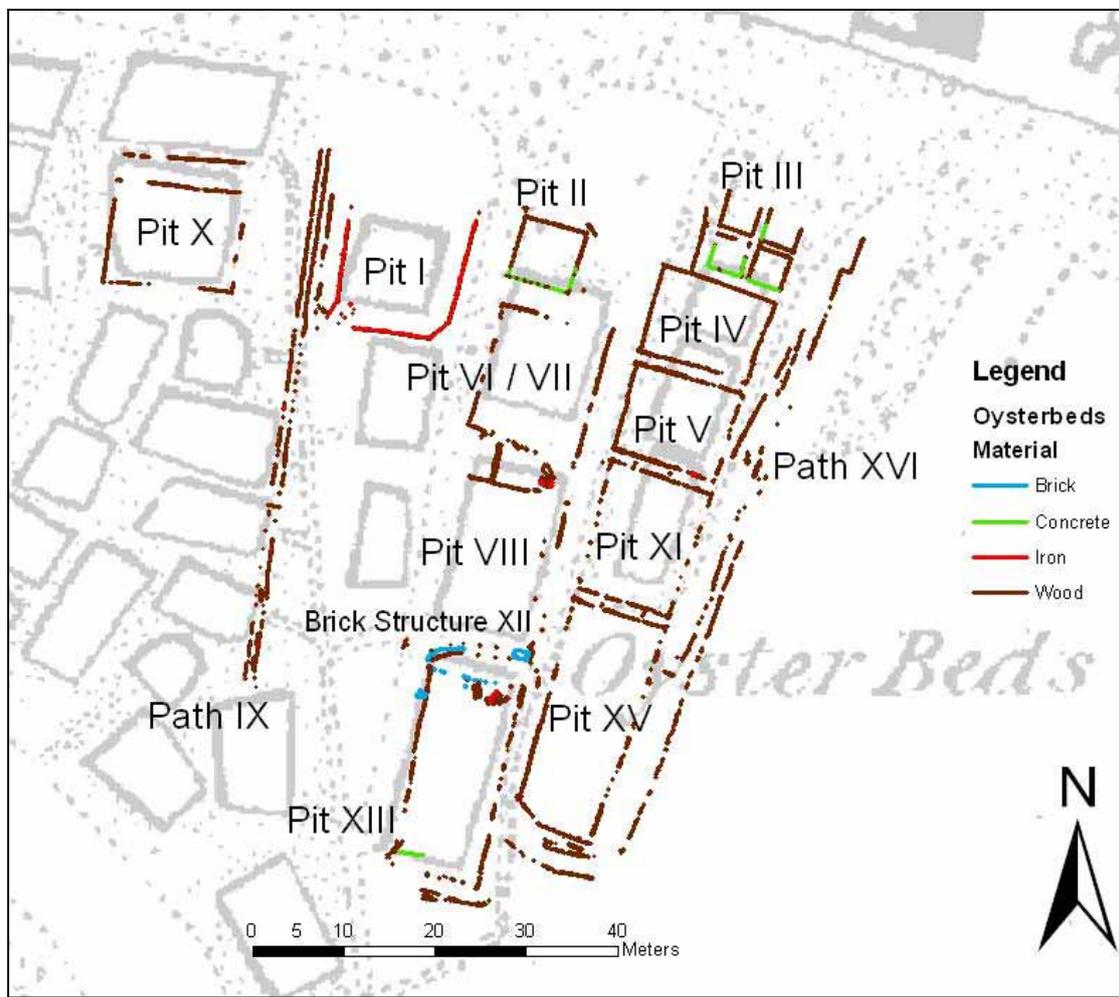
**Figure 22: Overall Site Plan showing main exposed features including oyster pits and pathways on the Emsworth foreshore.**

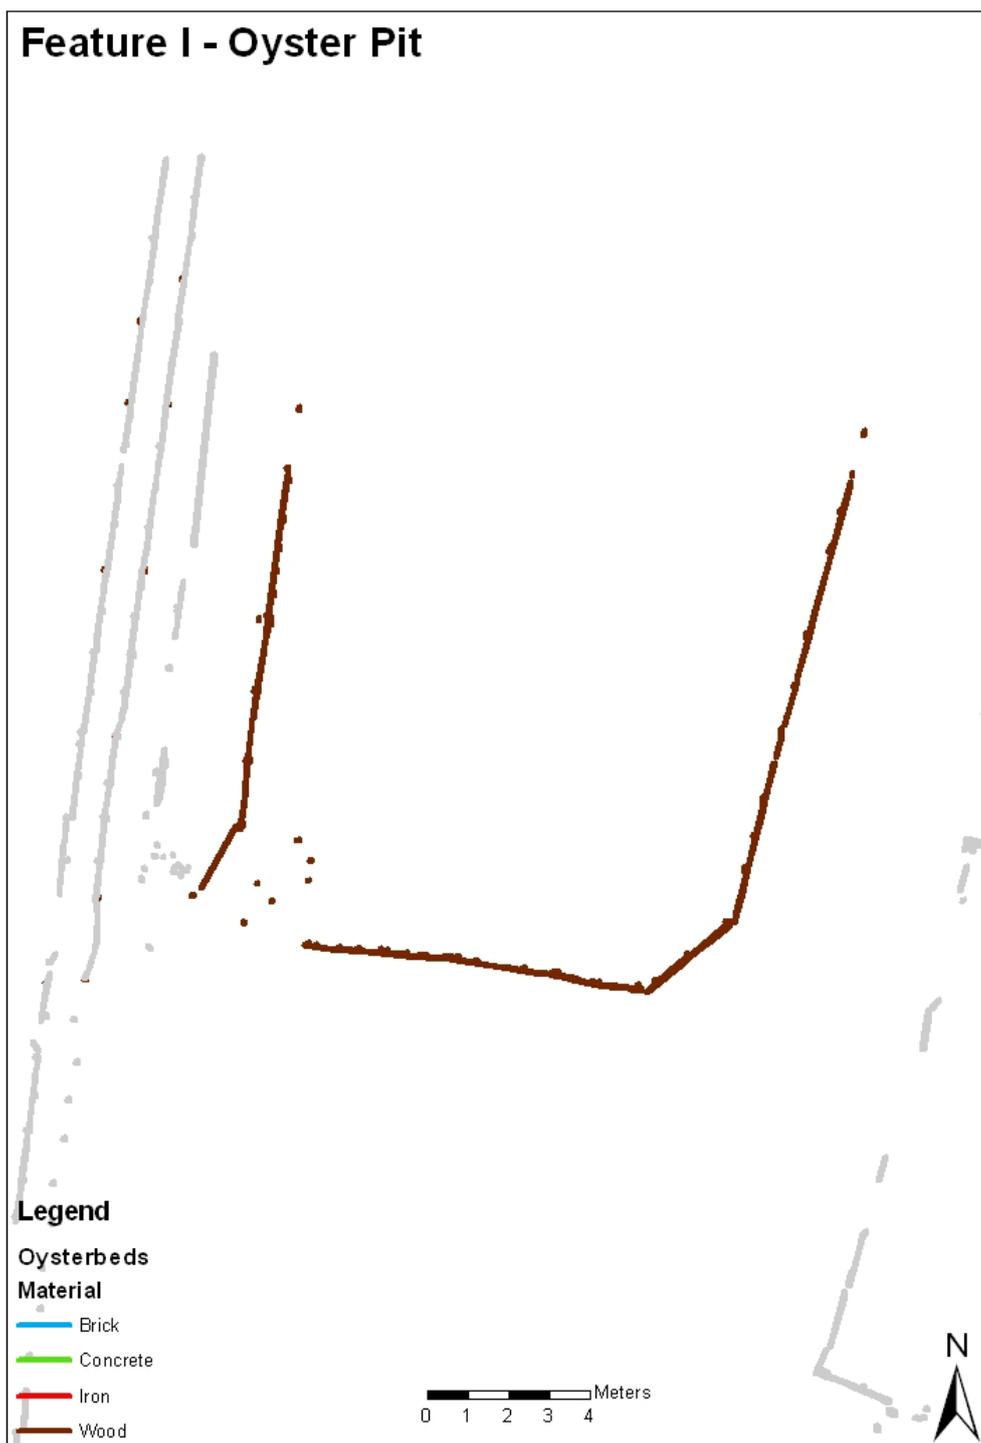
Pond I is a roughly rectangular structure measuring approximately 12m by 15m. The northern side of the structure is no longer visible, although the timber components of the south and east sides of this pond are quite prominent and upstanding.

**Figure 23: Plan of Feature I, oyster pit.**

There appears to be a small channel at the south west corner of this pond, with a cluster of timbers near it that may indicate the remains of a sluice in use on this pond.

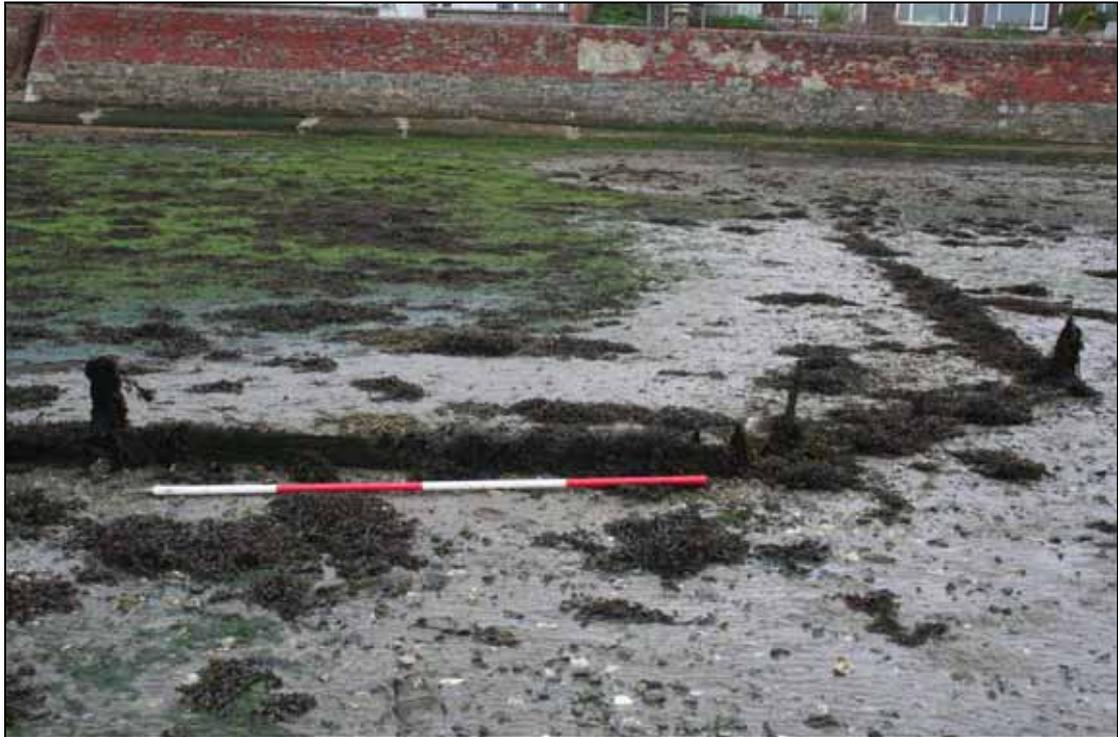
**Figure 24: Pit I viewed from the south, showing missing structure on its northern side and the possible sluice structure at its south east corner.**

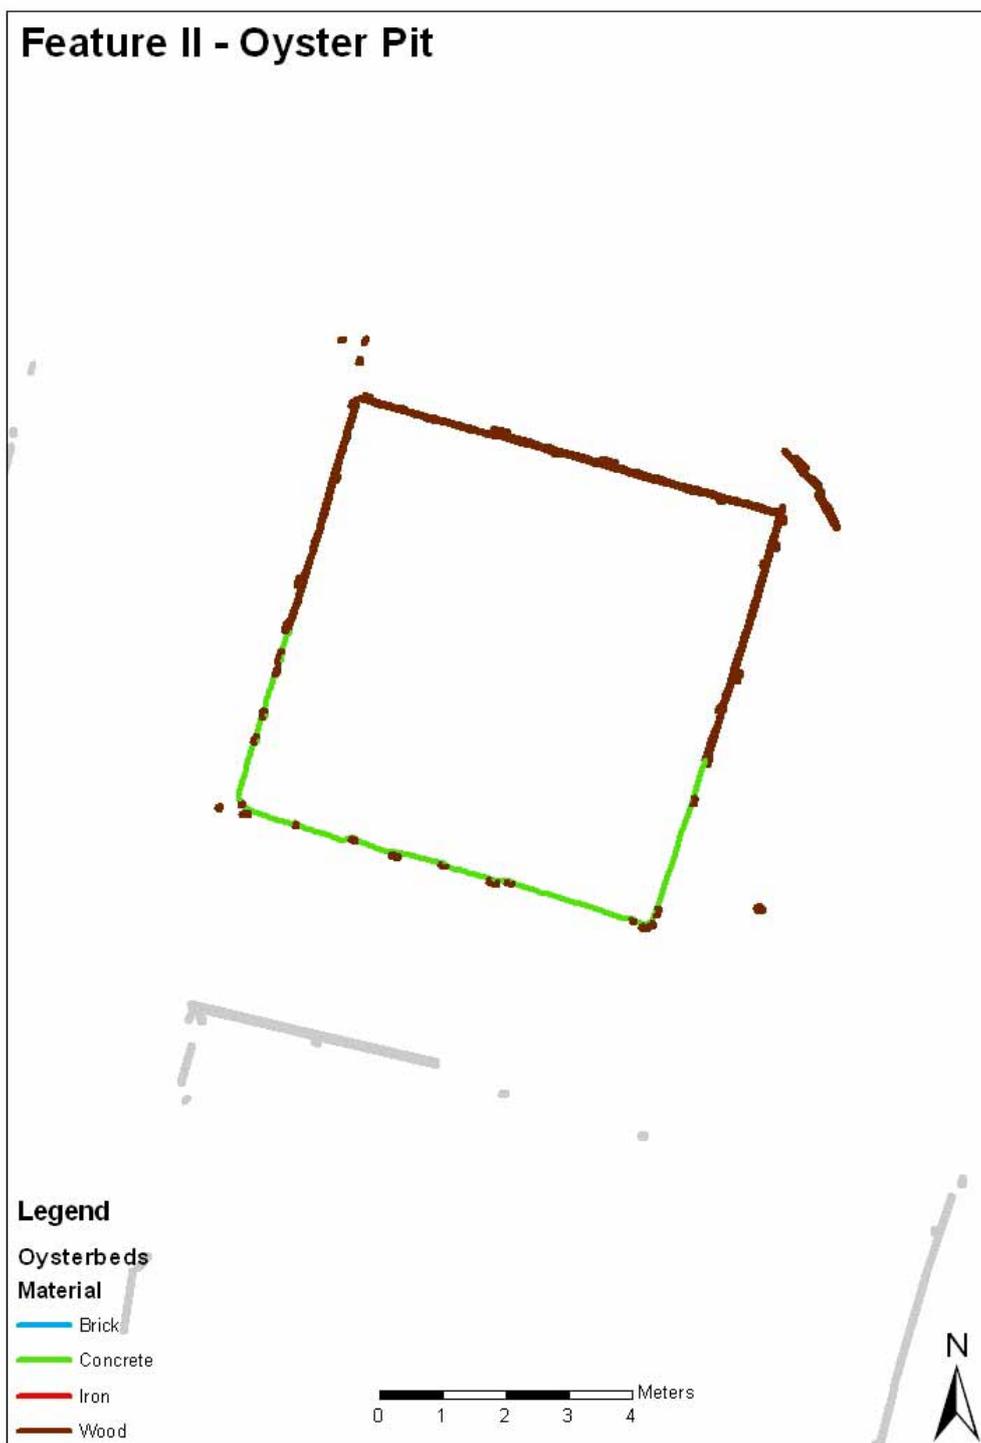
Pond II is square in plan measuring approximately 7m by 7m, with elements of the wooden structure surviving on all sides of the pond.

**Figure 25: Plan of Feature II, oyster pit.**

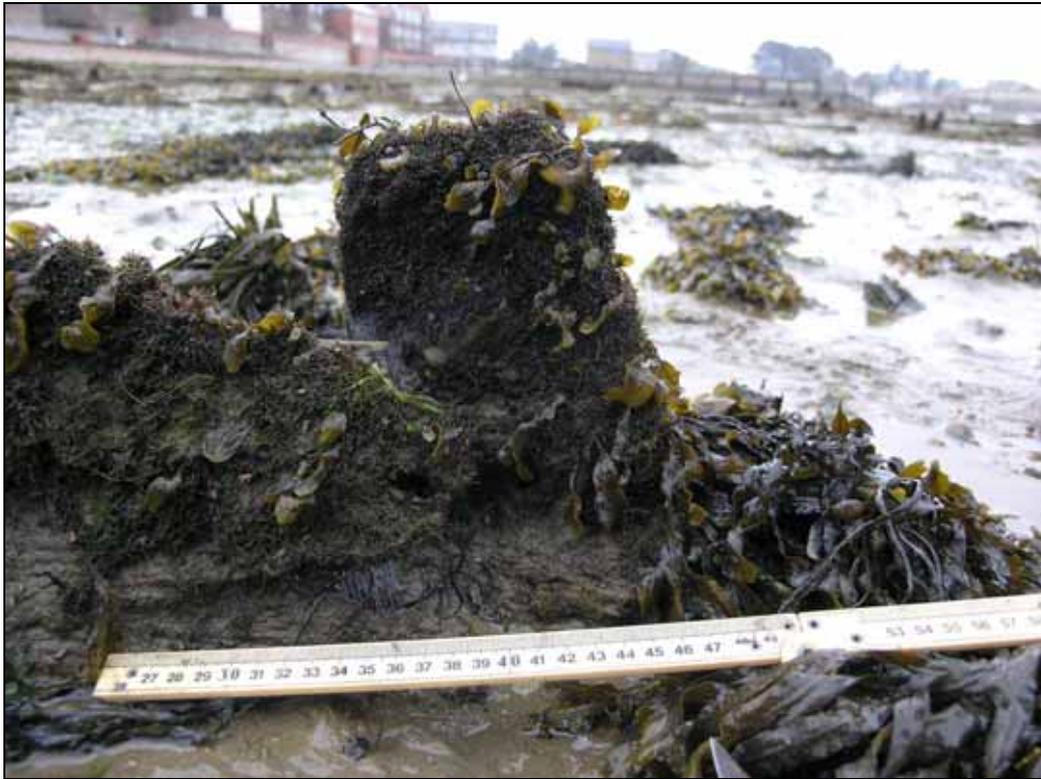
One post 2.7m from the north east corner of the pond has two planks butted together against it. While no fastenings survive the nail holes used to attach the planks to the posts are clearly visible.

**Figure 26: An upright post with two abutting planks with visible nailholes.**

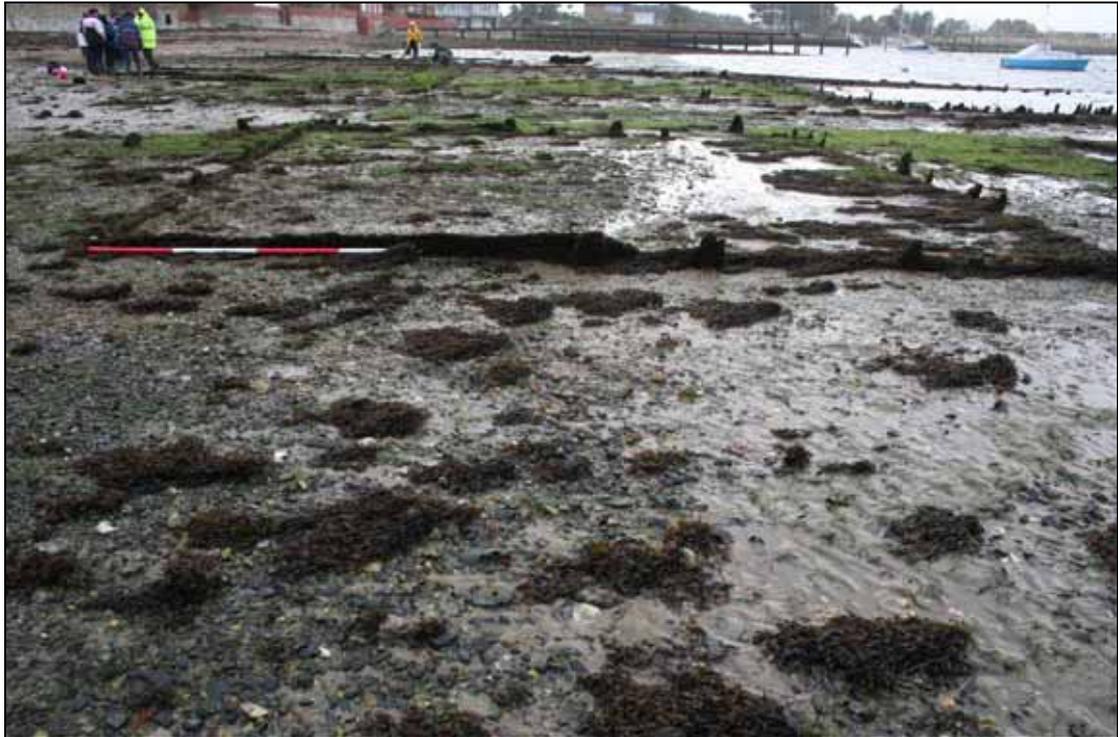
This pen has a visible concrete floor, which now stands slightly above the surrounding foreshore ground level. Only the southern portion of the concrete floor is visible, as the northern part of it is buried by shingle, but it seems likely the floor covers the entire base of the pond.

**Figure 27: View of Pit II taken from the west.**

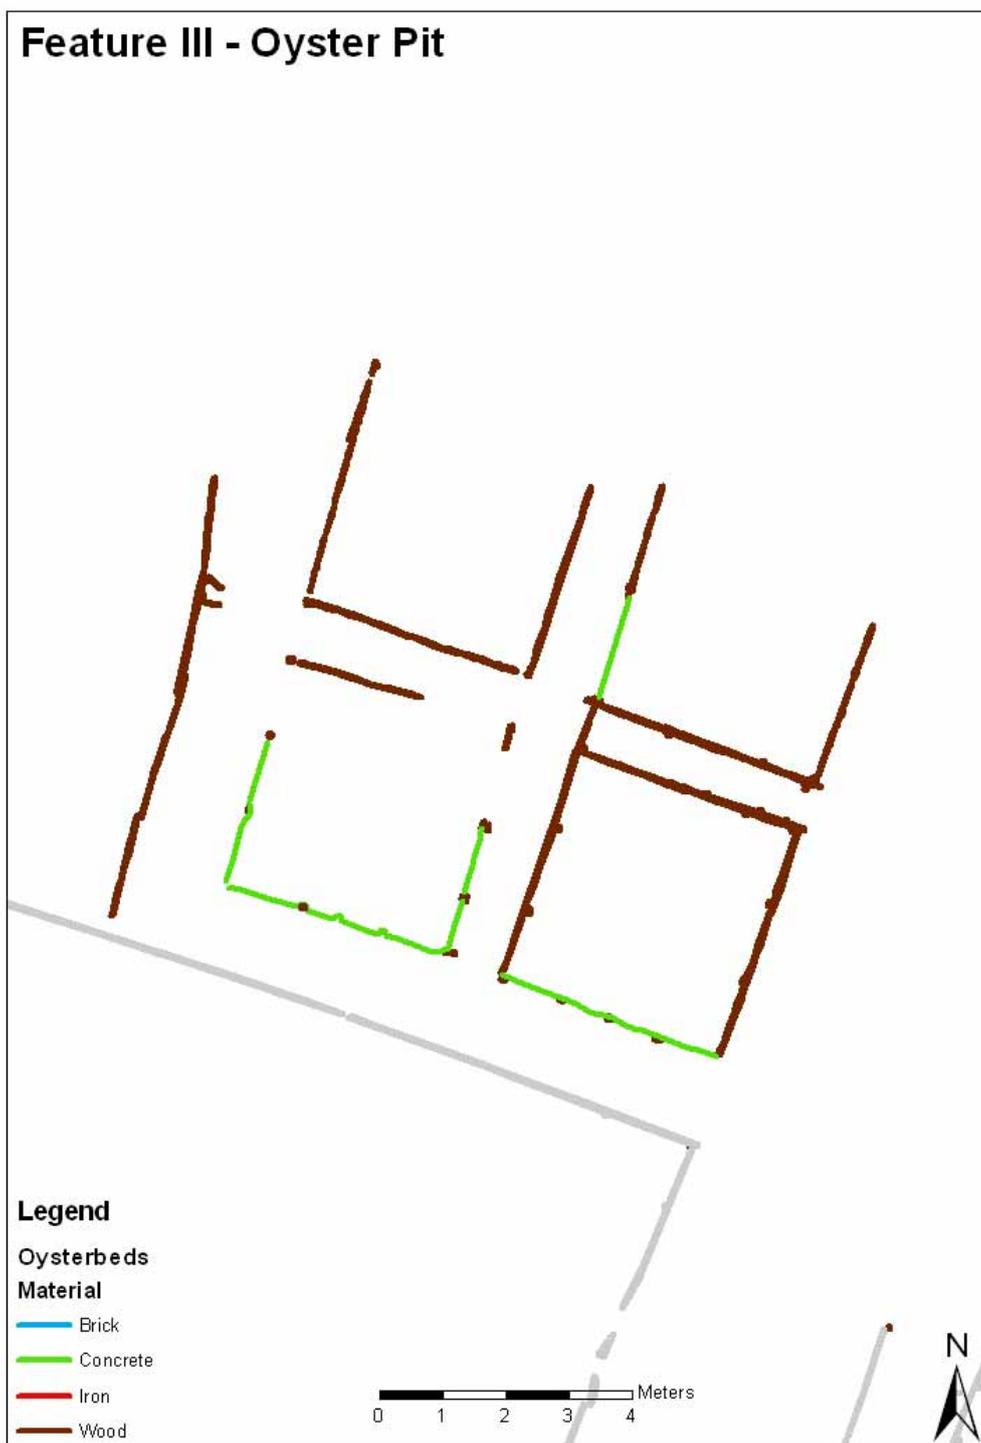
Pond III appears to be subdivided into four smaller pits (IIIa, b, c and d clockwise from the top left in the plan in **Figure 28** below) with small walkways dividing them. The overall size of the structure is 8.2m by 8.6m, making it just less than square.

**Figure 28: Plan of Feature III, Oyster Pit**

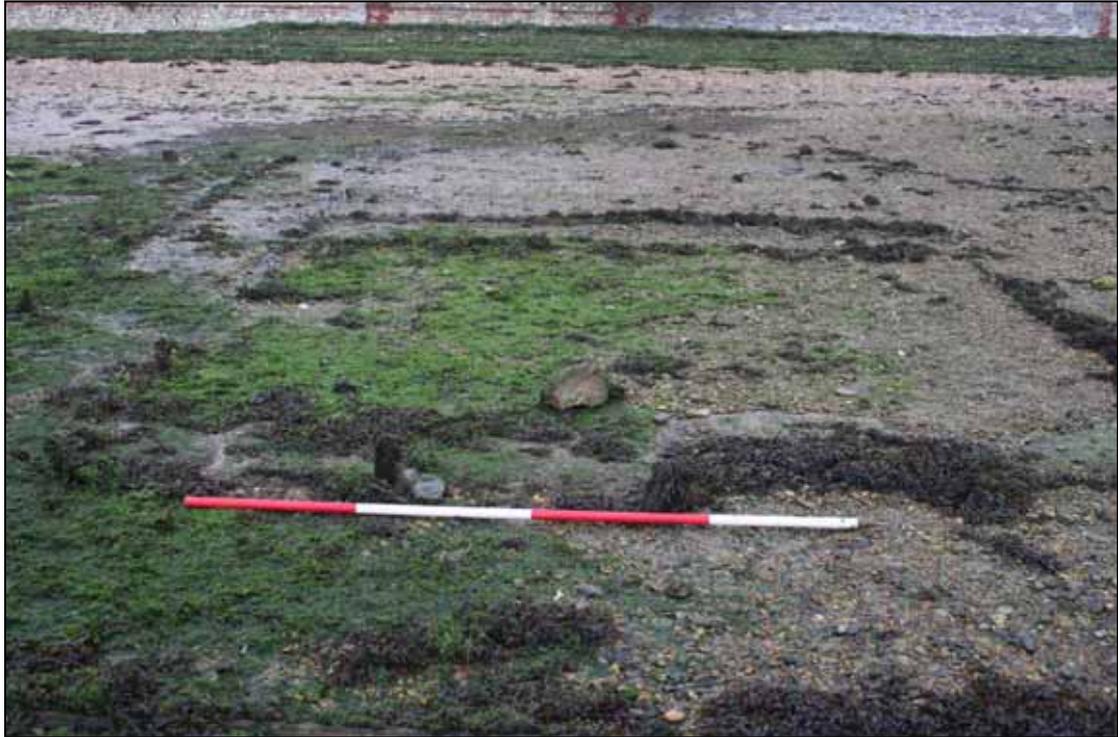
**Figure 29: View of Pit III looking north.**

The timber elements of these pits are made of horizontal planking supported by regularly spaced posts. The two smaller pits to the north of this structure (IIIa and IIIb) appear to have little surviving timber on their northern sides. All four of the pits have concrete bases, although the IIIa was only partially visible as it was mostly covered by shingle. Of all of these pits IIIc is the best preserved

On the 'Oyster Bed and Layings' map based on the 1898/1915 OS maps, this pit is marked as pit number 21 owned by J. D Foster.

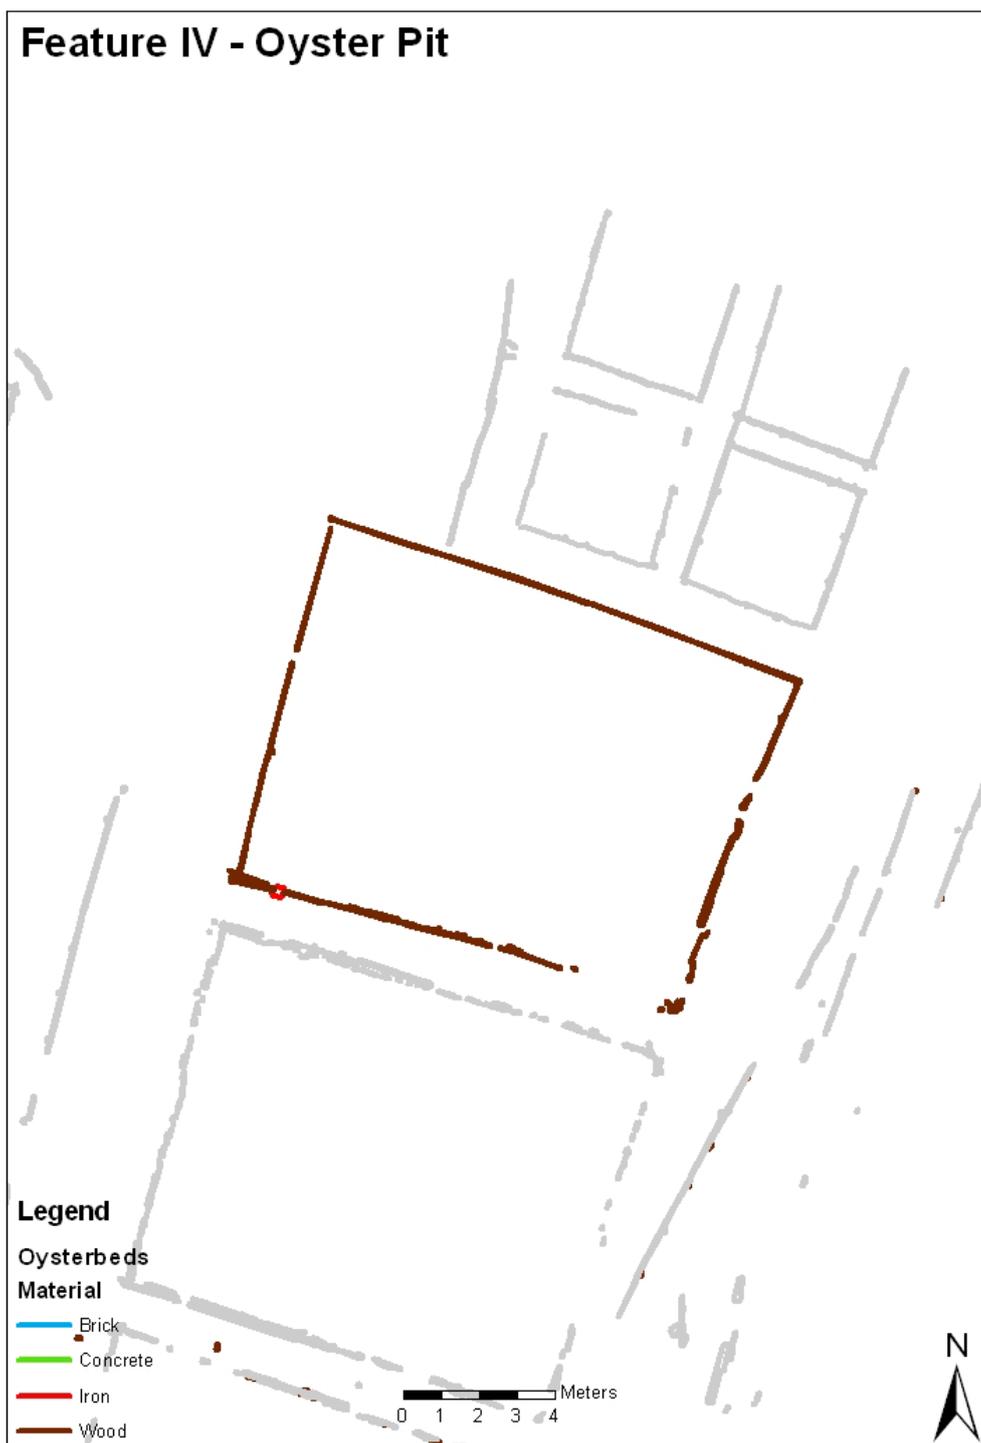
This pond is reasonably well preserved and measures 13m by 10m. The northern side is constructed with two 0.05m (2-inch) planks, both of which are still in a good condition, and their exposed faces are still flat and showing few signs of abrasion. There are few visible posts along this side aside from posts surviving at each end.

**Figure 30: Plan of Feature IV, oyster pit.**

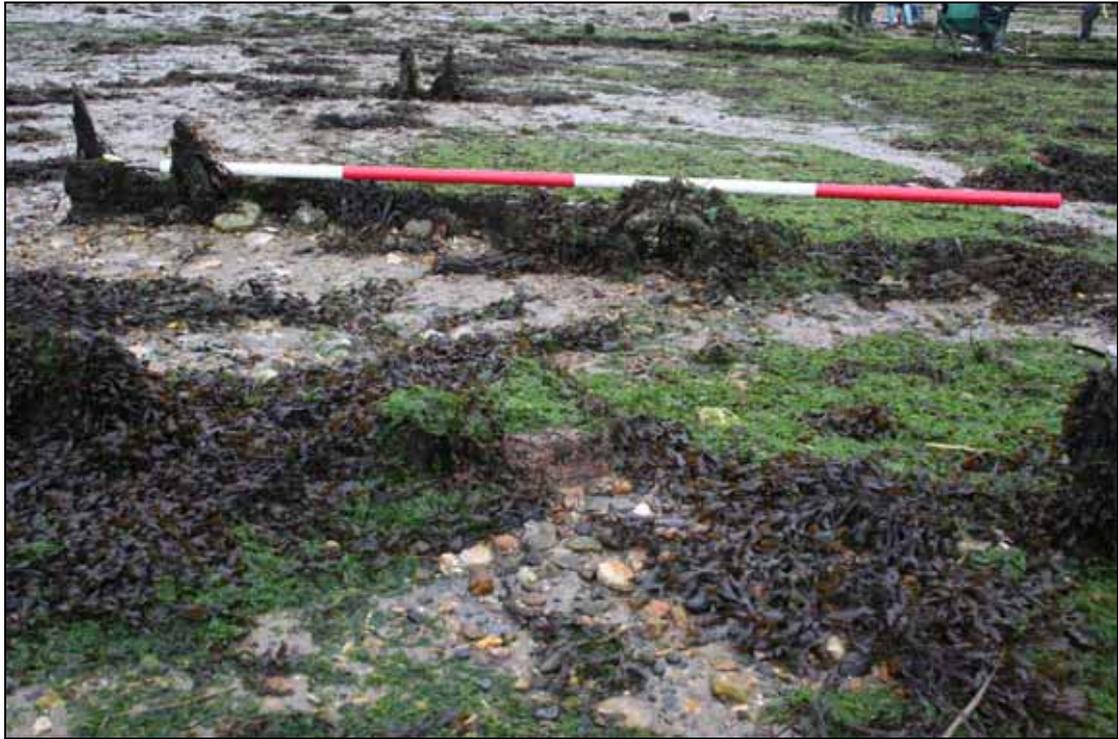
**Figure 31: View of southern wall of Pit IV containing an iron 'sluice' (in front of the right hand white portion of the photoscale).**

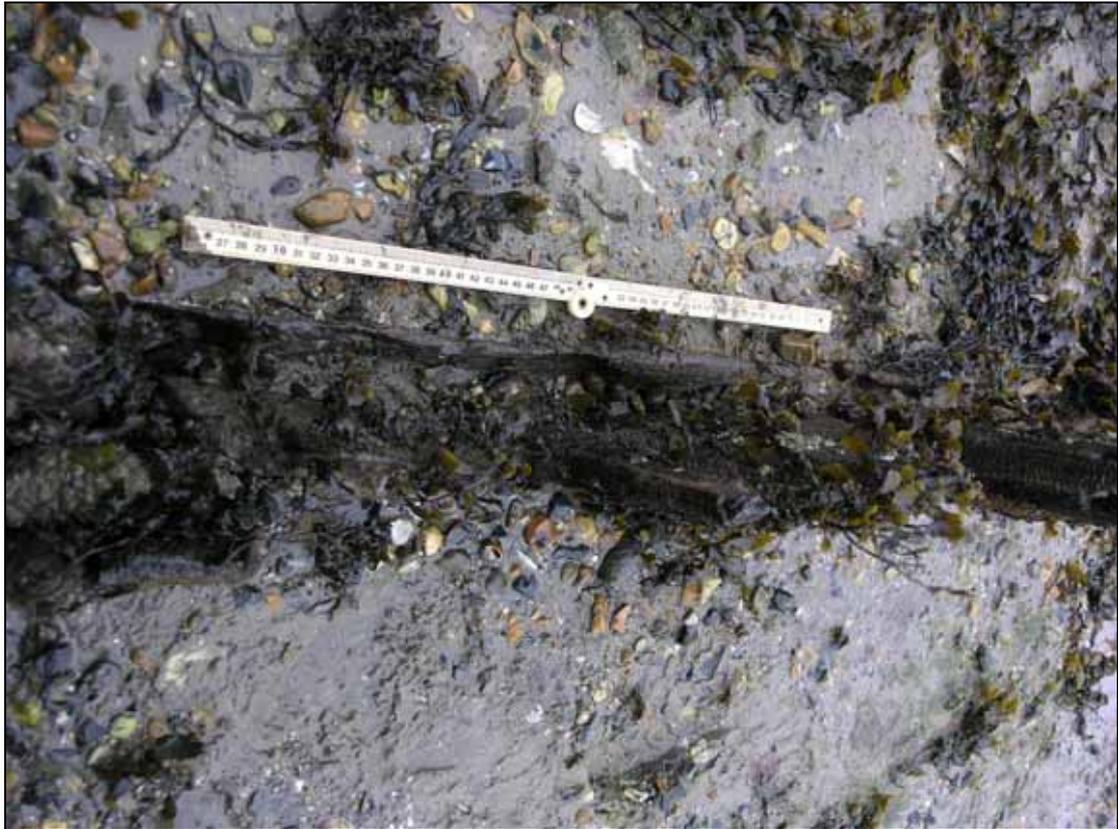
**Figure 33: A horizontal plank (beside the scale) with vertical planking inside it visible on Pit V.**

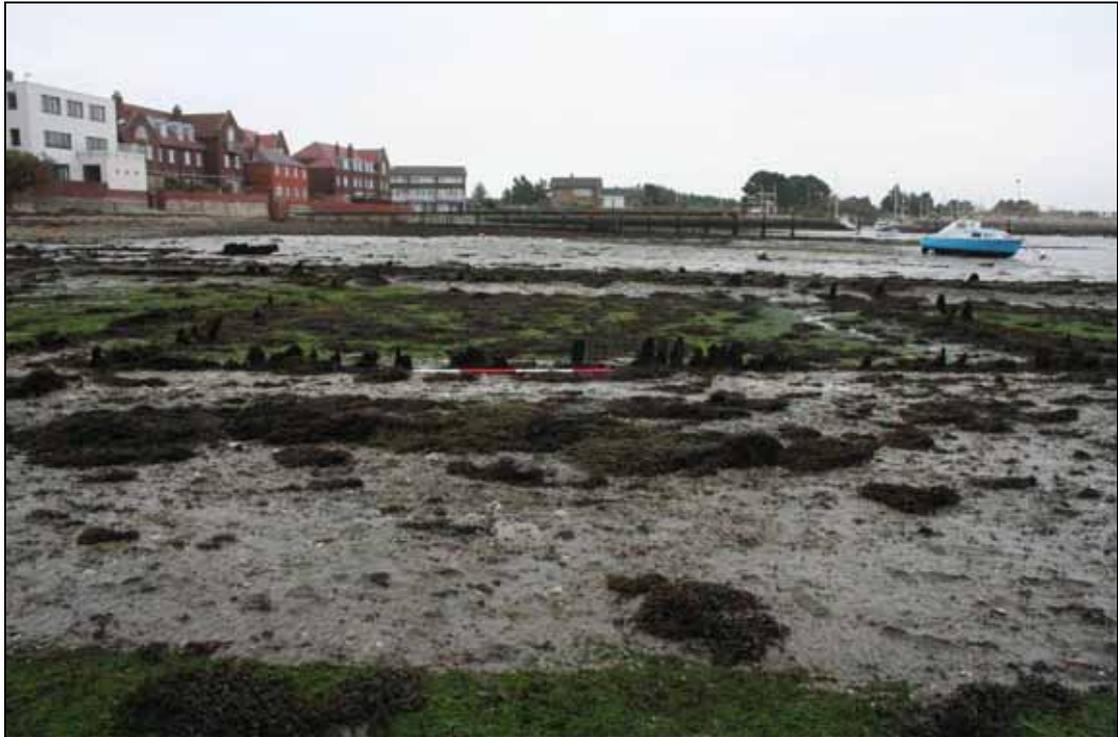
**Figure 34: View of Pit V taken from the west. Upstanding vertical timbers are clearly visible by the photoscale.**

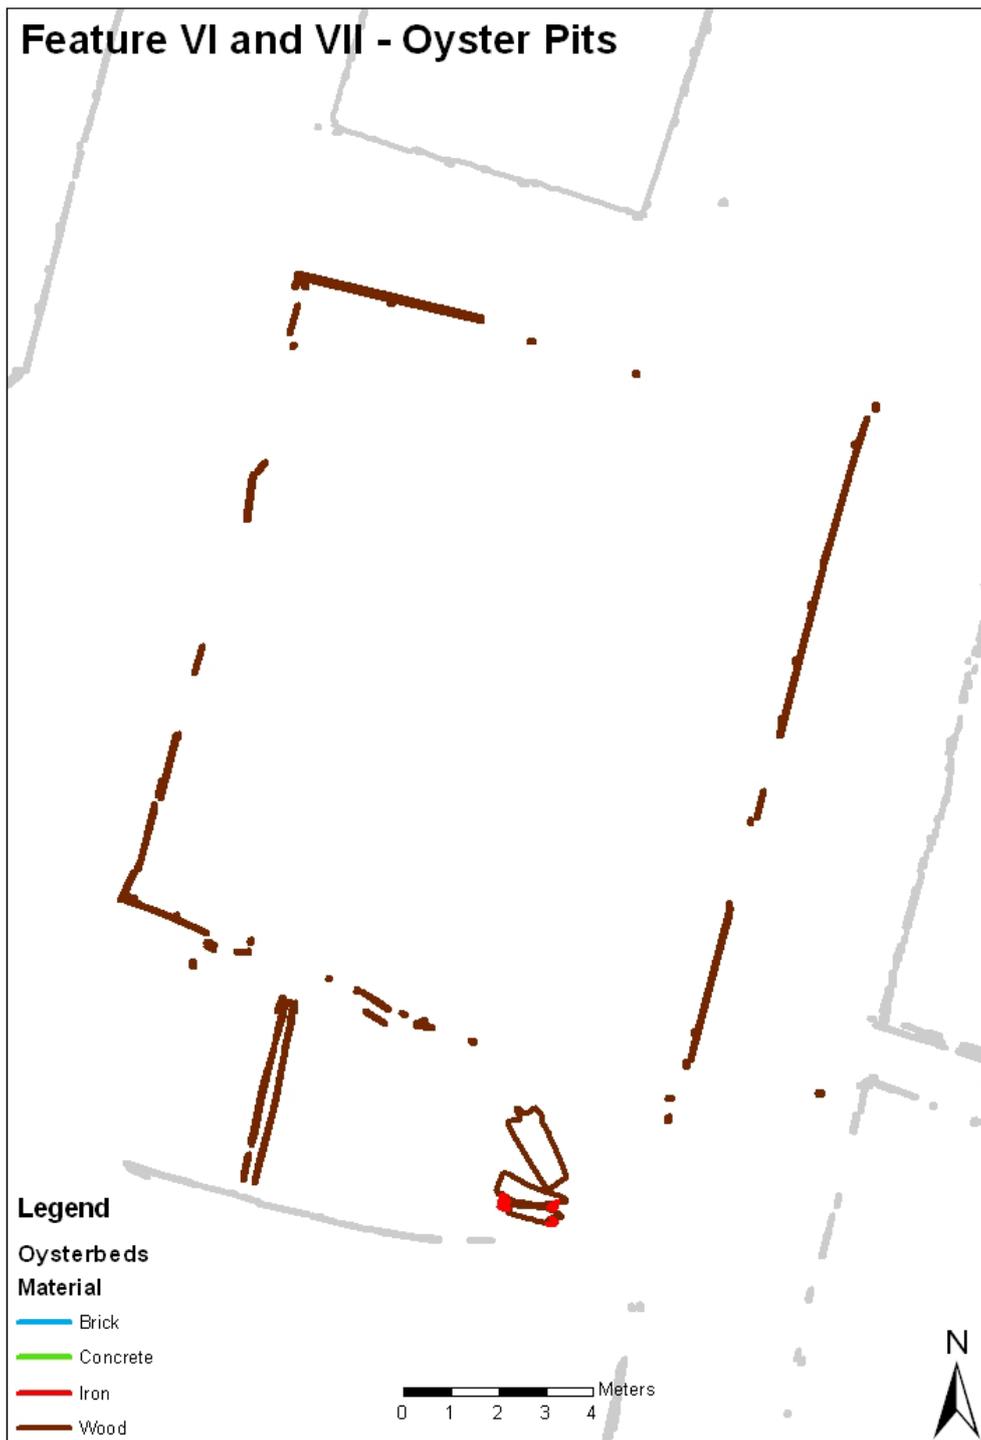
**Figure 35: Plan of Feature VI / VII, Oyster pit.**

These pits are described together here as it seems they are a single feature rather than two separate pits as previously thought.

The main pit structure measures 15.5m by 12.4m and is constructed of horizontal planking supported by posts. The timber structure of this pit is very poorly preserved. Notably a timber gutter or conduit feature runs to the south of the south side of the pit 4m from the southwestern corner. The gutter seems to have run into pit VIII.

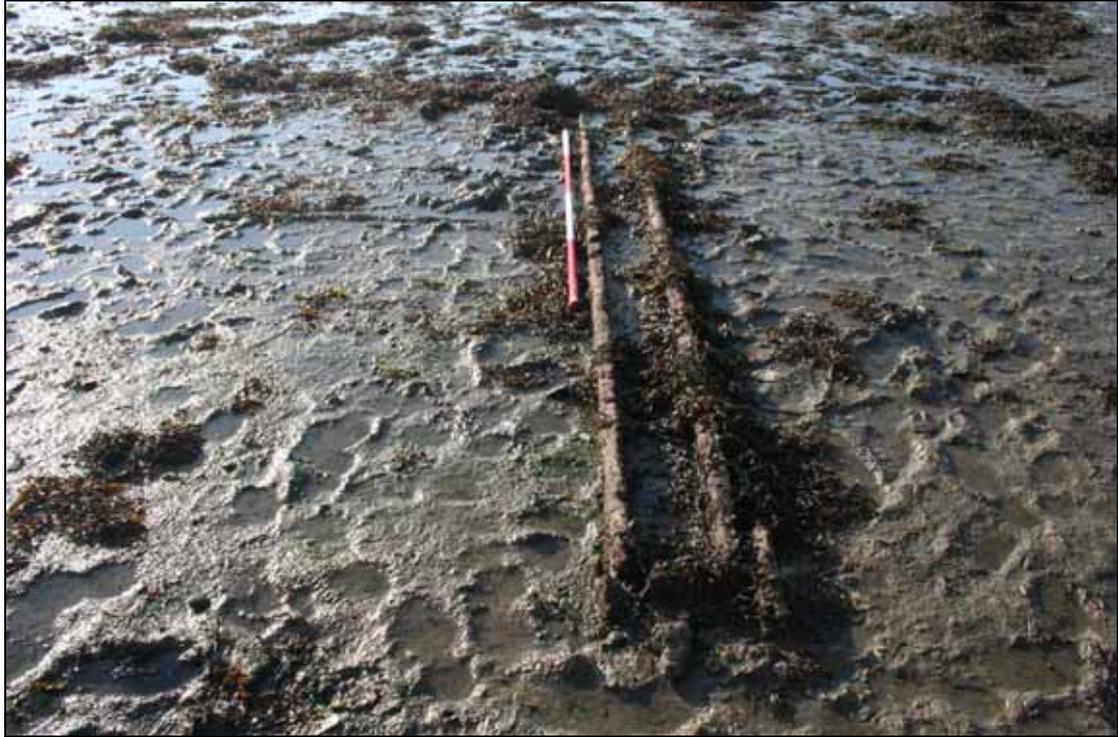
**Figure 36: Timber gutter or conduit at southern end of Pit VI/VII looking north.**

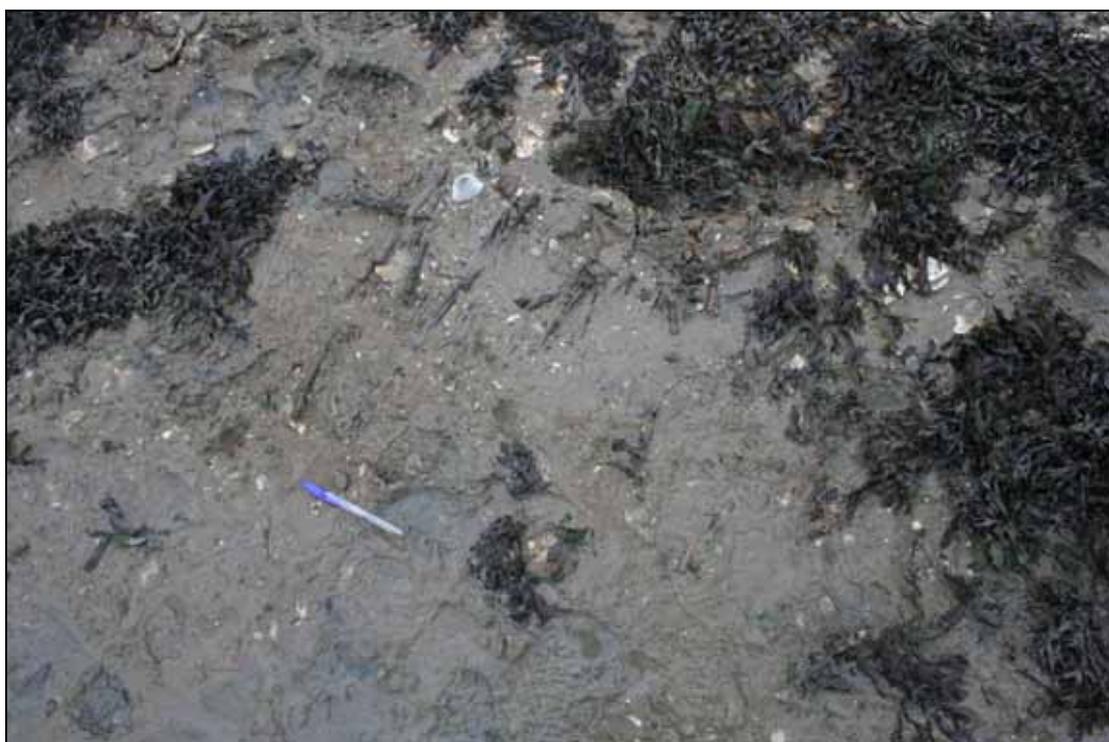
The western side of this pen is not visible and the south and east sides are mostly defined by posts with little or no visible planking. A small patch of what may be reed or wickerwork was observed on the western side, this may indicate some method of making the pens watertight, although it seems unlikely they would have required much waterproofing. Alternatively they may be the remains of a basket or similar container, or a means of consolidating the pathway but an insufficient amount of it was exposed to support or confirm either of these possibilities.

**Figure 38: Possible exposure of reed work seen by Pit VIII.**

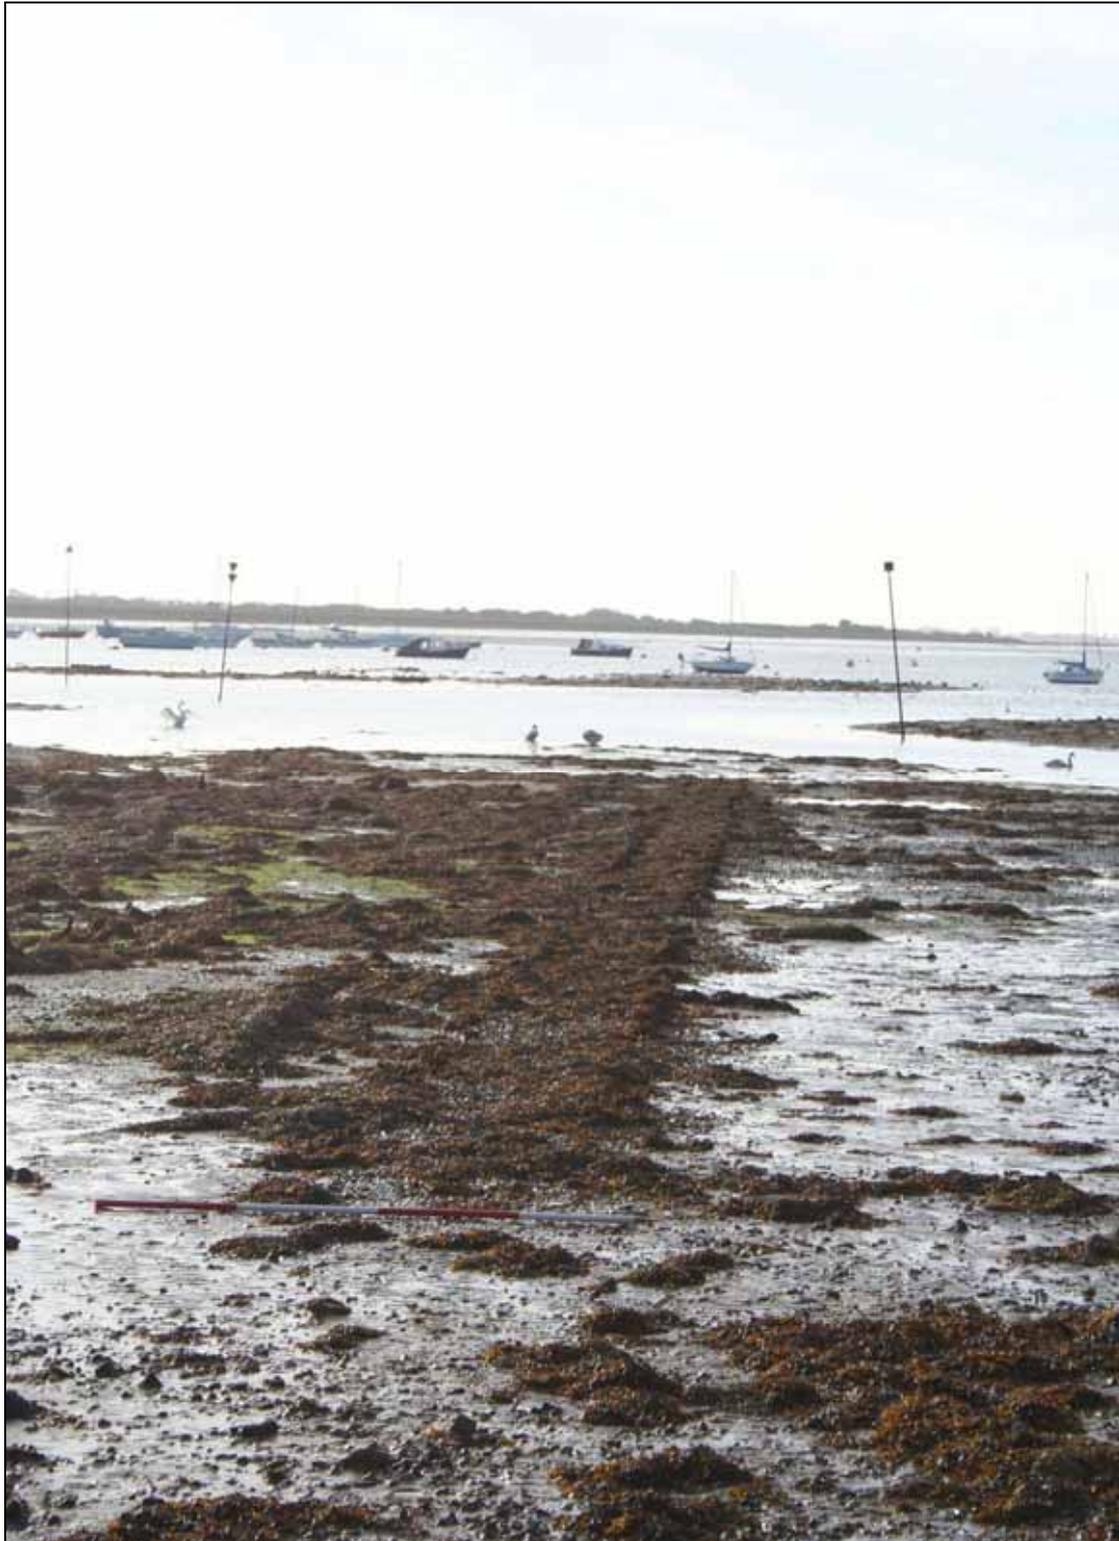
**Figure 39: Feature IX the 1960's mooring access path that cuts across one of former main drainage channel for the pits.**

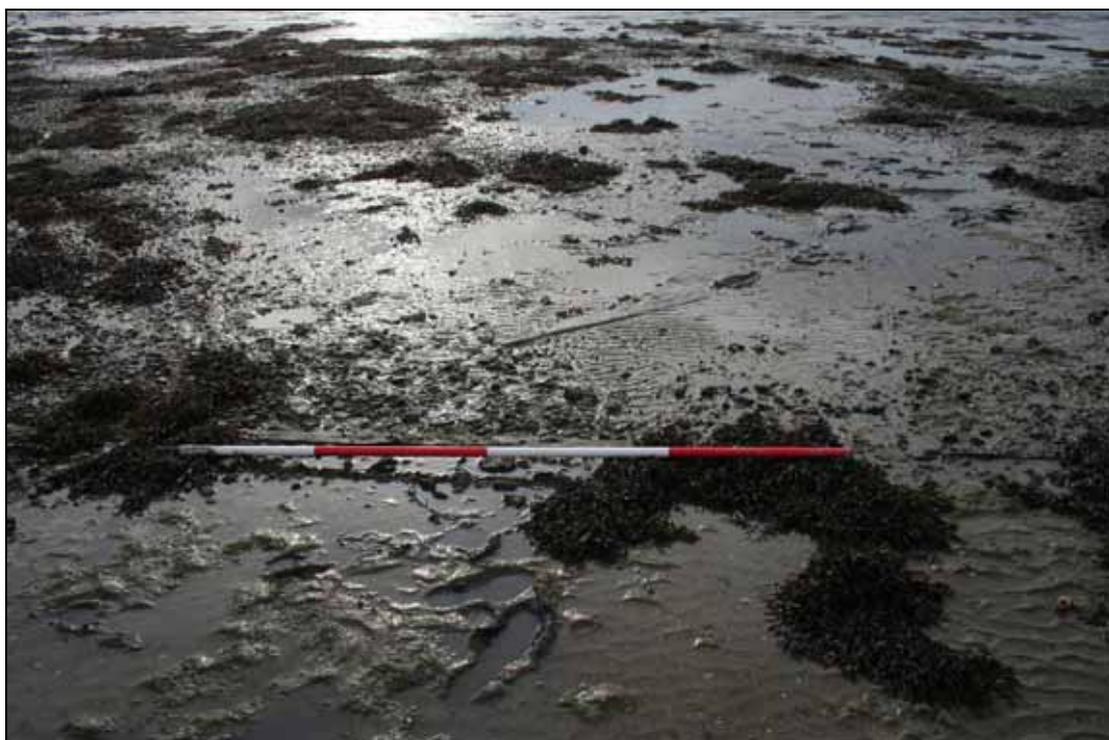
**Figure 40: Pit X looking south. The wooden structures of the pit were heavily covered by silt and shingle at the time of the survey.**

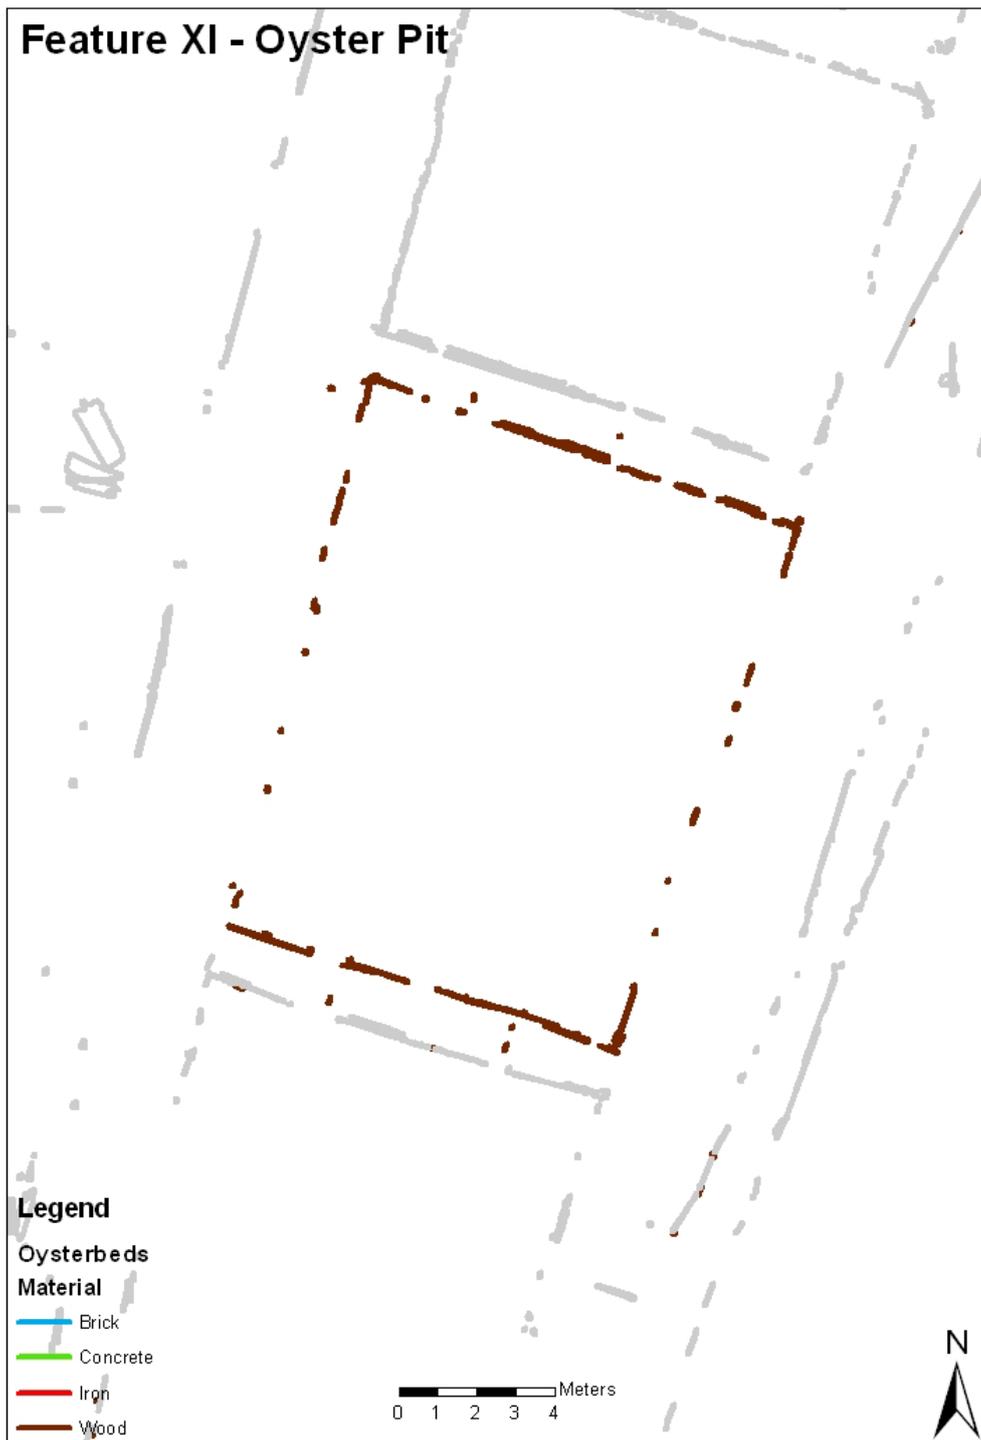
Pit XI is quite well exposed and measures 11.5m by 14.3m. It is mostly constructed with horizontal planking supported by posts in the same way as the other pits with horizontal planking, although in its north east corner, there is some evidence of a possible repair using vertical planking inside the pit. This north east corner of the pit is supported by a  $\frac{1}{4}$  cut rounded timber.

**Figure 41: Plan of Feature XI, oyster pit**

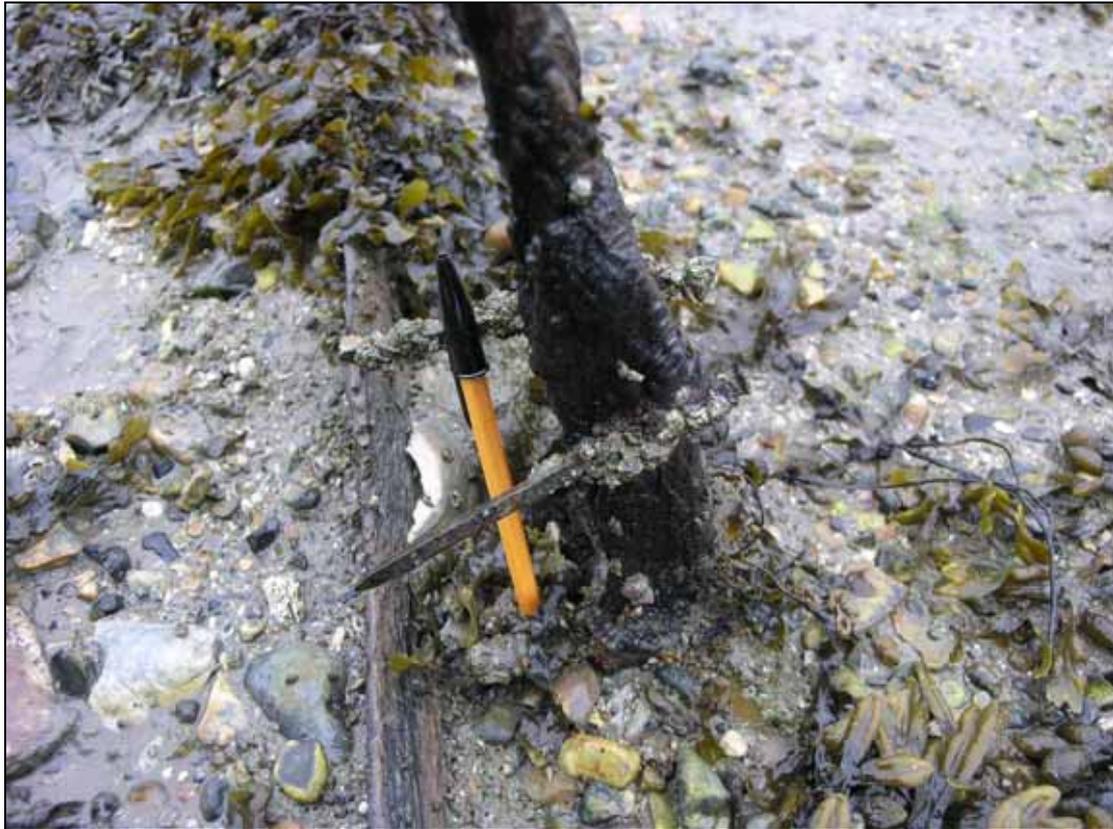
Nails used for fastening the planking to the posts are visible on the posts on the south side of this pit, above the surviving level of the planking. The nails are square in section, and show little sign of corrosion. The lack of corrosion suggests the nails may not be iron, but badly stained copper nails, although, the limited exposure of the nails meant detailed observation was limited.

**Figure 42: Nail through an eroded upright post showing little sign of corrosion suggesting it is non-ferrous perhaps made of a copper alloy**
