# **Uncovering the Past**

## **An Archaeological Study of Oyster Beds at Emsworth**

### **Final Project Report**

Hampshire & Wight Trust for Maritime Archaeology  
Room W1/95  
National Oceanography Centre  
Empress Dock  
Southampton  
SO14 3ZH

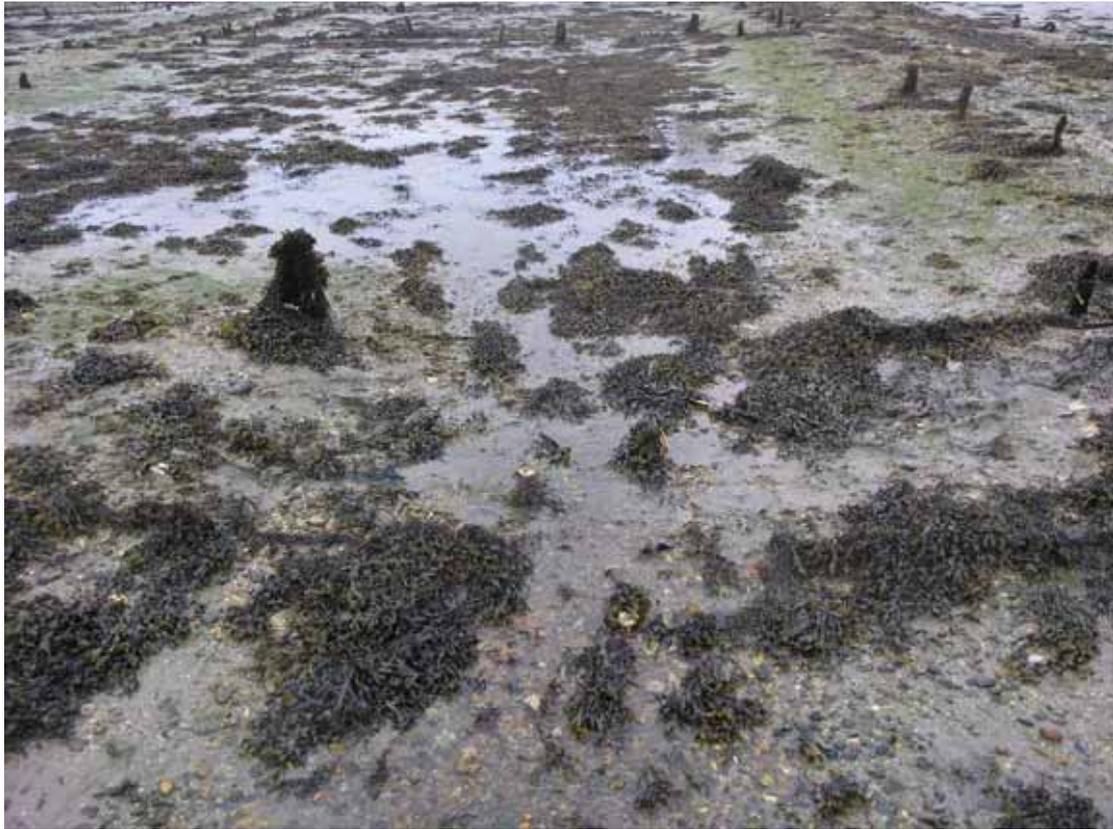
There is a gap towards the eastern edge of the south side of the pit that appears to correspond with a gap on the north side of Pit XV. A small waterway between the two pits is visible running between the two pits and there are also what seem to be the remnants of a structure to the eastern side of the waterway spanning the distance between the pits. This may be the remains of a structure similar to the conduit or gutter observed running between Pits VI and VIII.

**Figure 43: The south side of Pit XI looking north with a shallow but discernable “waterway” running through a gap in the side towards the north side of Pit XV.**

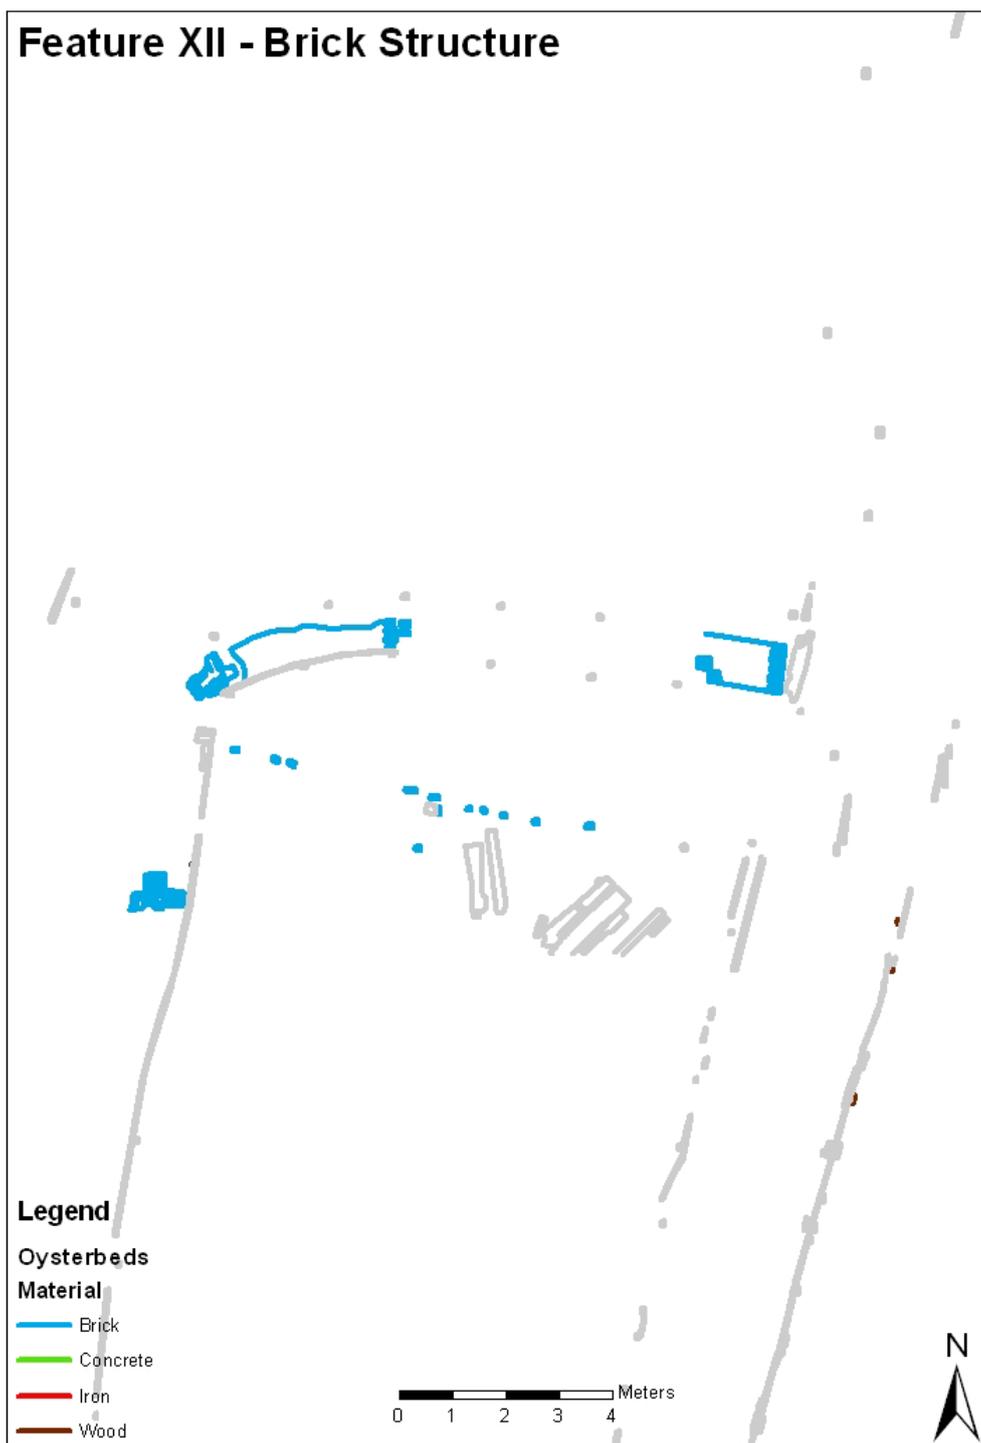
The collapsed remains of a brick structure were recorded between pits VIII and XIII. Early interpretations considered the possibility that the brickwork may have been reused or dumped building debris used to build up a walkway or the wall of an oyster pit. However, while the brick debris was fallen and broken, it was still lying reasonably intact in large pieces. In addition an aerial photograph from 1948 shows clearly that structure XII is a later brick built structure. The structure is recorded intact on the OS maps as late as 1974.

**Figure 44: Plan of Feature XII, collapse brick structure.**

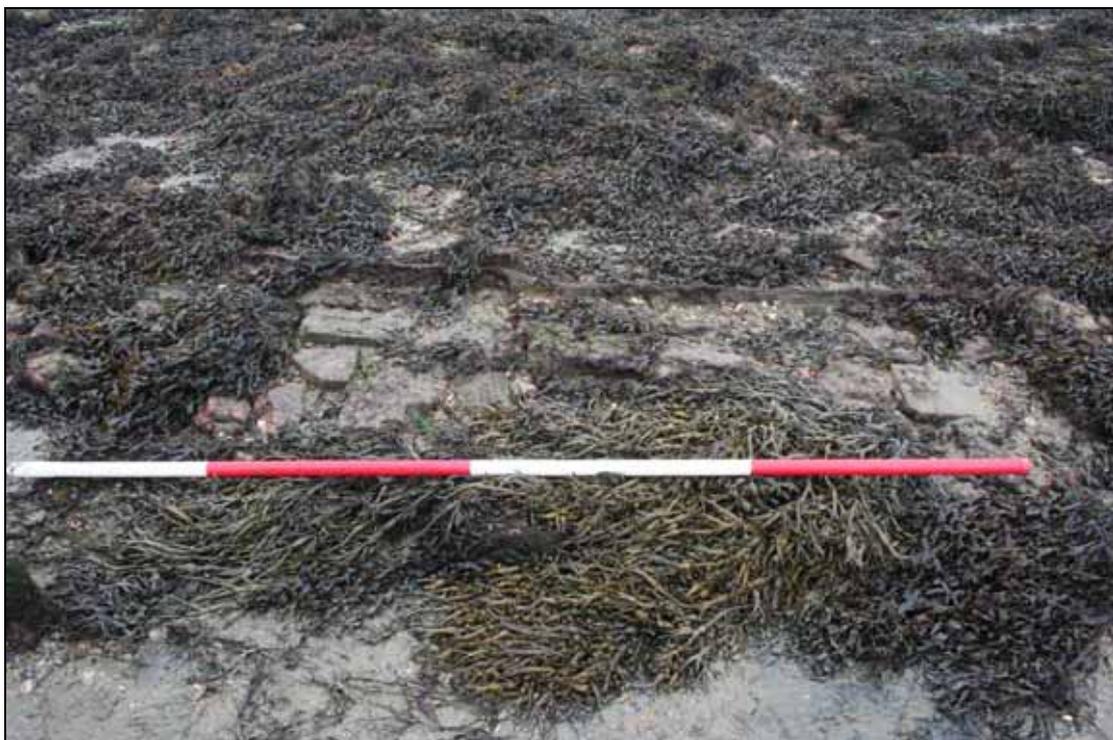
The full extent of the original structure is no longer apparent, and the absence of a large proportion of it suggests the structure may have been deliberately demolished (it may well have presented a hazard) to vessels in the area. The majority of the remaining brickwork lies scattered in a well defined area at the north end of Pit XIII. Generally the brickwork is contained within the surviving timbers of Pit XIII although some lies outside it on the western side of the pit.

**Figure 45: A section of the collapsed brickwork in Pit XIII**

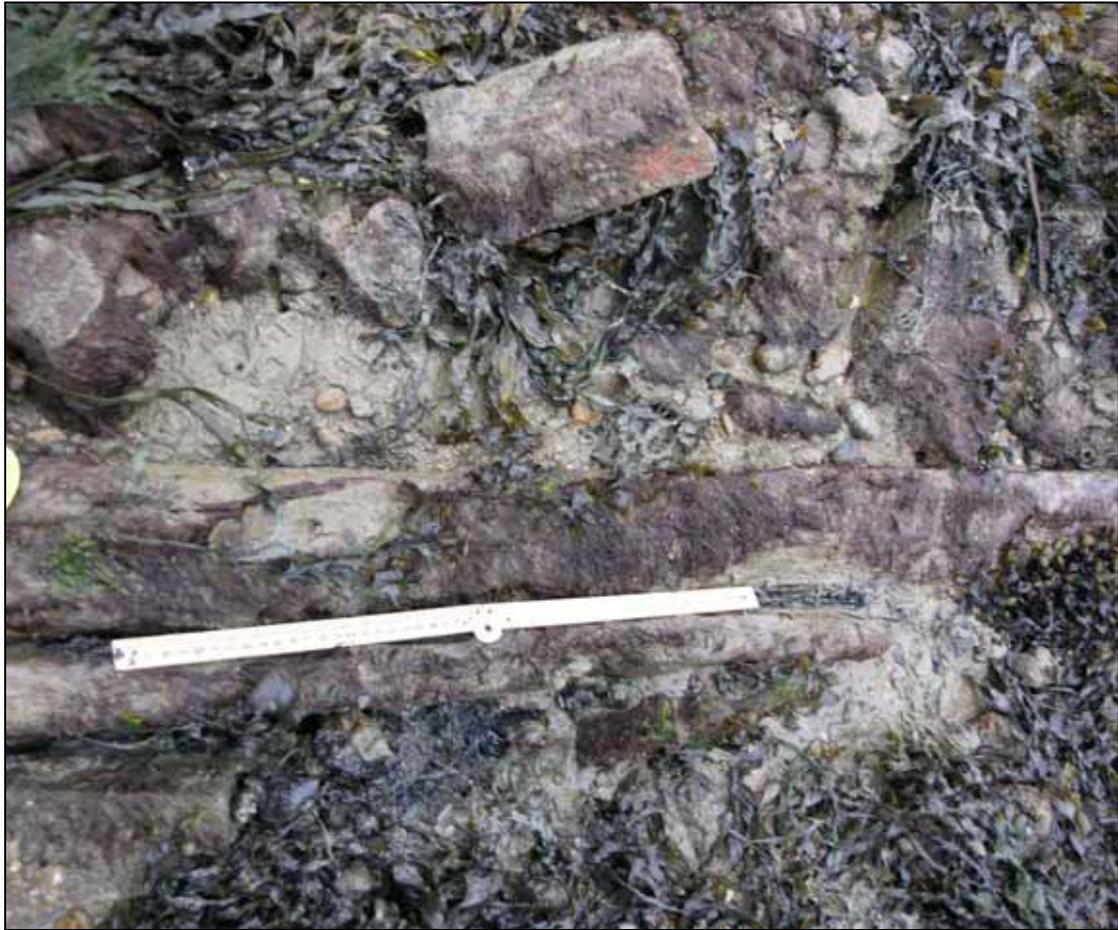
**Figure 47: overlapping horizontal timbers used in the structure of Pit XIII**

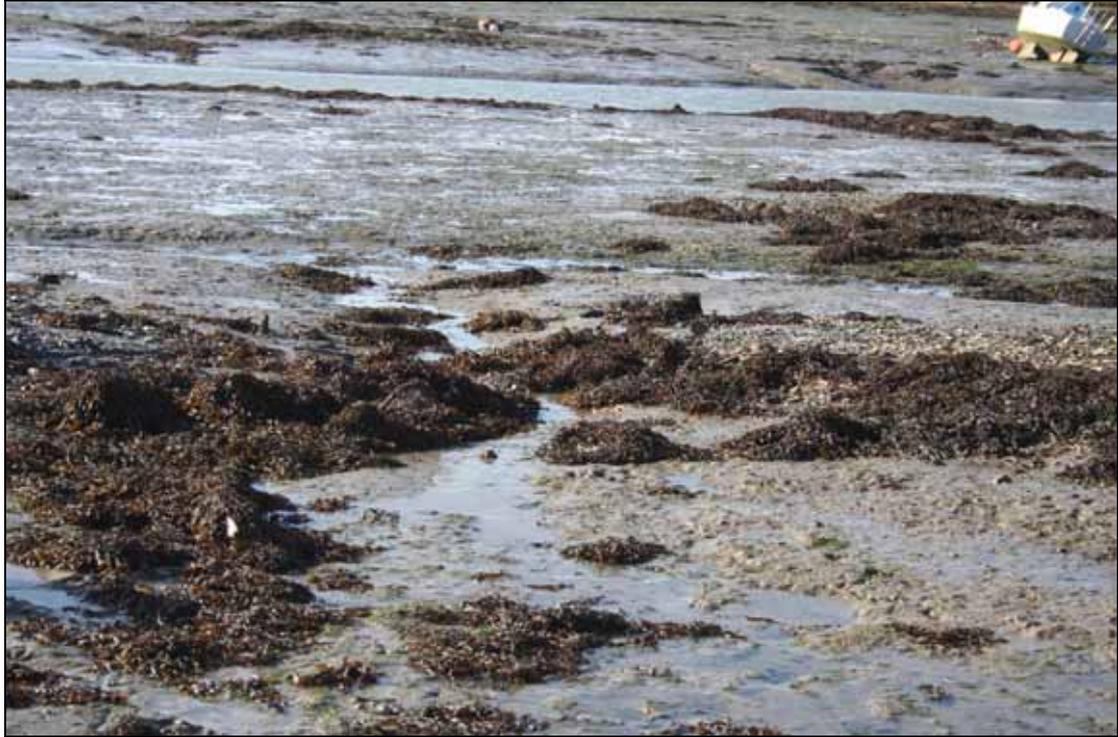
**Figure 48: A heavily weed covered Pit XIII looking south west. The gap in the south west corner of the pit is clearly visible with water draining through it towards the main channel.**

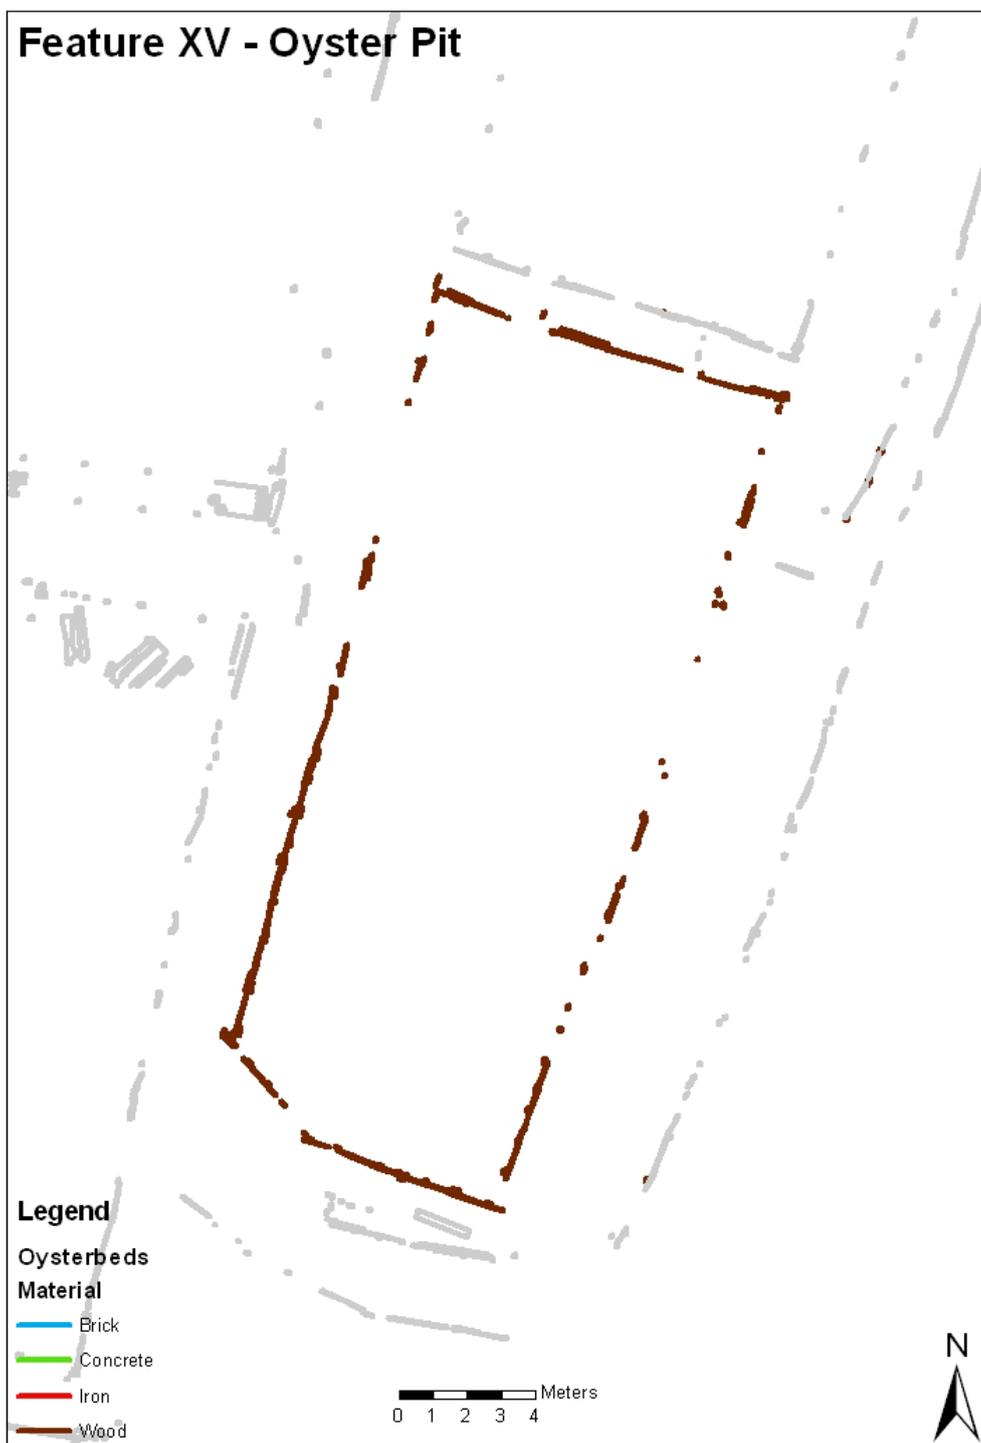
**Figure 49: Plan of Feature IV, oyster pit**

At the north of the pit on the western side, there is a possible repair made with vertical planks. The northwest corner of the pit is supported by a  $\frac{1}{2}$  cut log approximately 0.15m in width. The use of a roughly reduced timber here similar to the  $\frac{1}{4}$  cut timber in pit XI suggests repairs used very roughly fashioned and finished timber.

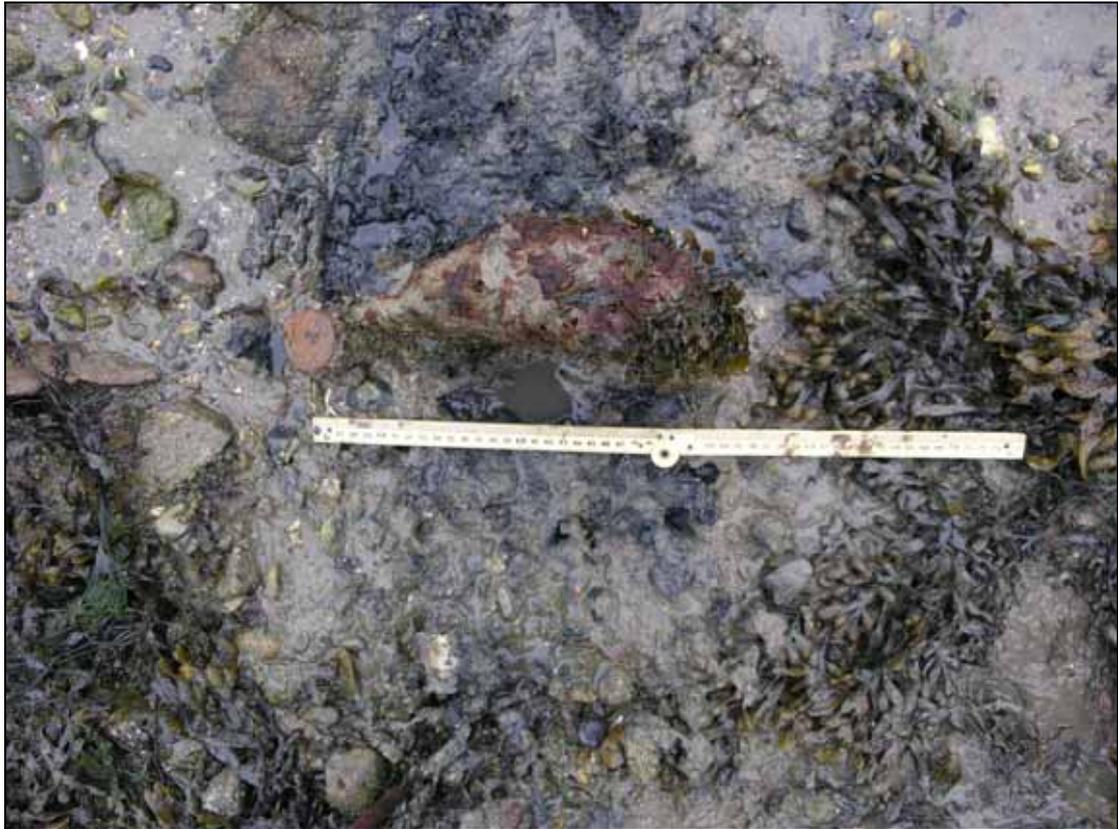
**Figure 50: A ½ cut log upright at the northwest corner of Pit XV.**

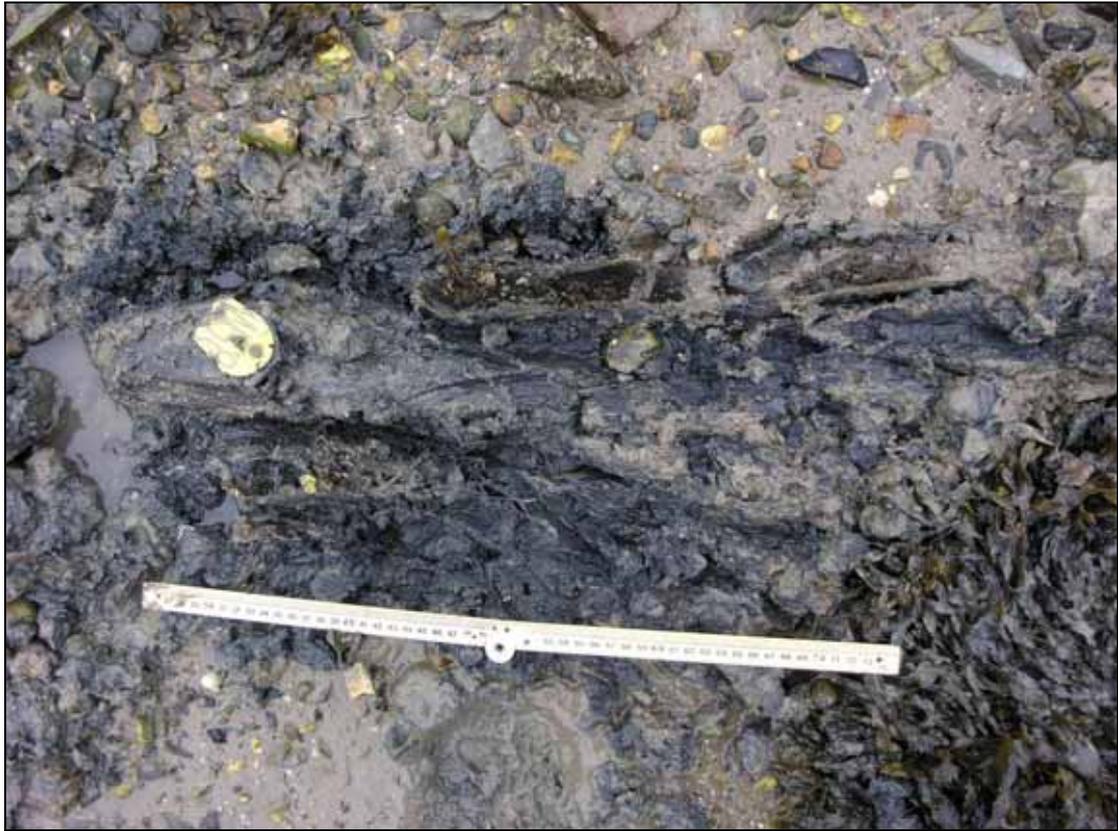
In addition in the south east corner of this pit the structure of the pit is different, a larger than usual horizontal timber is used there enclosed by vertical timbers, which may suggest another repair, or it may be the remains of a rough sluice structure.

**Figure 51: Vertical timbers beside horizontal timbers in Pit XV, possibly representing a repair.**

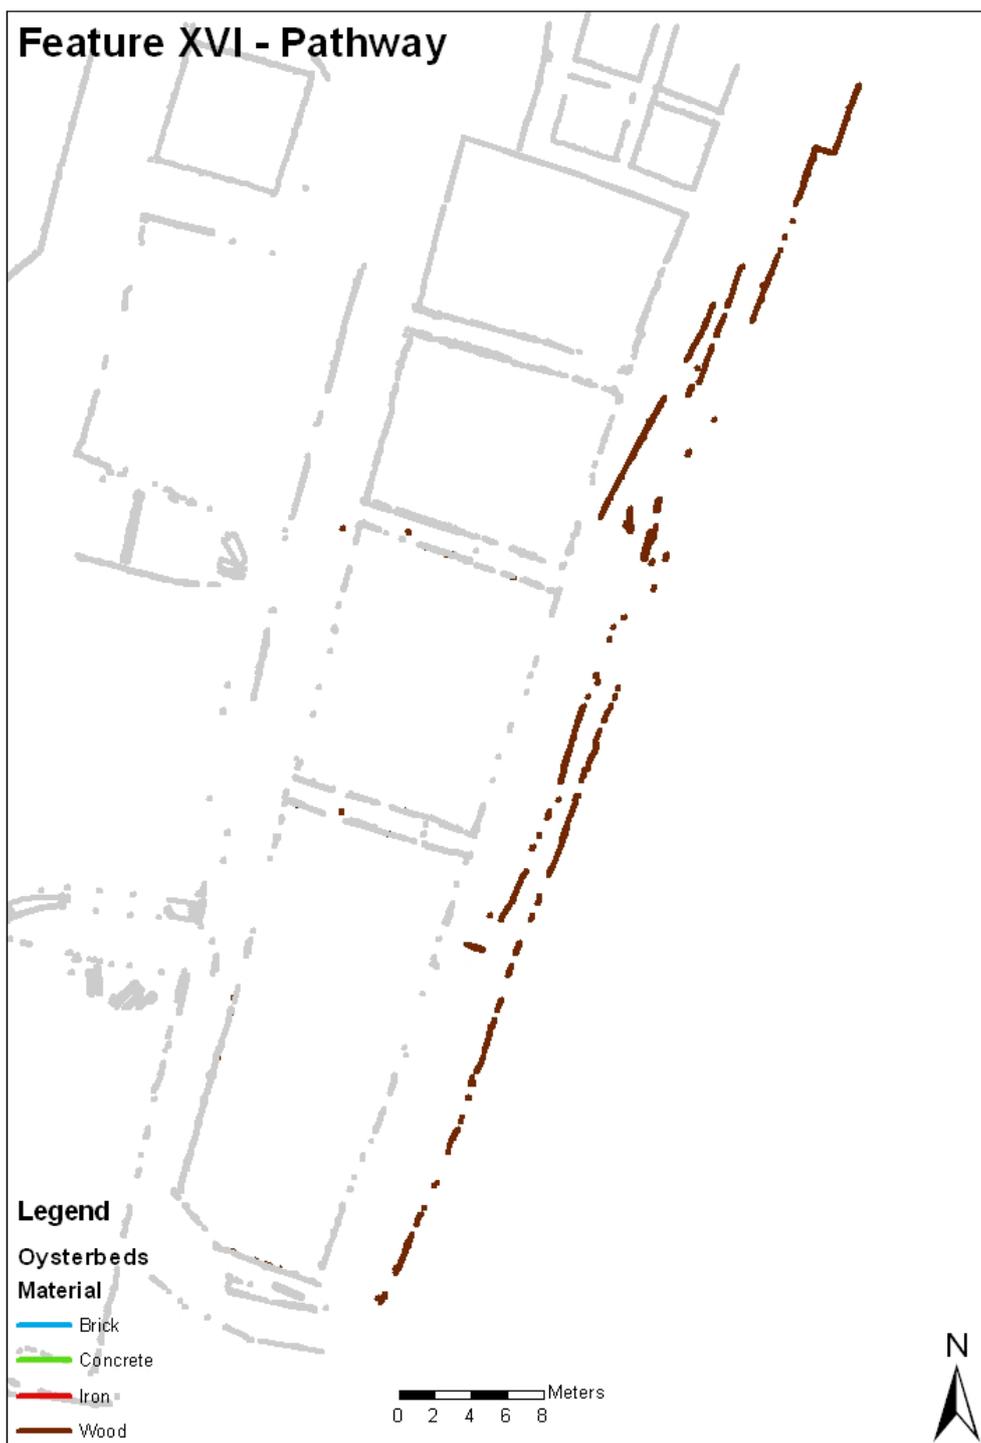
**Figure 52: Plan of Feature XVI, oyster pit.**

The path XVI runs north – south along the eastern side of the exposed pits. The path measures 73m long and it between 1m to 1.5m wide along its length. The path runs along the eastern sides of pits III, IV, XI and XV.

There is some irregular placing of the timbers used to contain the path, but these may be down to a fairly rough method of construction, or they may be a result of disturbance and patching to the path made necessary as the pits were repaired or altered. The path is poorly preserved compared to the later path IX, although this is probably due to its greater age and its longer exposure to the foreshore environment.

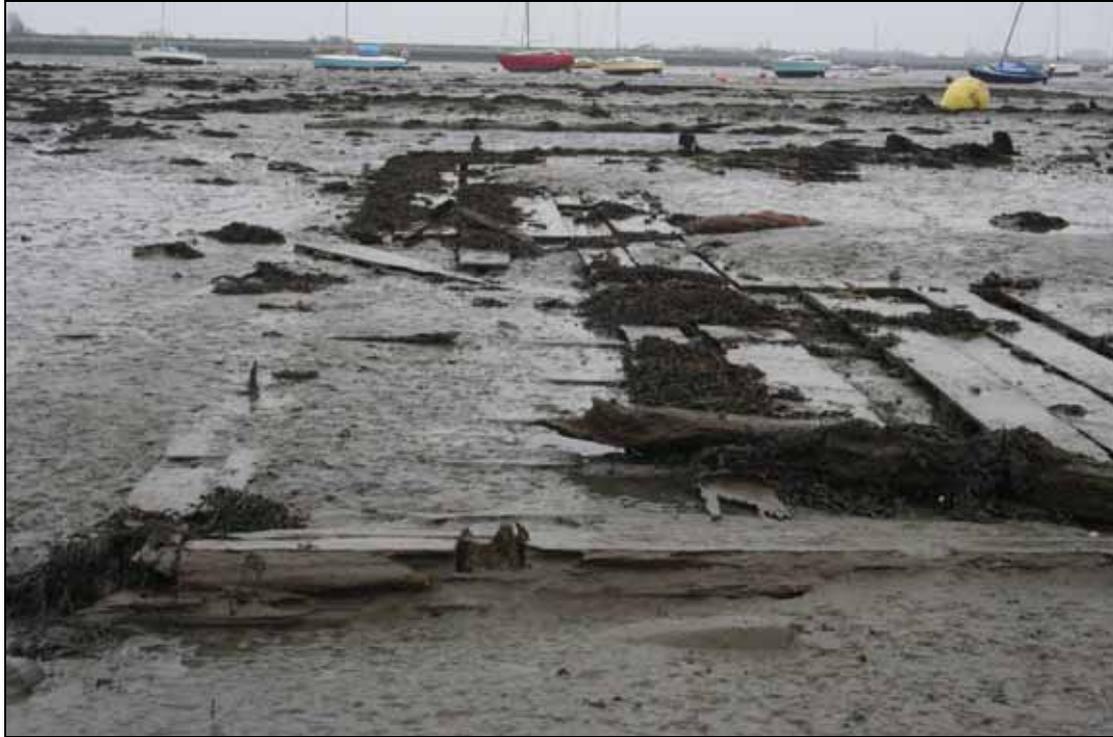
**Figure 53: The partially exposed remains of the Ark.**

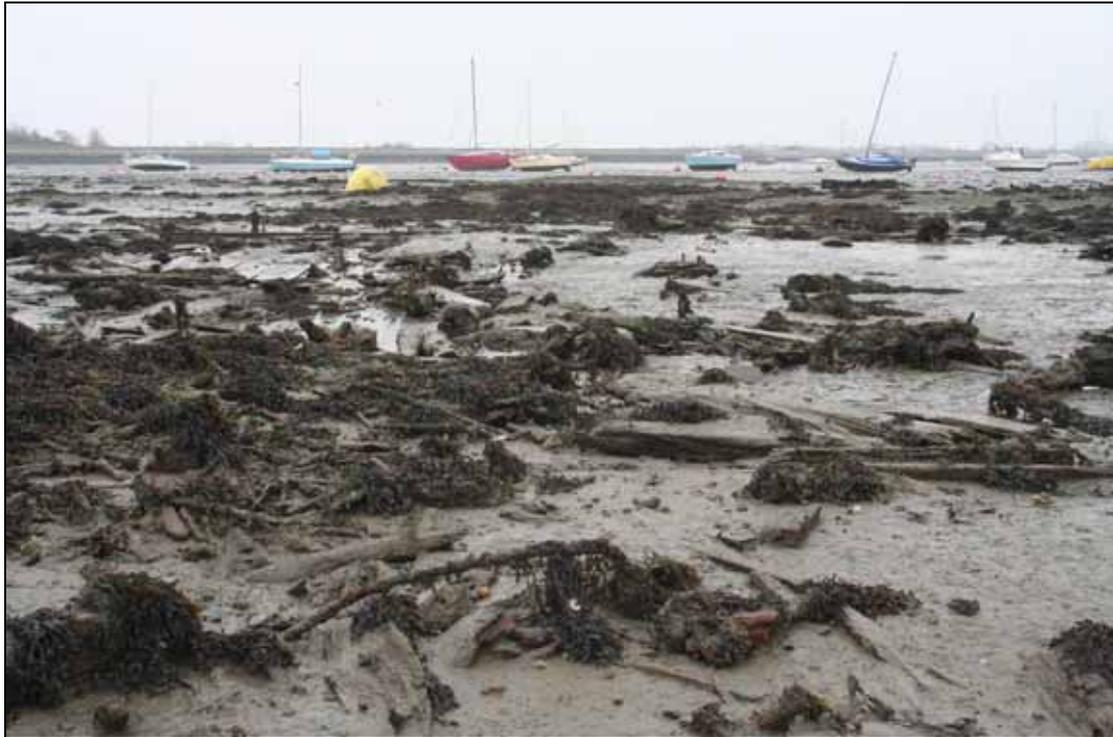
The surviving timber remains look well preserved, but the overall structure is badly broken and much of it is covered by debris and mud, which has obscured much of it and makes detailed description difficult. Additional survey of the Ark may be of benefit provided health and safety concerns can be adequately resolved.

**Figure 54: Debris and soft mud covering the site of the Ark.**
