**Forgotten Wrecks
of the
First World War**

June 2018

Sultan's Fighting Top Hamble River

Site Report

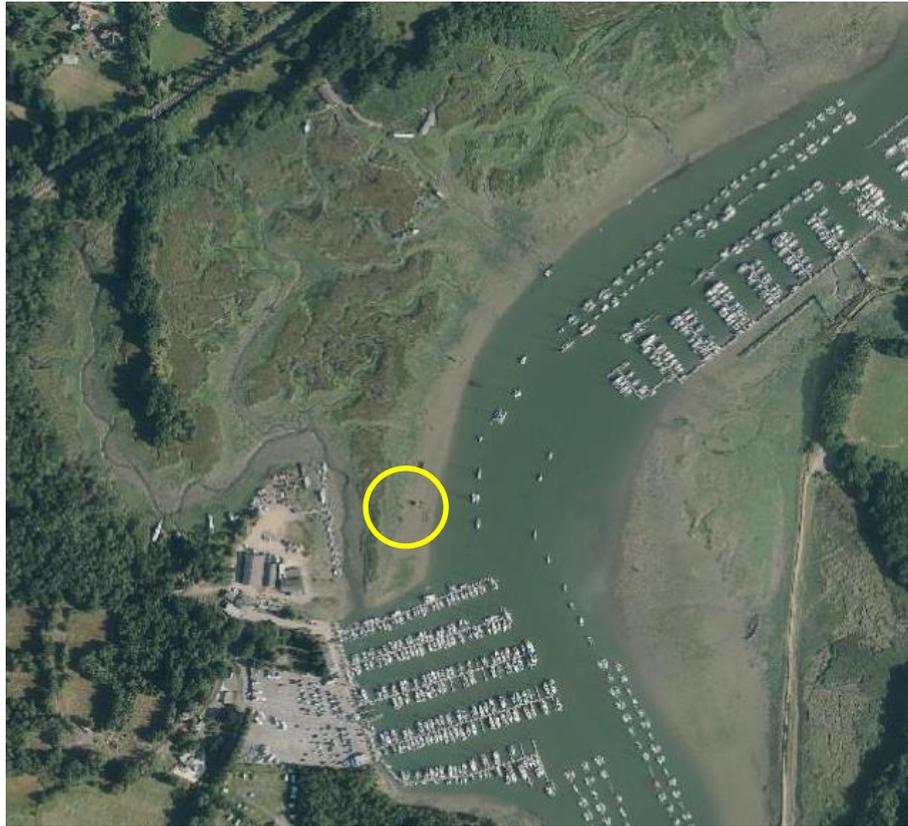
Figure 2: Aerial view of site (Channel Coastal Observatory 2016)

The location of the HMS *Sultan* mast that is the subject of this report is SU 48558 08369; X (Easting): 448558; Y (Northing): 108369; Lat.: 50.872789; Long.: -1.3112649, between the low- and high-water marks (Figure 2). The feature being a metal, cement-filled structure that protrudes from the riverbed (Figure 3).

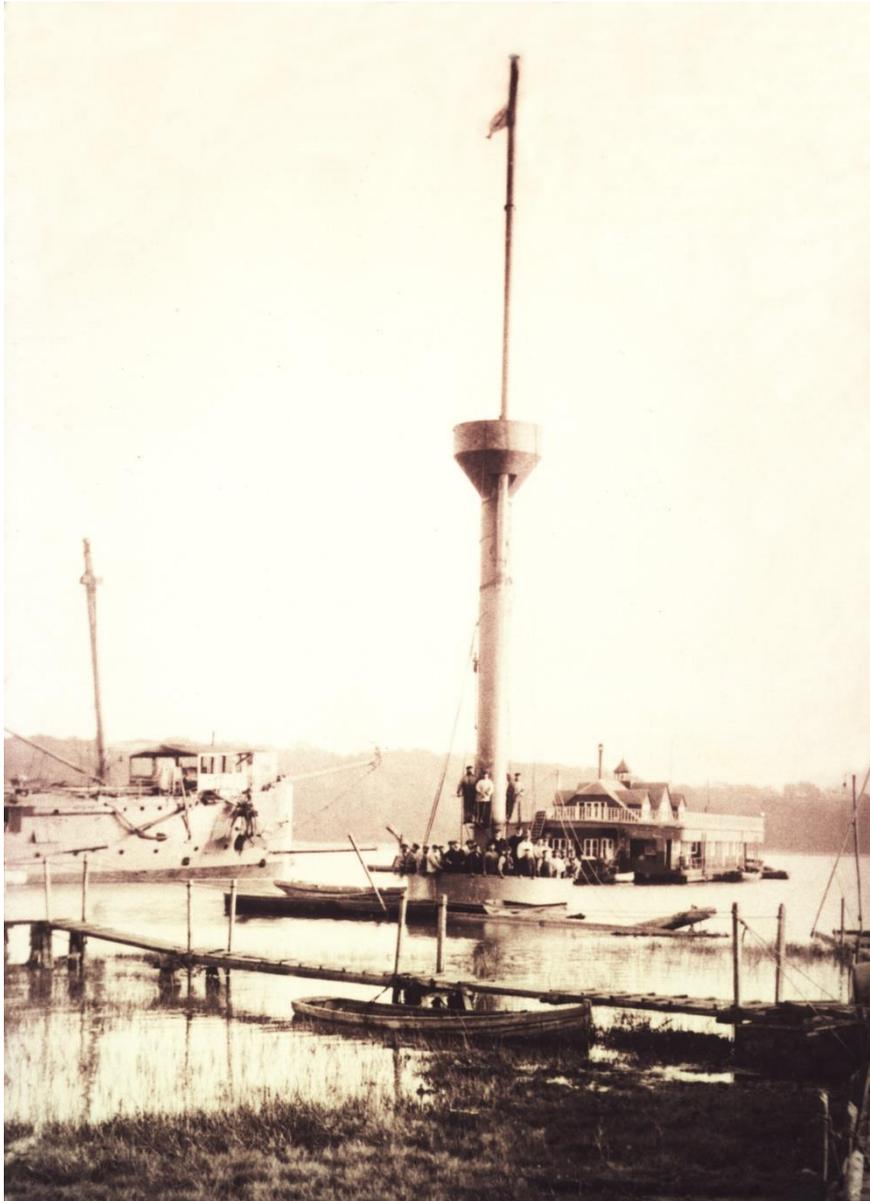
Figure 5: Mast ceremony (IMU). Probably 1908

It is not known precisely when the mast was put in place but a report in *Yachting Monthly* in September 1909 stated: *"The pier is not easily seen by reason of the hulks being moored in front of it, but an old military mast, with two fighting-tops, forms a conspicuous object close to the pier itself"* (IMU). Historical sources (Robinson 1987) refer to it originally being sunk into the mud to a depth of approximately 30 feet (over 9 metres). Figure 5 shows the mast at around this time.

The upper mast section and fighting top is still in place, rising up from the centre of the lower fighting top, the remains of which still survive close to the water level today.

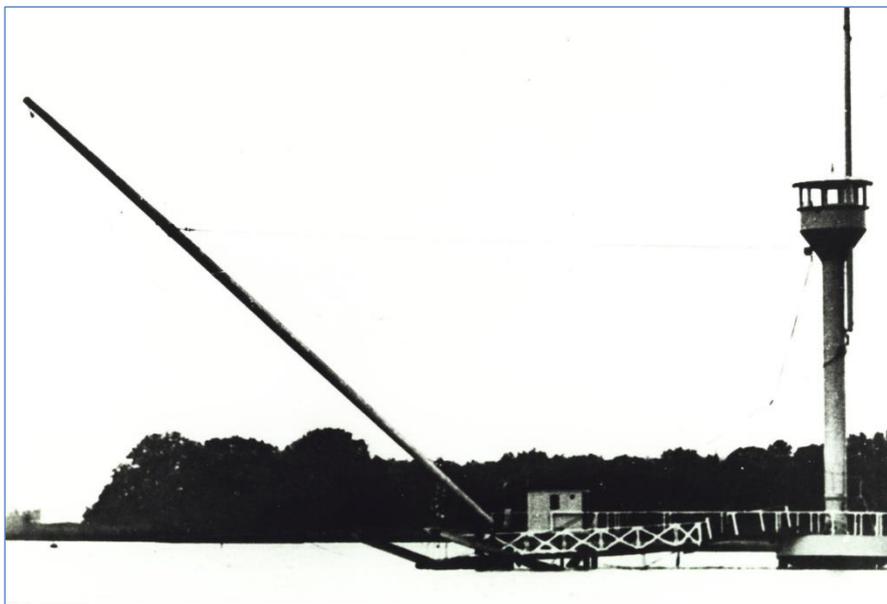
Figure 6: Mast with additional enclosure added to the upper level after its original placing (IMU)

In Figure 6 it can be seen that a jetty structure has been built across the lower fighting top and a roof added to the upper fighting top.

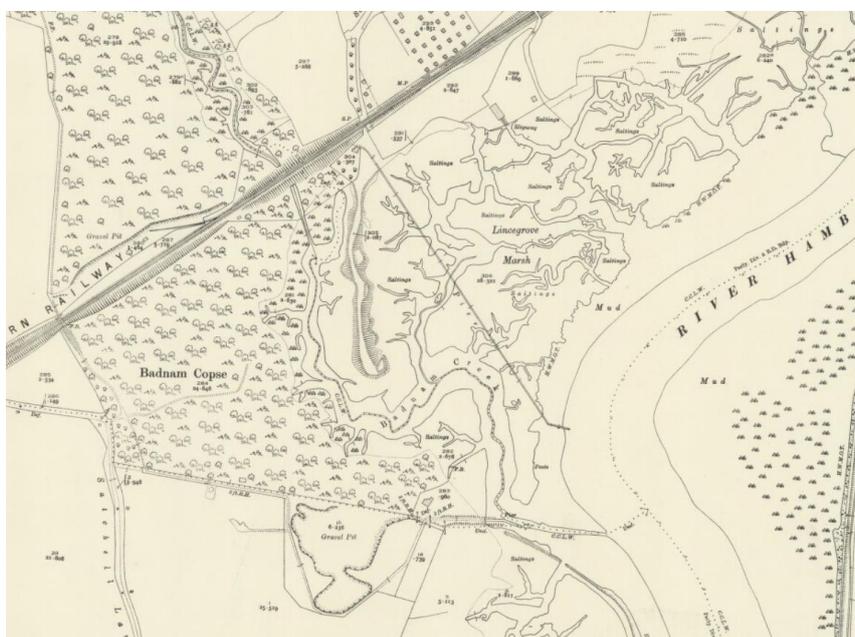
Figure 12: OS 25-inch 1932

During the war years, many OS staff members were posted overseas, producing maps for military purposes. The inevitable economies post-war and the backlog meant that no revisions were published of the area until 1932 (Charles Close Society). Figure 12 shows the jetty and mast. The 30-acre plot has been split, with a gravel pit occupying part.

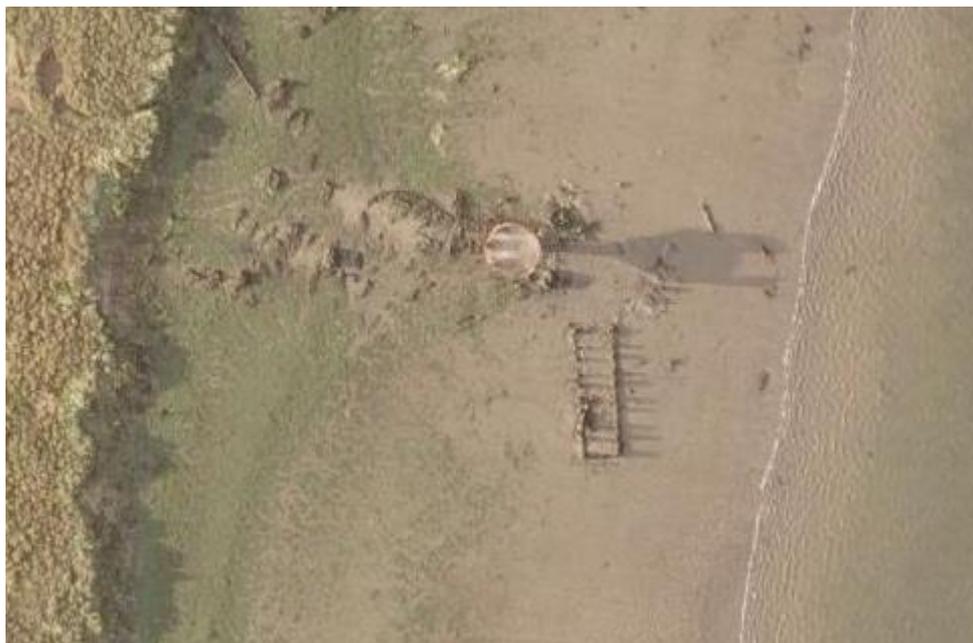
Figure 15: Channel Coast Observatory view - 2013

This resource has the advantage over other satellite imagery in that it shows coastal areas at low water (Figures 15 & 16).

Although the view from directly overhead does not show many features of the fighting top, it is interesting to note the shadow in Figures 15 and 16.

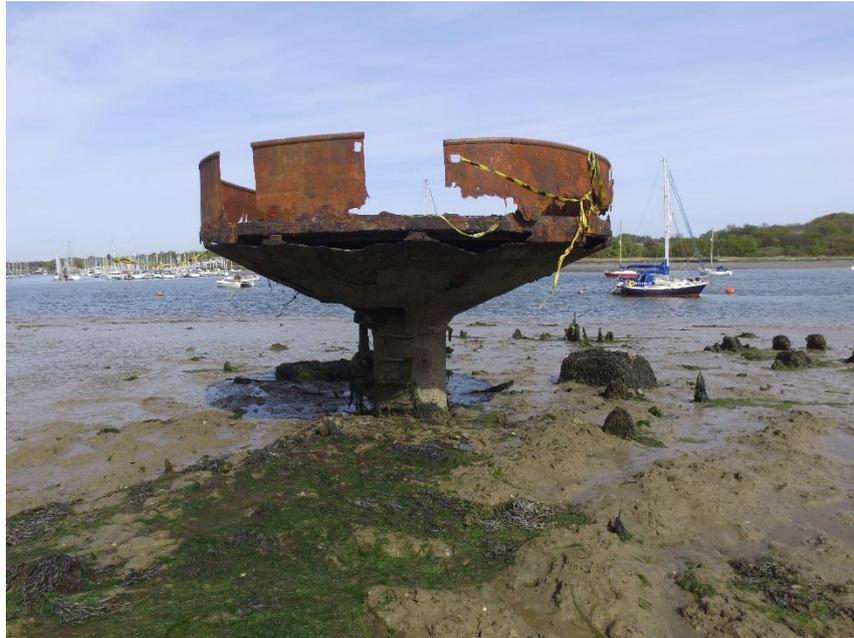
Figure 19 Fighting top viewed from the west

The metal fighting top from *Sultan* protrudes from the mud, being visible at all states of the tide. At low tide, a section of the mast can also be seen below the fighting top (Figure 19). It is only the lower fighting top that survives, the upper one having been removed in the 1950s (see Section 2.2).

The diameter of the fighting top is approximately 4.8m and the maximum height of the metal rim approximately 0.8m, with a 4cm reinforcing band around the top. The raised rim of the fighting top is extremely corroded. Several sections (approximating to one quarter of the total) are missing.

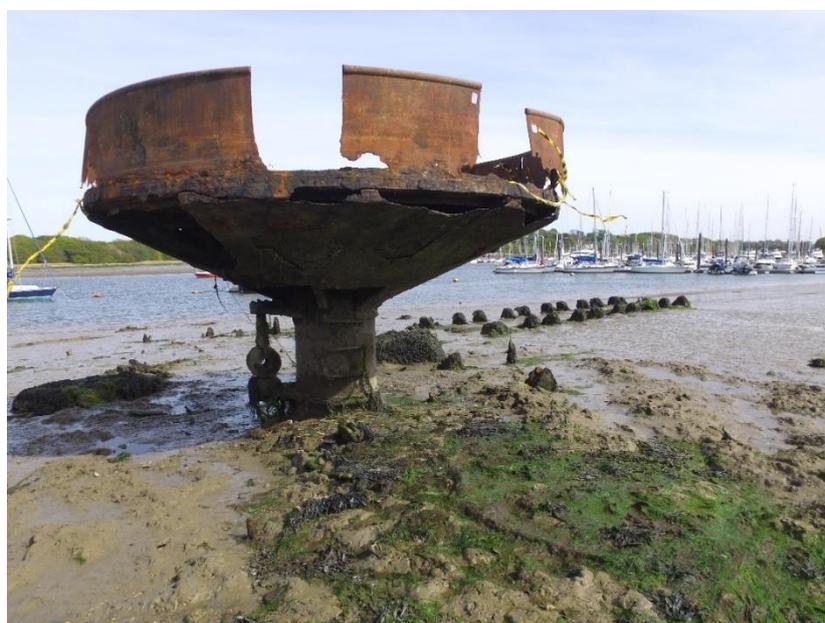
Figure 20 Fighting top, west side

On the west (shore-facing) and east sides, the straight and relatively clean edges to the missing sections suggests intentional removal. On the western side, two sections have been cut out, approximately 60cm wide, with approximately 1m between them. Small square holes can be seen in the top corners of the rim on either side of one of the missing sections, though their purpose is not known. (Figure 20).

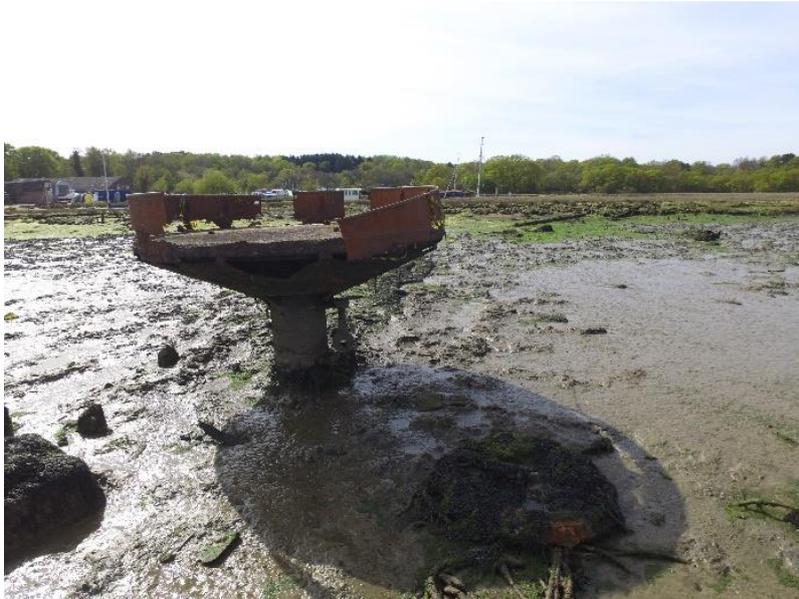
Figure 21 Fighting top, east side

Opposite, on the east (river-facing) side, another deliberately cut section is missing (Figure 21). It is possible that there was also a central bit of rim on this side (to match the west side) that has since broken off.

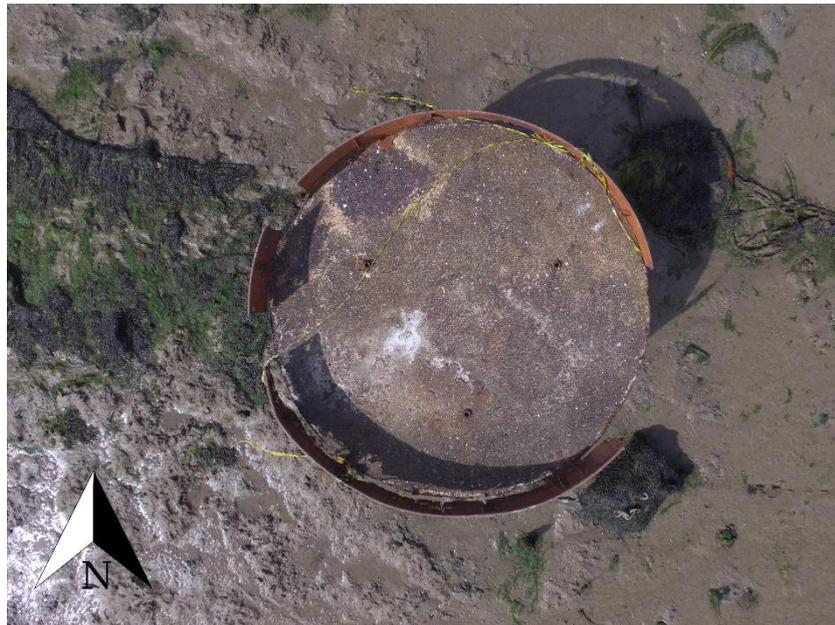
Figure 22 Fighting top from above.

The alignment of the two missing sections in the fighting top rim can be seen most clearly in the photo taken from directly above (Figure 22). It is highly likely that the recesses were cut in the fighting top rim to accommodate the pier structure shown in Figure 6.

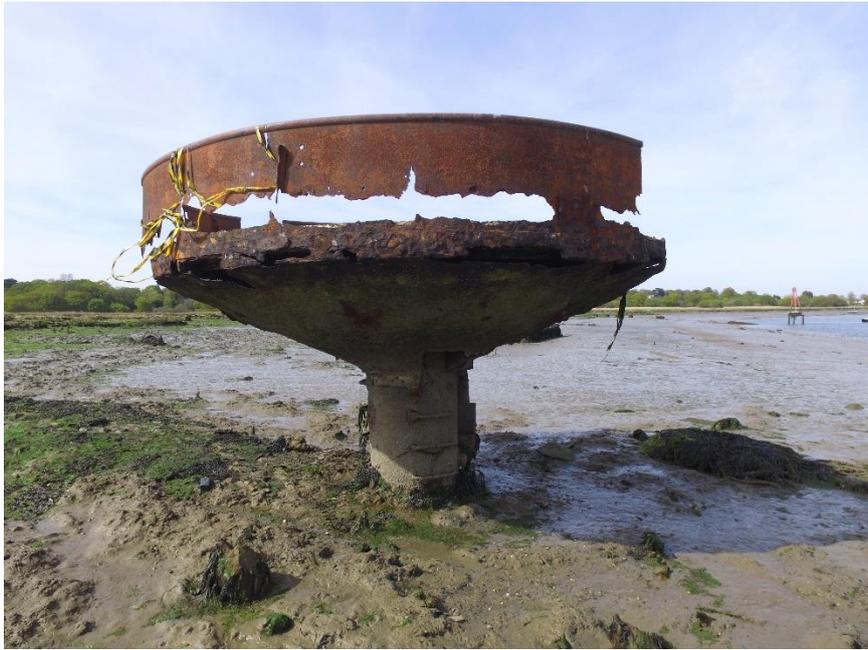
Figure 23 Fighting top, south side rungs

Ladder rungs, that would have been used for climbing the mast from the deck to the lower fighting top, can be seen on the northern and southern sides of the mast. On the south side three rungs are visible (with a possible fourth close to the mud, obscured by weed). Fixing points indicate that an additional rung at the top is no longer present (Figure 23).

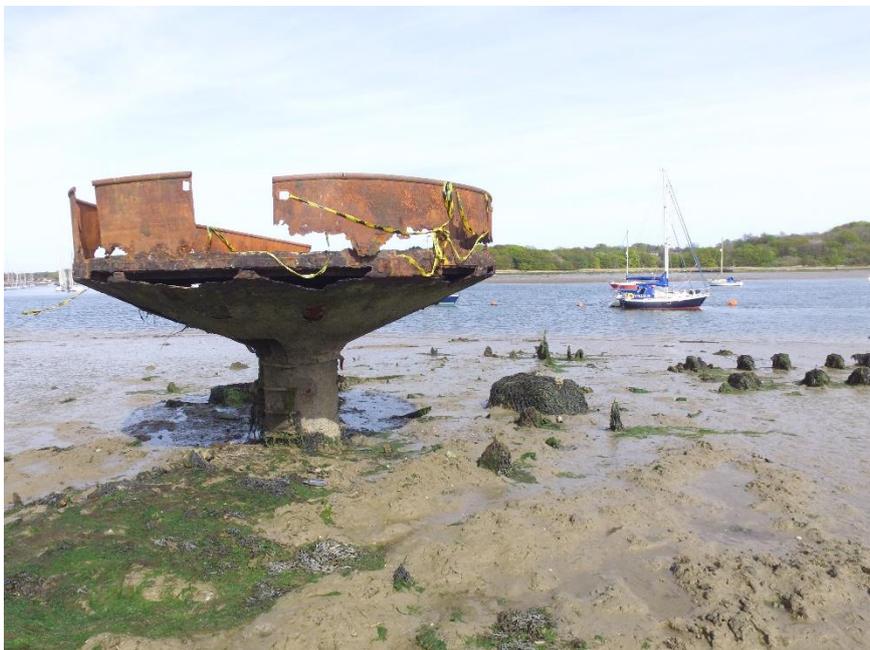
Figure 24 Fighting top, north side rungs.

On the opposite (north) side of the mast, four rungs are visible. On both sides, square-ish access holes into the fighting top can be seen.

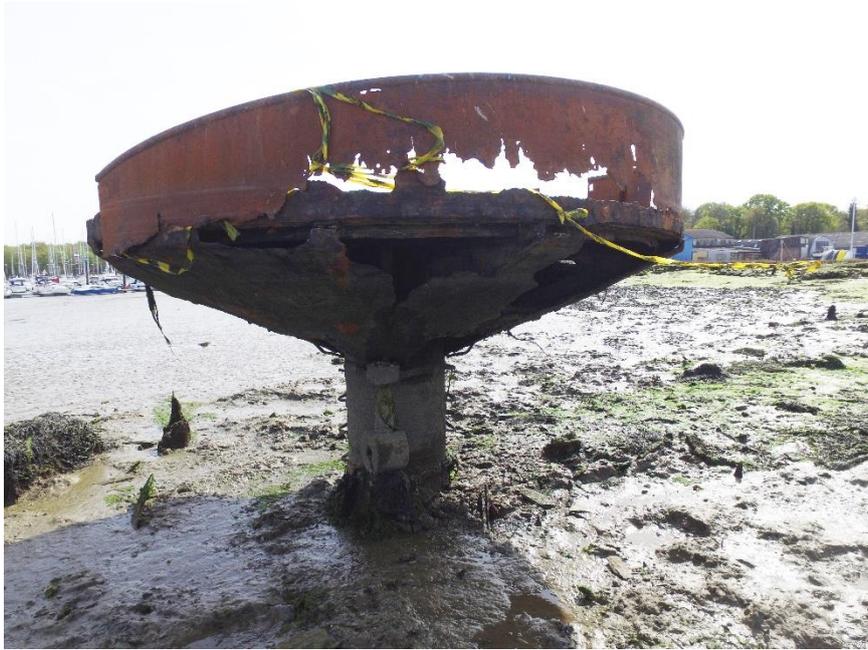
Figure 25 Fighting top, northeast side

At low tide, the underside of the fighting top can be seen: again, heavily corroded, particularly on the northeast side. Approximately 1.25m of the lower mast is exposed beneath the fighting top, disappearing into the mud. The approximate diameter of the mast is 85cm. The corrosion provides a rare view of the internal structure and construction methods and materials of a Victorian era fighting top (Figure 25).

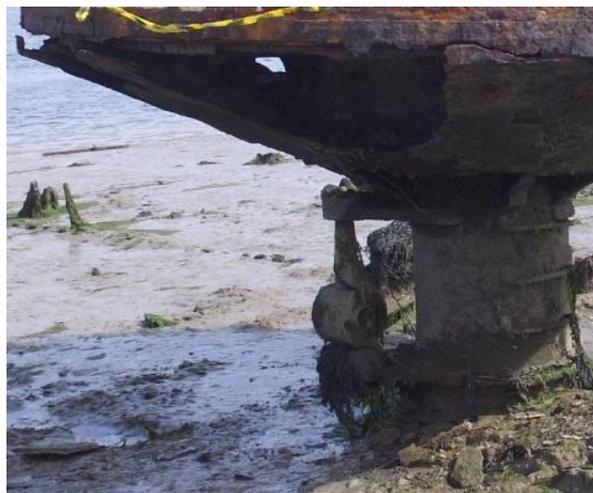
Figure 26 Rigging feature.

On the northern side of the mast, two metal brackets are fitted, one near the base of the fighting top, the other just above the riverbed. Between the two brackets is a fitting (Figure 26). It is highly likely that this feature relates to the rigging that would have supported *Sultan's* mast, being part of the arrangement by which the shrouds or stays were attached to the mast (Figure 27).

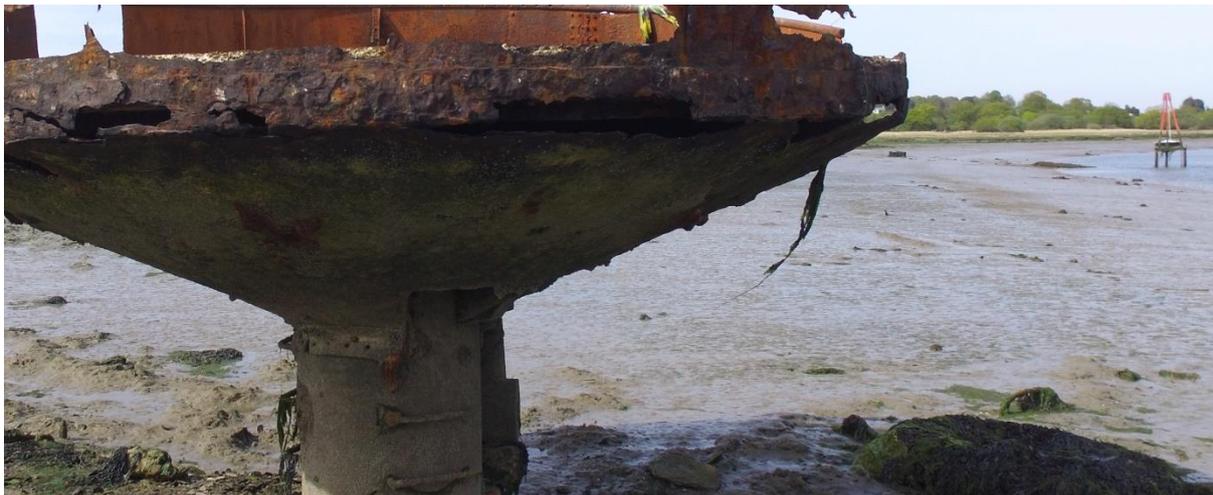
Figure 28 Fighting top, southwest side.

No equivalent fitting is present on the opposite (southwest) side of the mast, though at the top, where it meets the fighting top, a line of small holes can be seen in a reinforcing strip, suggesting there may have been something attached here previously (Figure 28).

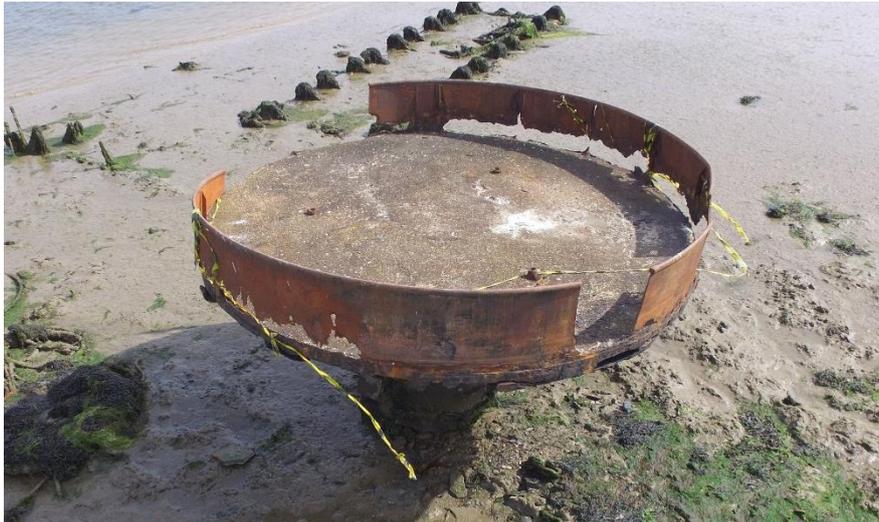
Figure 29: Fighting top showing fixings.

The fighting top itself was filled with concrete, most probably straight after the removal of the upper section and three metal fixings are embedded in the concrete. While no documented evidence relating to the installation of a 'suitable hydrographic mark', as proposed in the SHB minutes (Figure 10) could be found, IMU recalls a red port-hand can marker held up by metal poles. The three fixings embedded in the concrete may be related to such a mark (Figure 29).

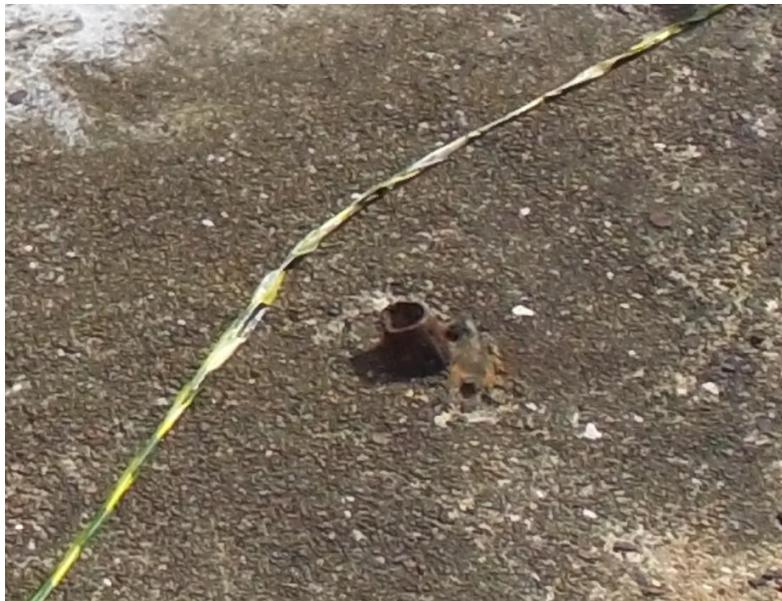
Figure 30: One of the fixings.

Figure 30 shows one of the three fixings, which appear to have been cut off close to the concrete. All are tubular and angled towards the centre of the platform. This one alone appears to be attached to a securing bracket.

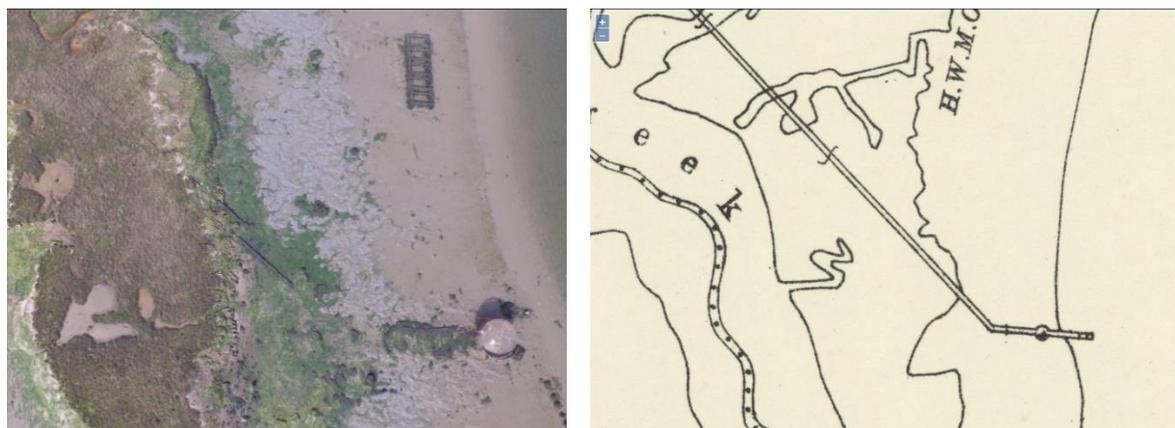
Figure 31: Possible jetty remains.

On the intertidal mudflats to the west and north of the fighting top, some of the probable remnants of the jetty can be seen in other drone photographs taken in the area.

Remnants of a structure can be seen below the high water line and traces of it across the marsh; the angle corresponds with that shown for the jetty on the 25-inch OS map of 1932. Whether or not they are linked cannot be verified without closer on-site examination.

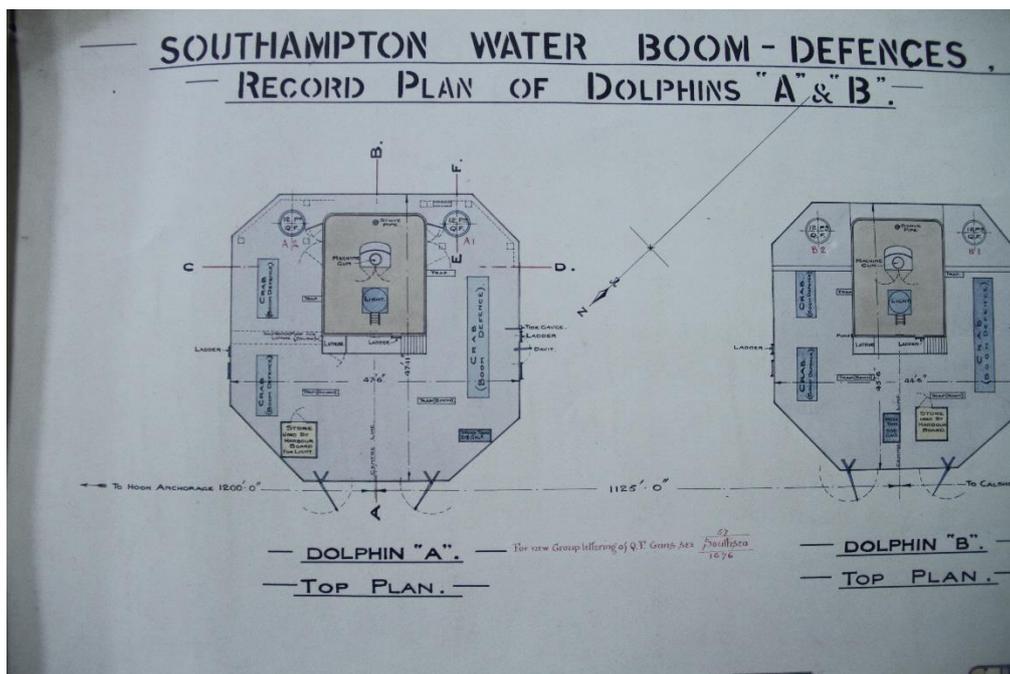
Figure 33: Part of the detailed plans for dolphins (TNA WO 78/4955)

The 'new Defence' used wire hawsers supported by dolphins, and has been visualised at <https://skfb.ly/68EHq> (credit to B.Norman). Although the old Boom had utilised dolphins, these had been constructed around 1896 (one was severely damaged by fire in 1900 – SHB minutes), so would have been replaced. It is not known whether the new ones were in exactly the same locations. TNA document WO 78/4955, which carries the date June 1910 has detailed plans of the two new dolphins (Figure 33). This is most likely a revision, since the planning for the new ladder boom had begun several years earlier.
