FORGOTTEN WRECKS

HAMPSHIRE AND ISLE OF WIGHT

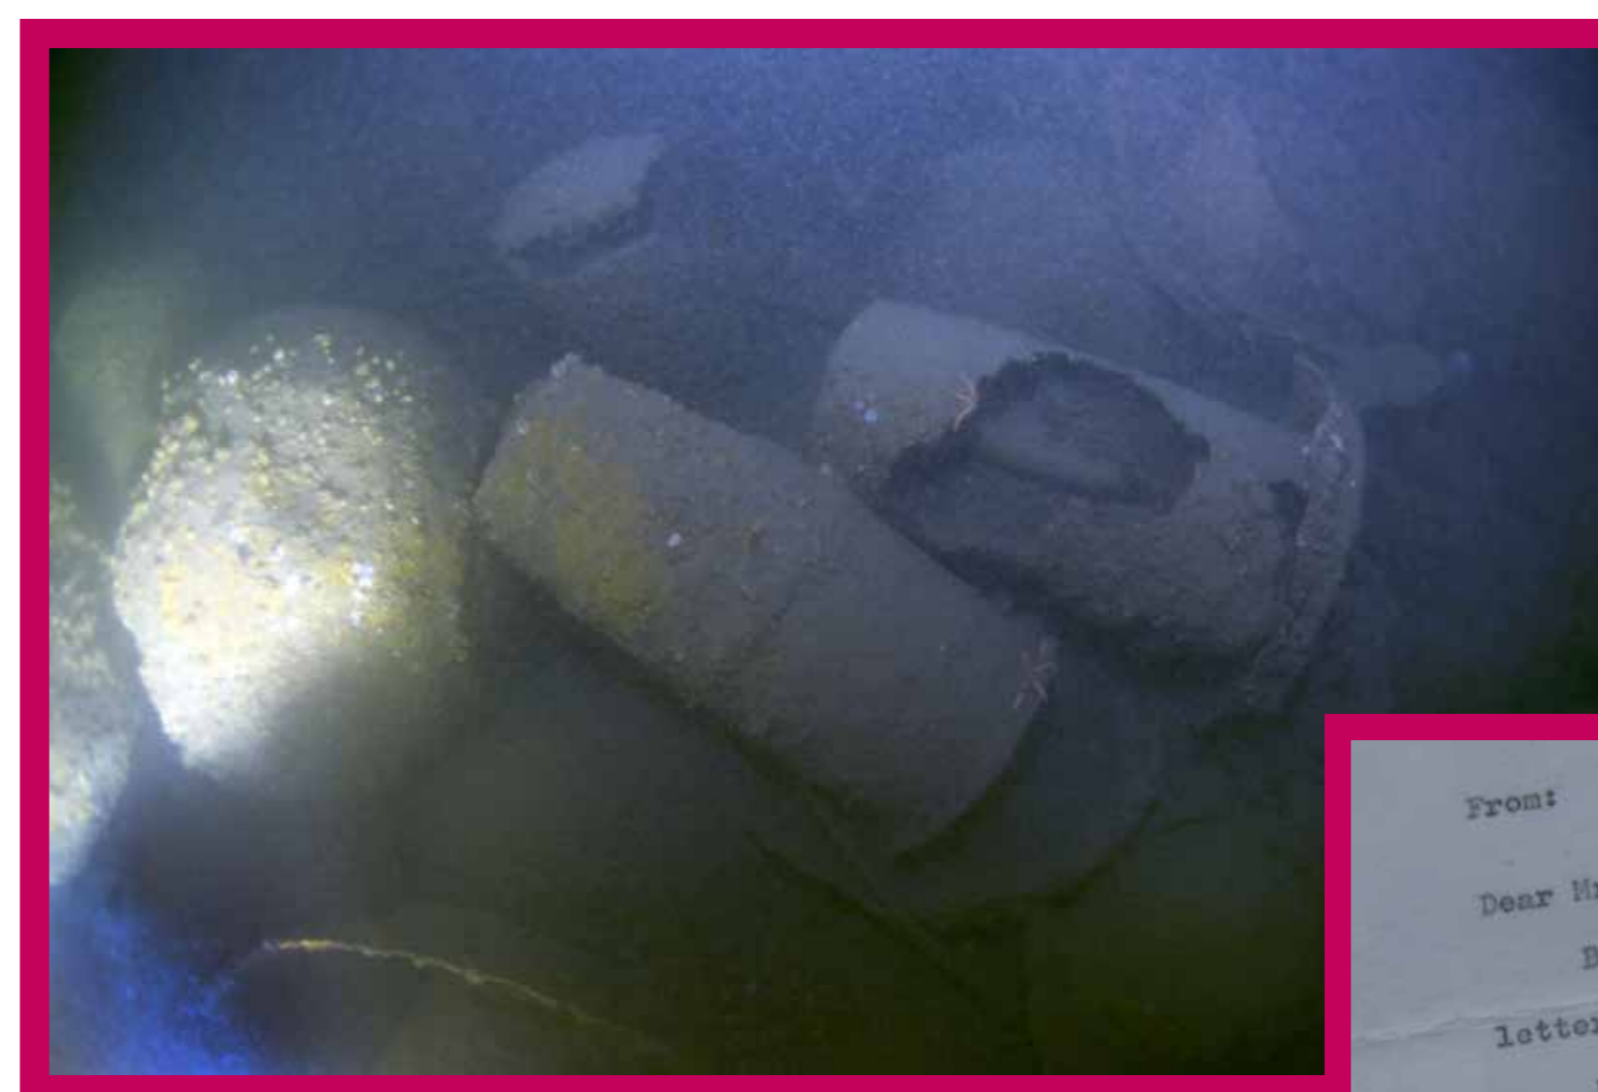
Left: depth charges on the SS *Eleanor*. A depth charge is an anti-submarine weapon which detonates when it reaches a specific depth. They were made from steel canisters about the size of an oil drum and filled with TNT.
Photo courtesy of Mike Pitts.

Today the *Eleanor* lies approximately 9 miles off St Catherine's point, the most southern point of the Isle of Wight, in 40 metres of water. The cargo of mines and depth charges still remains stacked in the areas of the cargo holds, although their explosives have been washed away.

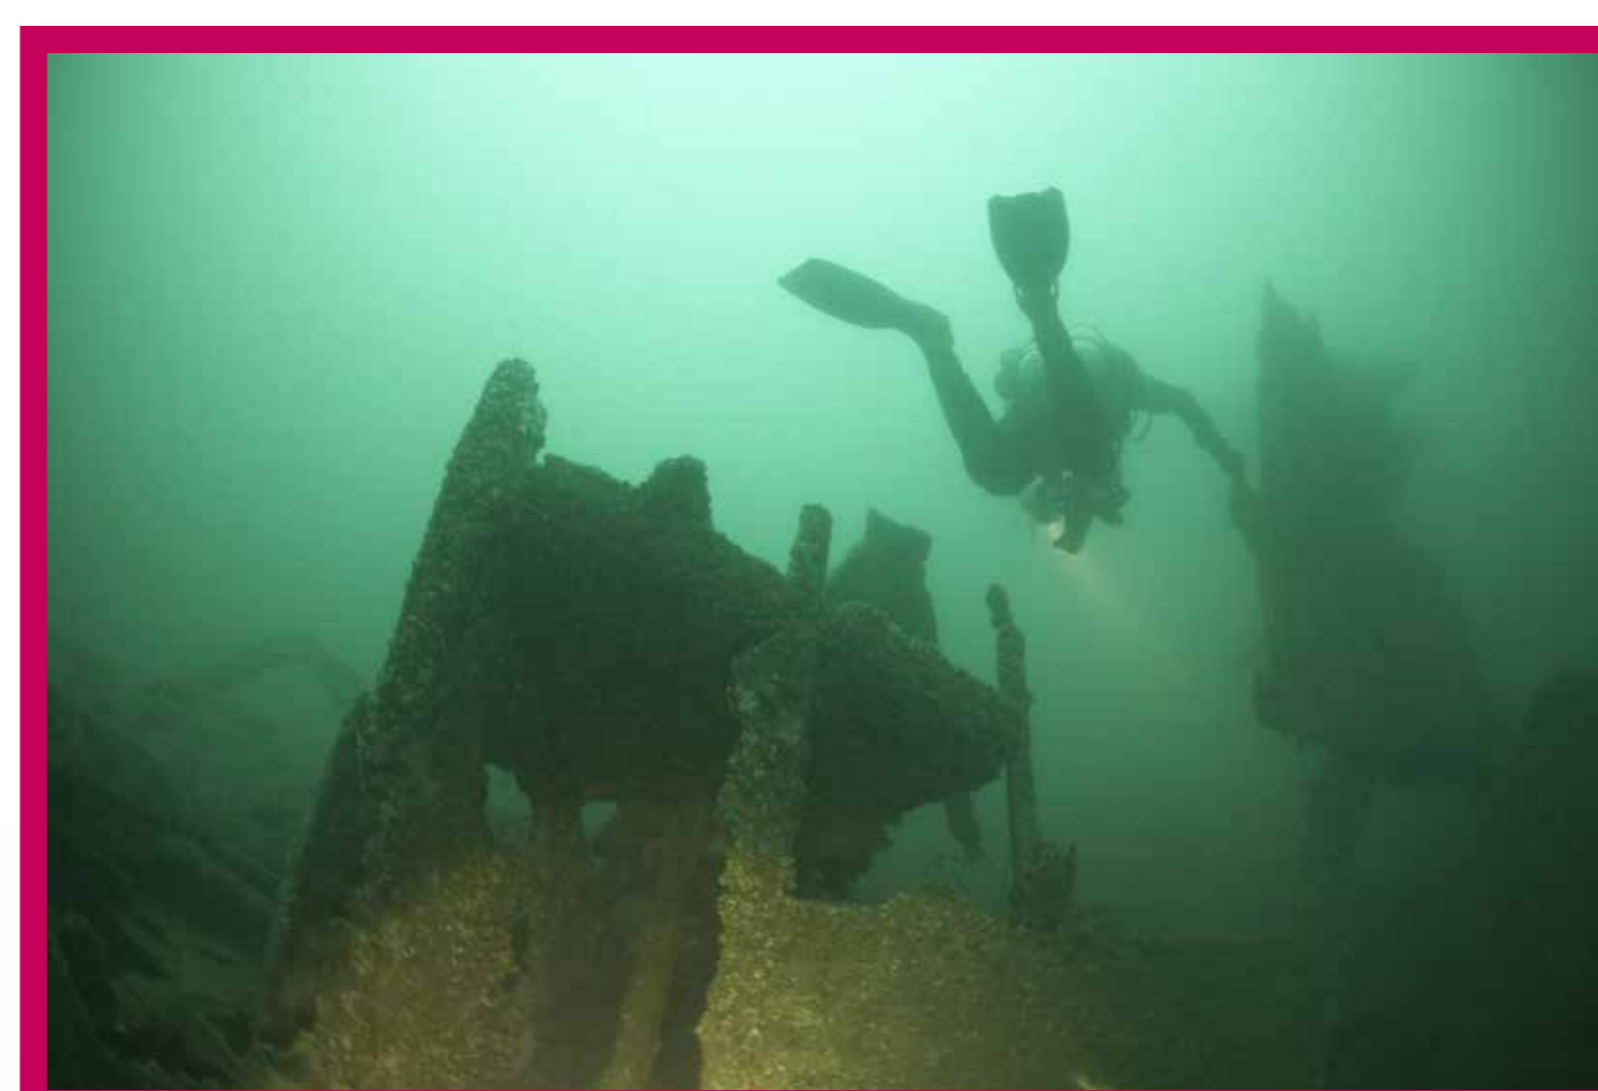
Left: a diver swims across the wreck of the SS *Londonier*. The structure of the propeller, hull and rudder can be seen to the bottom left of the diver.
Photo courtesy of Hamish Morrison.

The wreck of the *Londonier* is in 40 metres of water, approximately 8 miles south of the Isle of Wight. Although the ship's hull has collapsed, the engines and deck gun are still clearly identifiable.
