The Mystery Wreck

(Aggregate Area 122/2 -
UMD), Eastern Solent:

Desk Based Assessment

Stage 1: Final Report

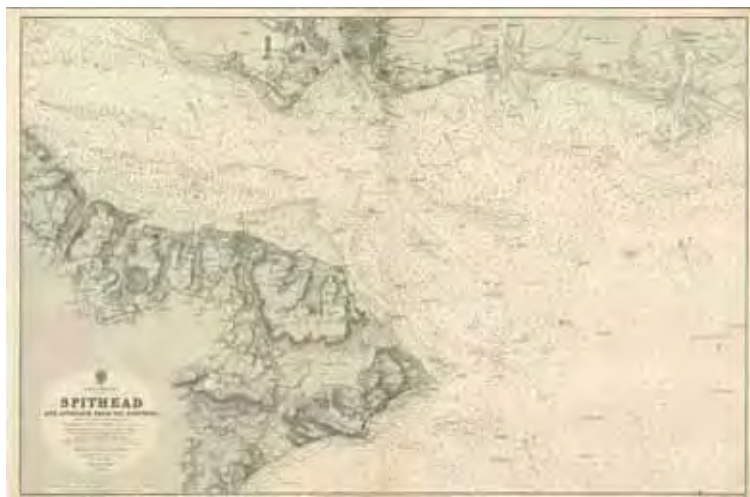
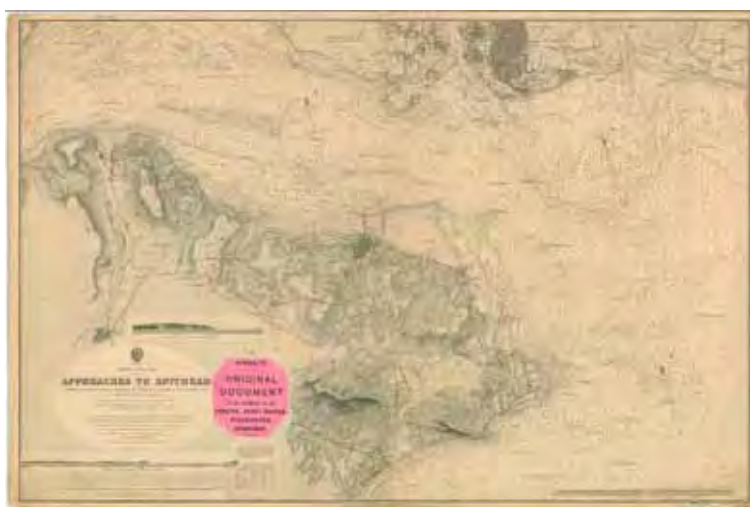
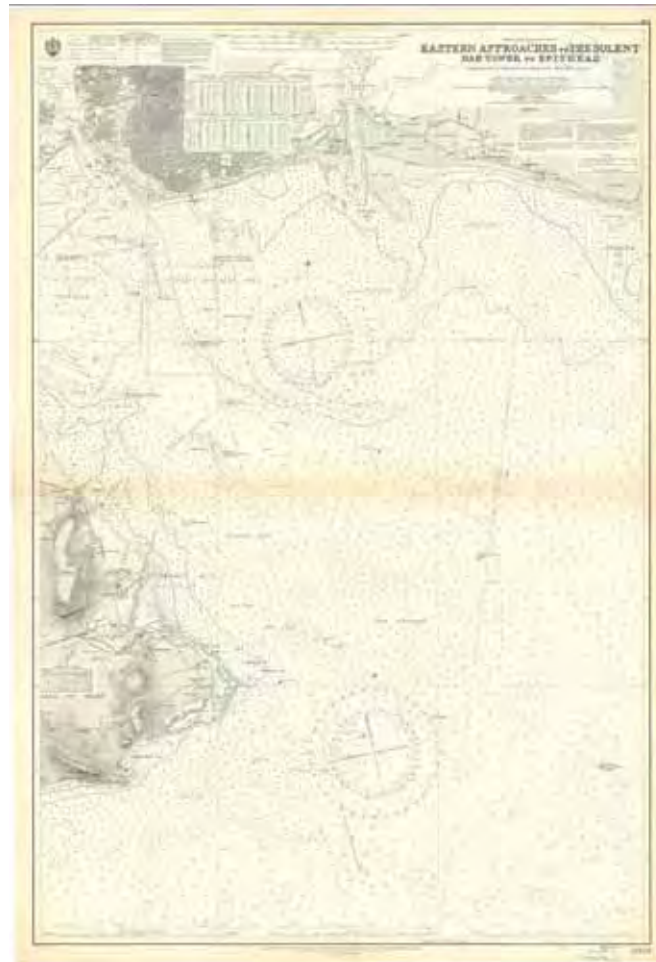
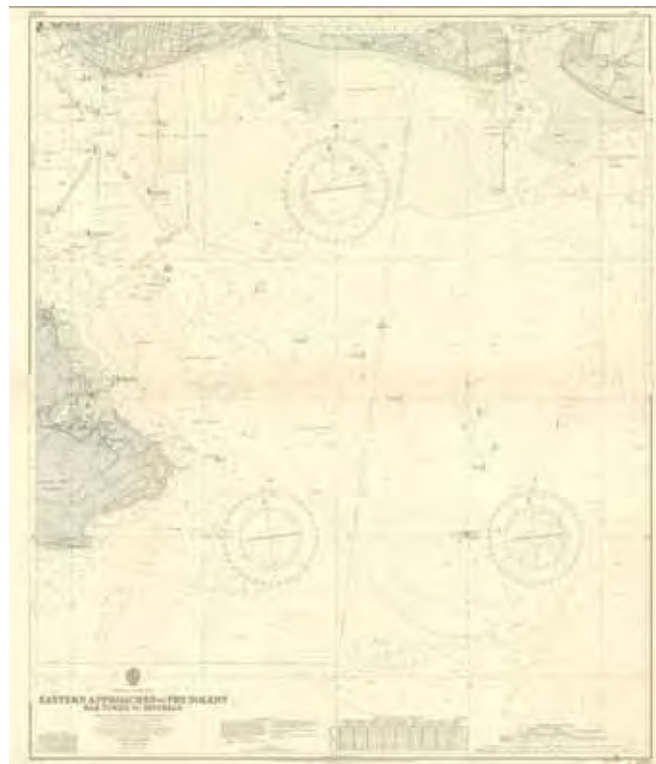
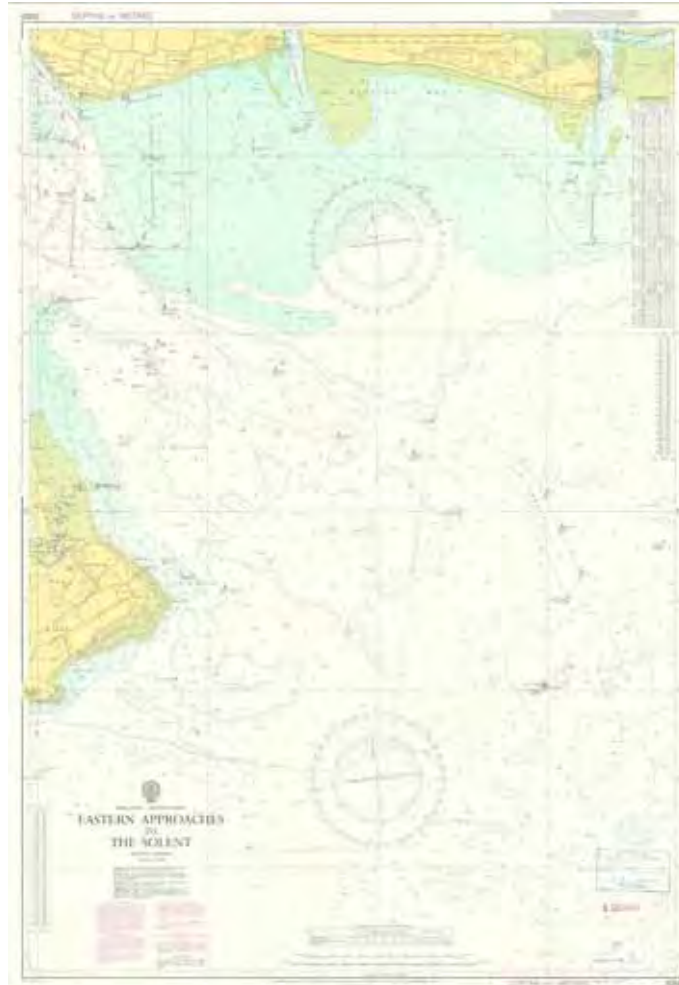
**Figure 6: Topographical changes on the Horse and Dean Sands since 1783
(© UK Hydrographic Office)**

Figure 6 uses these historic charts to illustrate how the topography of the Horse and Dean Sands has changed since 1783. For illustrative purposes these historic charts are presented separately.

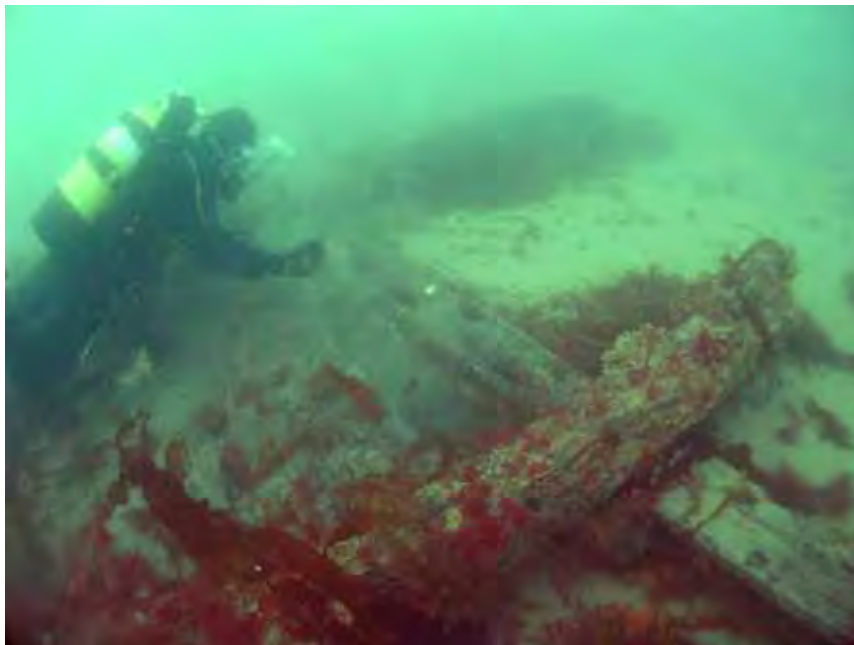
Photo 1. Diver filming western end of the Mystery Wreck

In general the structure comprises large planks lying flush with the seabed with regular cross members and some longitudinal components (**Photo 1**). Measurements taken during 2004 on the western section (Dive 7: 14/06/04) indicate that the planks range from 26 to 32 cm in width. A larger frame timber measured up to 38 cm wide by 18 cm high.

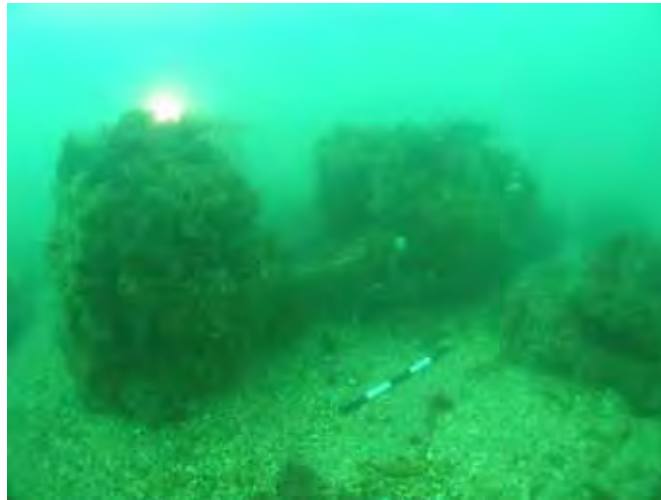
Photo 4. Large iron object found on the wreck site

Other identifiable features include a large iron object c. 75 cm long with an iron loop uppermost, a large iron cylindrical feature (**Photo 4**), a water pump and a possible capstan or windlass. Many concretions and roughly rectangular stone bricks have also been reported, possibly representing cargo or ballast. Two guns have been identified, a small signal canon and a carronade (**Photo 5**).

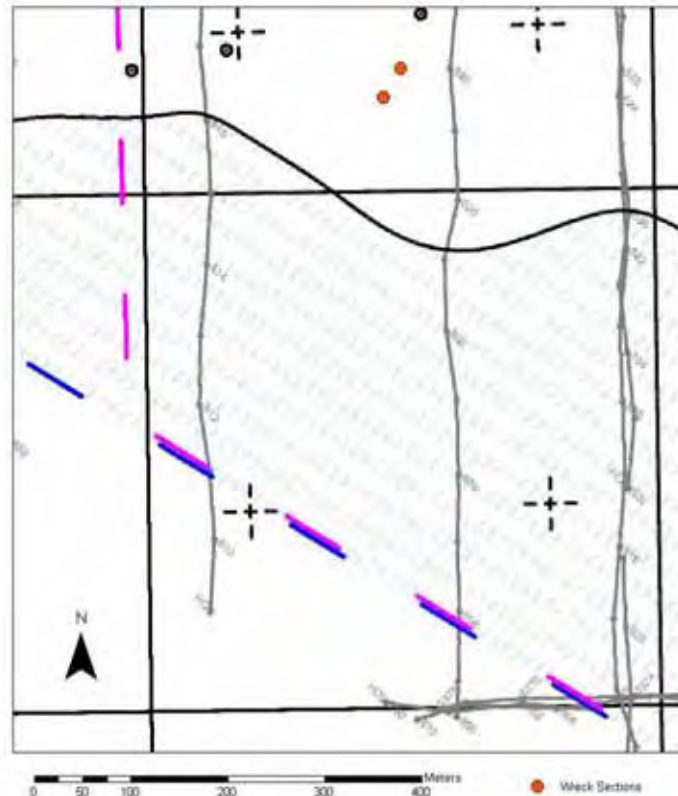
Side scan sonar data was obtained in 1995 using a Dowty Widescan (100/325kHz) analogue system. The archived data was viewed in paper format on thermal paper printouts. The 2003 bathymetry report (Andrews Survey 2003a) also contains a track plot and an interpretation of anomalies detected in the 1995 side scan survey. The approximate position of the site was identified on the track plot and the two adjacent north-south lines (H06/H07) were examined (**Figure 10**). Features identified were then cross-referenced with the Andrews Survey (2003a) interpretation.

Figure 10: 1995 side scan and sub-bottom profile track plot

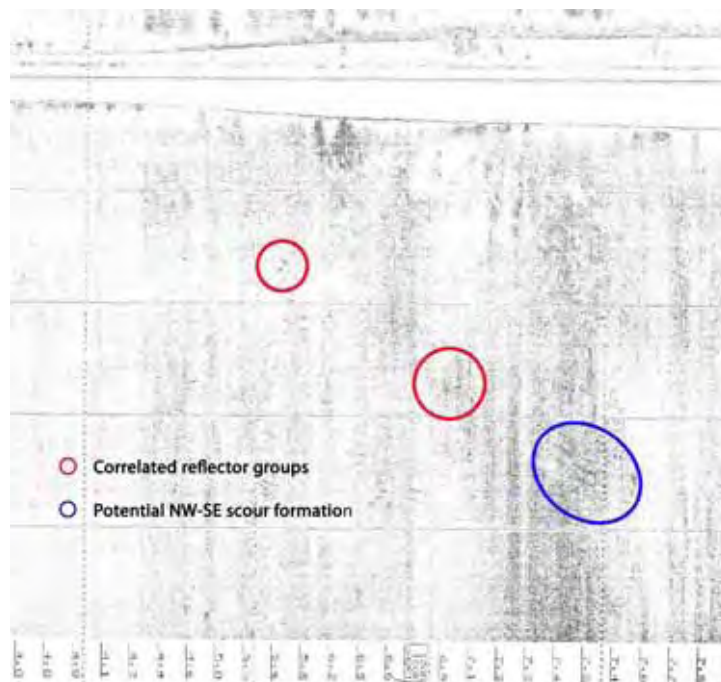
Without other coordinate data to work from, the anomalies on the thermal printout are extremely hard to identify, but two discrete reflectors, one a large point cluster and the other a linear oriented 'L' shaped feature perpendicular to the general bedform, are apparent (**Figure 13**). These do broadly correlate with the GPS positions recorded for the wreck sections.

Figure 13: Detail image of two anomalies and scour area

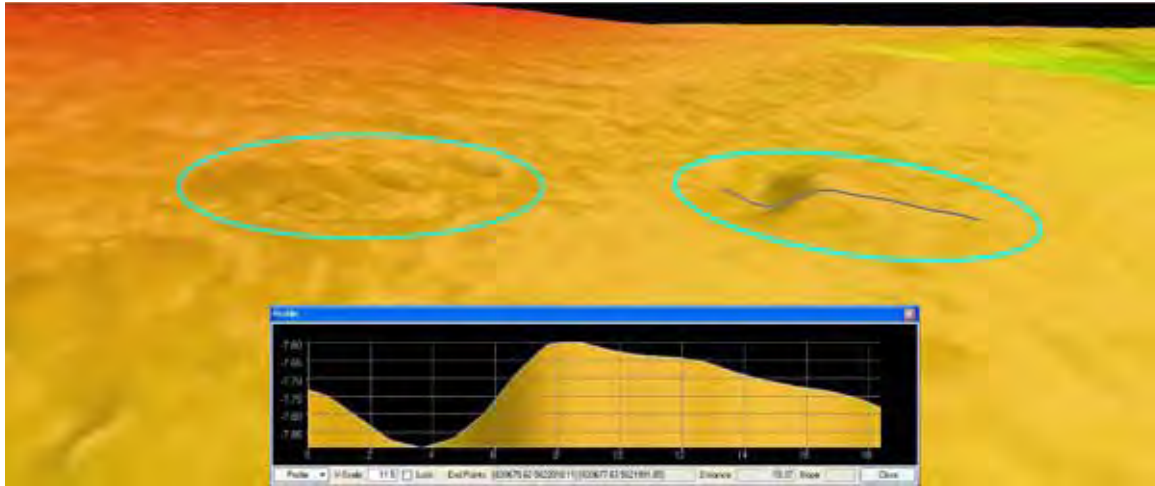
There is no clearly identifiable material at the north-western point. However, an area of disturbed seabed with clear pitting can be seen approximately 20 m north-north-west of the western section, and this may relate to the second reported second section of the site (**Figure 16**). Given the low profile of exposed material as reported previously, this material may simply not be visible at this resolution.

Figure 16: Perspective view looking east-north-east with a x6 exaggeration; to the right, the main feature highlighted with a cross section and shown in the inset image; to the left, a potential associated material featuring several pits or depressions
