**May
2014**

East Winner Bank Shipwreck

*Archaeological
site visit report*

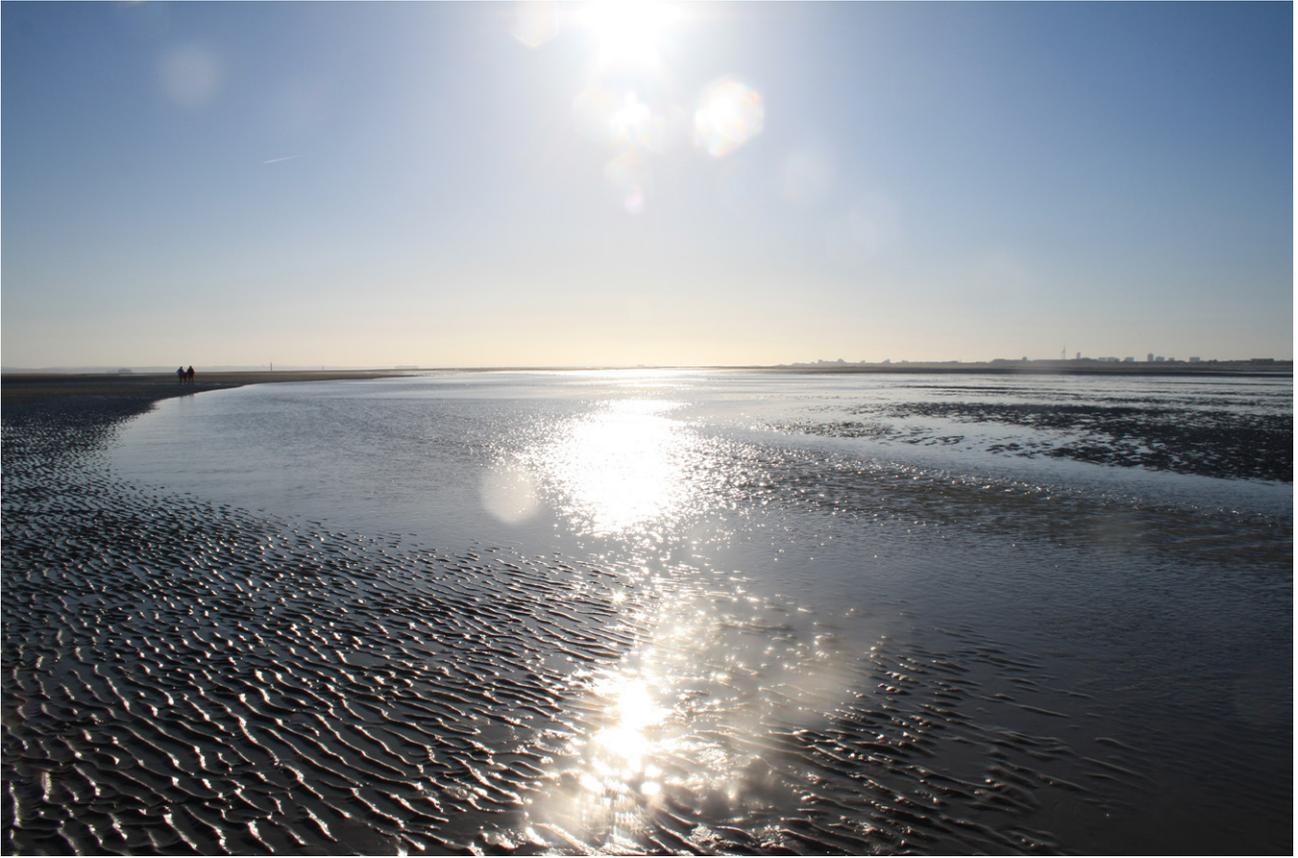
The circulation of sand on the East Winner itself is also covered by SCOPAC (O3) based on the previous work of Harlow (1980). This has noted that the East Winner bank is covered by ripples, sand waves and low dunes; analysis borne out by aerial photos (Figure 1) and observation while on site (Figure 2). Such features are noted by SCOPAC as characterising high sediment mobility, but in this instance operating within a closed system because of the inability of sediment to move in a westerly direction across the Langstone Harbour channel. Accordingly, a system has been proposed (SCOPAC: O3) of net transport in an offshore direction by tidal currents on the western face of the bank and onshore transport on the eastern flank as a result of wave action. Study into the overall shape and volume of the East Winner by Whitcombe (1995) has highlighted the fluctuating expansion and regression of the bank caused by shifts in the alignment of the outer Langstone Harbour channel.

Figure 2. General view, looking west across the East Winner bank, from the wreck site at low water (18.00 BST) on the 16th April 2016.
