Maritime Archaeology Trust

2019

Lelant Quay, Hayle

Site Report

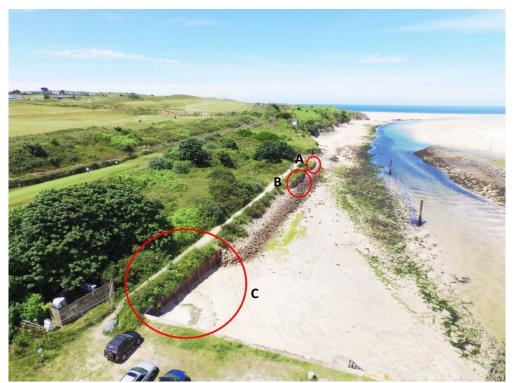
Figure 7: Lelant estuary, sections of ship hull revetment circled, Lelant/Dynamite Quay at bottom of photo (2016)

Three main sections of revetment survive (Figure 7) and it can be seen that the two most northerly sections (A & B in Figure 7) were once connected and appear to be from the same ship's hull. While Section A/B and C both appear to be constructed using recycled ships' hull, differences in apparent material and construction features suggests that the revetment hull panelling nearest Dynamite Quay (C in Figure 7) is from a different ship to that further north (A/B in Figure 7).

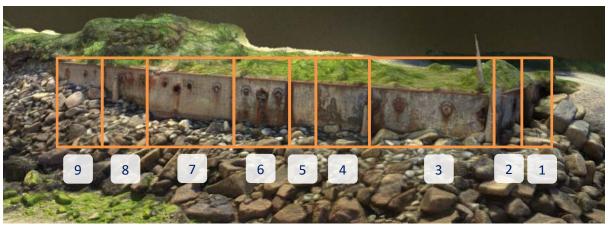
Figure 10: Northern most section of revetment, indicating separate panels (2016)

The northern most section of revetment (Section A), still extant in 2016, is approximately 16m in length, comprising 9 ship's hull panels (Figure 10).

To aid description, the individual panels in Section A have been numbered 1 to 9 (Figure 10).

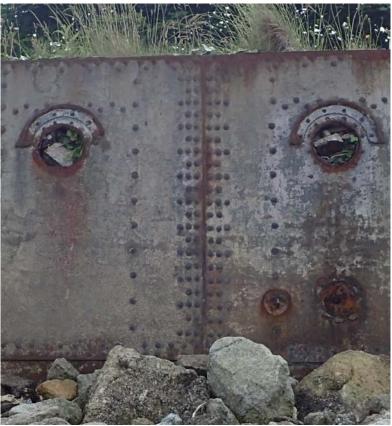
Figure 14: Treble chain riveting pattern for vertical joins

The vertical joins between panels (in Section A and B) are treble riveted butt joins. Though they could not be seen, it is assumed that a butt strap is located behind/inside the vessel. The riveting pattern here is referred to by McCarthy (after Thearle) as 'chain riveting', with alternately three and two rivets on both sides of the join (Figure 14).

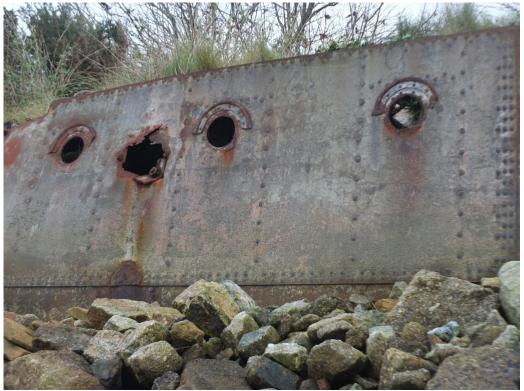
Figure 15: Horizontal joins – double riveted lap join

The horizontal joins (in Section A and B) are fastened with the top strake overlapping the one below, secured with a double riveted lap join (McCarthy 2005: 152) comprising a double row of rivets, one rivet above the other (Figure 15).

Note the riveting pattern around the portholes, with a double line of rivets (zig-zag pattern) across the top of the portholes and a single line down each side of each porthole (Figure 15 & 16).

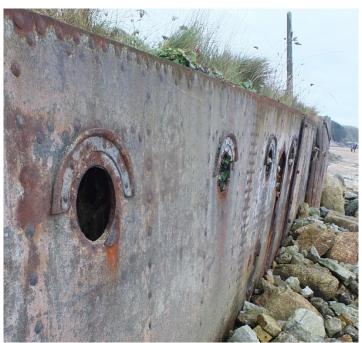
Figure 17: Reinforcements above portholes

A semi-circular reinforcing strip/visor can be seen above each of the portholes, fixed with 6 rivets (Figure 17). This is a typical feature for naval ships of the first half of the 20th century.

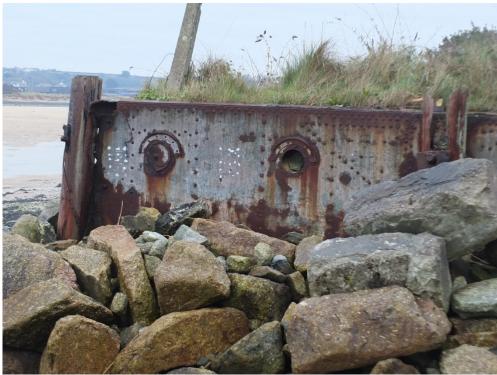
Figure 23: Panel 2

At the northern end of Section A, there are two panels (Panels 1 & 2 from Figure 10) at approximately 90 degrees to the panels so far examined in this section. Panel 2 has two portholes (one covered), see Figure 23.

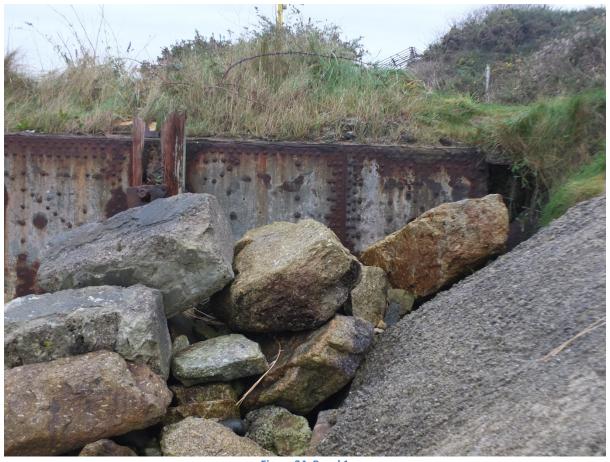
Figure 24: Panel 1

Panel 1 has no portholes (Figure 24). The top edge of the hull panels appear to be the ship's gunwale, this assumption is reinforced by the presence of deck fitting in Section B of the revetment (see Section 3.2.2).

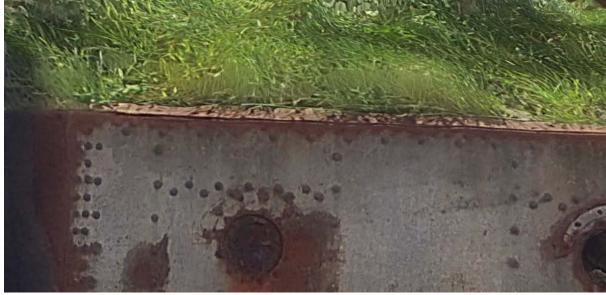
Figure 26: Gunwale riveting pattern Panel 10

The gunwale riveting pattern for all of the Section B panels (10 - 17 see Figure 25) is the same as Panels 6-9 in Section A (Figures 15 &16) except for Panel 15, on the end where it meets Panel 14. Here, the gunwale riveting pattern matches that for Panels 4 & 5 of Section A. Panel 15, like Panel 4, also has a diagonal line of riveting (towards top right corner of panel).

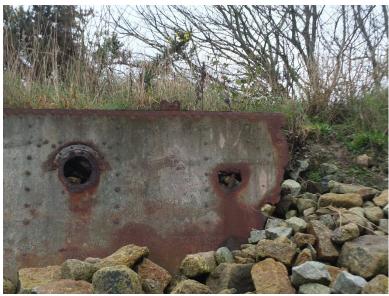
Figure 27: shroud plate on the gunwale (Panel 10, Section B)

On top of the gunwale, on Panel 10 is a shroud plate: a fixing point for standing rigging (Figure 27).

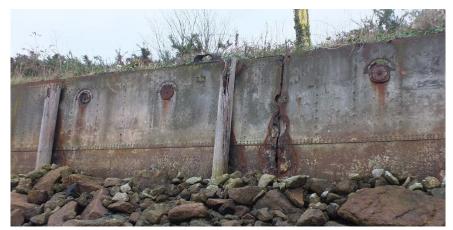
On the gunwale of Panel 14 a left hand fairlead can be seen (Figure 29 & 30). This would have been used to guide the vessel's mooring lines and along with the shroud plate on Panel 10, confirms that the top of the revetment was once the gunwale of a ship.

Figure 29: fairlead on gunwale of Panel 14, Section B

Figure 29 shows that for Section B, more of the lower strake can be seen. Note how the vertical joins in the lower strake (Figure 29) are also treble riveted and that the joins are staggered so joins in the upper and lower strakes do not line up, thus providing greater structural hull strength.

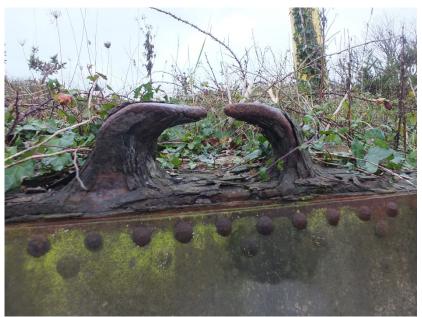
Figure 30: left hand fairlead, Panel 14, Section B
